The John F. Kennedy Center for the Performing Arts  
Washington, DC

## 2022 Comprehensive Building Plan

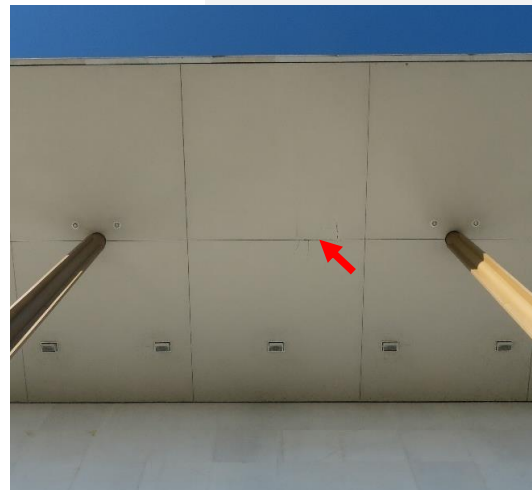
Figure 10. Staining and active leak location at stucco panel joint at the south facade.

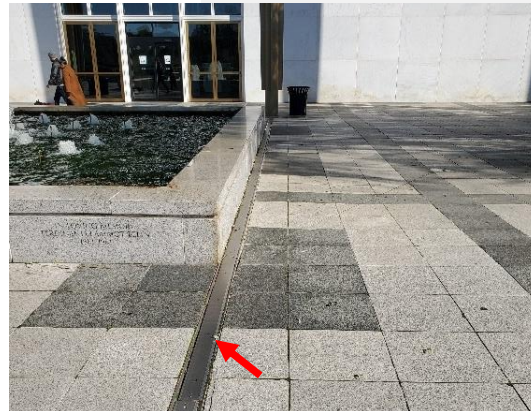
Figure 31. Plaza Level metal expansion joint cover at the west side of the plaza. Note active leaks were observed along this expansion joint at the Level A parking area below.

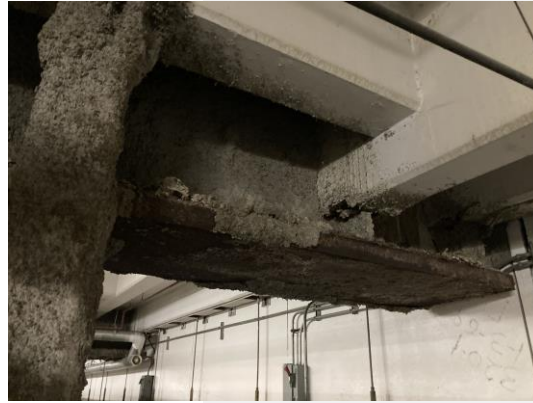
Within the parking garage at the A-level, there are additional local areas of missing fireproofing. The ceiling of the A-level at the west side of the building is made up of a system of large steel plate girders, which cantilever beyond the lower levels' footprint to form the overhang at Rock Creek Parkway. Steel hangers support the A-level floor from these girders above. The steel girders and hangers are encased in spray-applied fireproofing, which has become patchy and is missing in local areas. The fireproofing is in notably worse condition at the two girders that are aligned with the building expansion joints, due to water infiltration at the joints. The smaller steel beams, running perpendicular to the cantilevered girders, are typically encased in concrete. The concrete encasement is in good condition at typical girders but is cracked and spalled near the expansion joints above. At these locations, patches of the encasement have come loose and are missing.

Figure 39. Missing fireproofing at A-level structural support

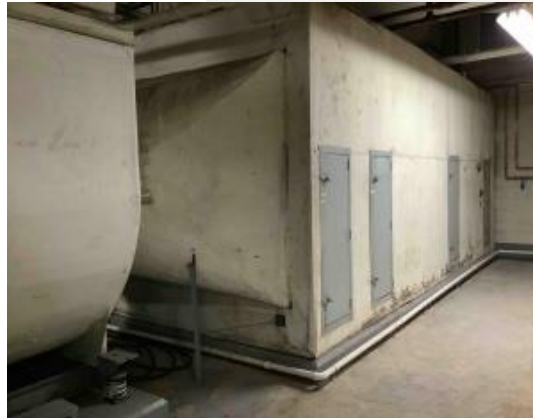
Figure 64. Existing Refurbished AHU – original casing with new interior components

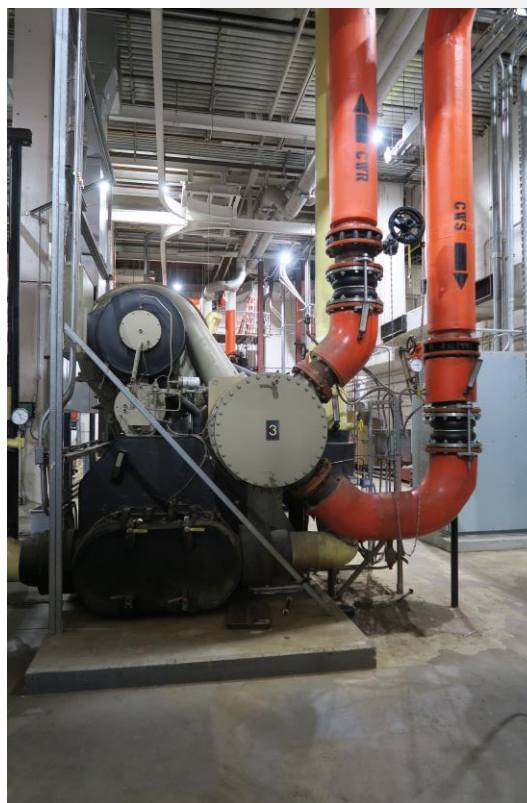
The existing chillers have been in operation for nearly 20 years. With proper maintenance, the anticipated service life for an electric centrifugal chiller is 25-30 years. The chillers have been routinely serviced and appear to be in fair to good condition. A "Chilled Water System Evaluation and Analysis" study was performed in support of the 2015 Comprehensive Building Plan. This study recommends the replacement of two of the chillers with new, high efficiency, VFD driven, variable flow chillers in order to increase plant efficiency and yield significant energy savings, while being a less costly option than replacing all four chillers. High efficiency, VFD driven chillers afford the facility an opportunity to capitalize on available low condenser water temperatures and allow one or two chillers to meet loads, an improvement over the current need to use two or three chillers. Various other aspects of the plant control system, including pumps, chilled water bypass, and

Figure 68. Existing Chiller (#3)

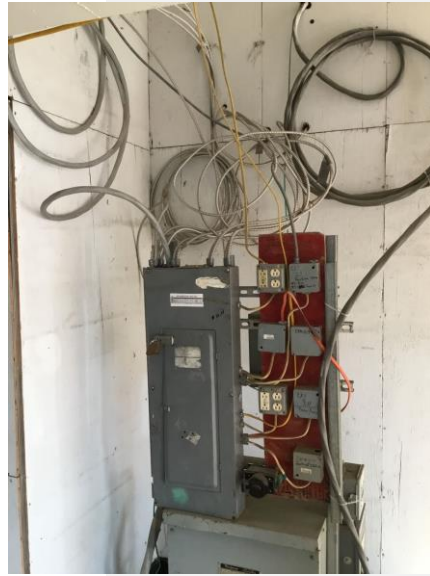
Most of the facility's electrical rooms and closets are original to the construction of the building, and some do not meet the requirements of the electrical code in terms of layout, working space, and firestopping of penetrations. It may be required to increase electrical space square footage to meet code-required working clearances and dedicated equipment space.

Figure 75. Existing Electrical Panel

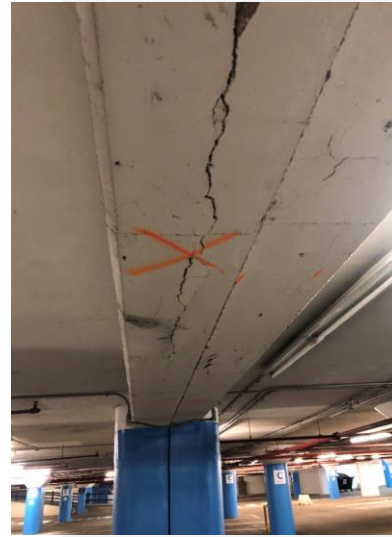
Figure 88. Concrete Cracks at Parking Garage Level C

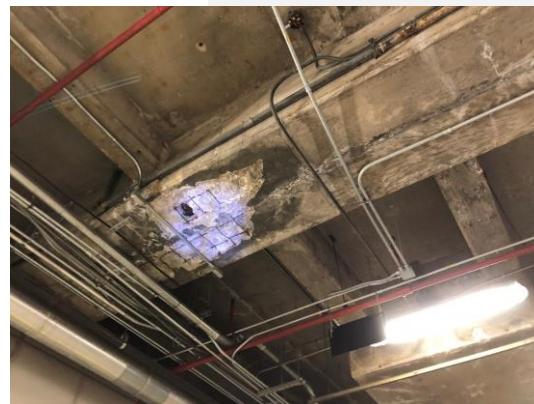
Figure 89. Exposed and Corroded Rebar at Loading Dock Concrete

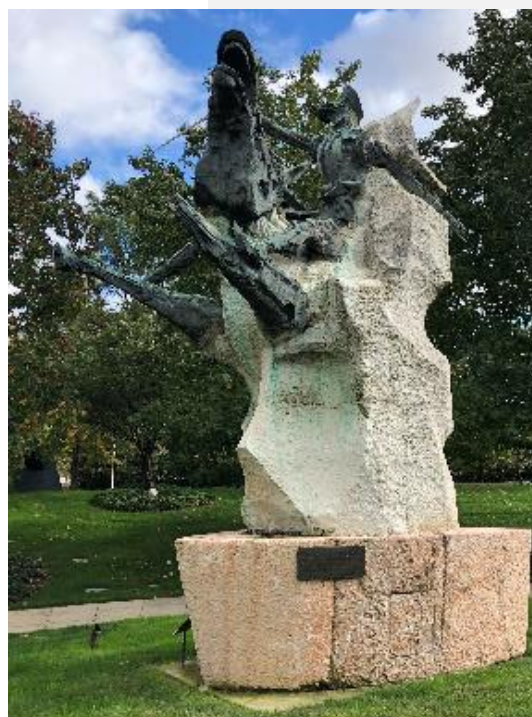
The protective wax coating on *Don Quixote* has deteriorated and is no longer providing a protective barrier. As a result, the bronze surface has dulled, and the patina has oxidized in an undesired and irregular manner. Also, the lack of protective coating caused the white limestone to develop copper staining caused from water run-off from the bronze

Figure 91: *Don Quixote* located on the north lawn of the Kennedy Center.

Individual conservation work for *Don Quixote*, *Untitled*, *War or Peace* and *Amerika* to restore the protective coatings and prevent further deterioration from occurring on the sculptures.
