# John F. Kennedy Center for the Performing Arts

## 2021 Comprehensive Building Plan – Presentation of Facts and Findings

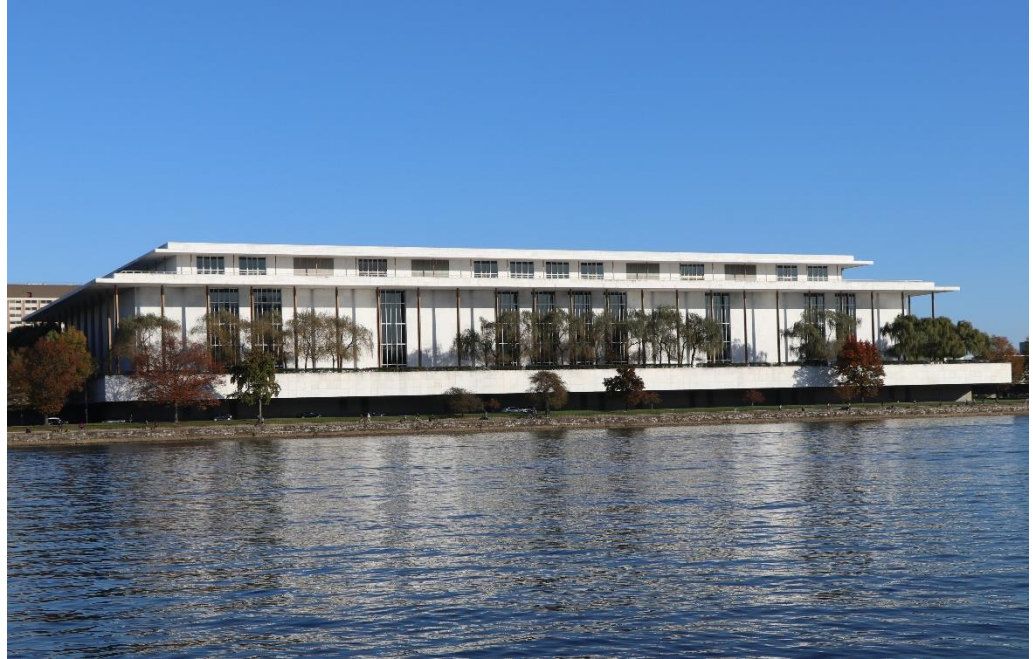
- Overall, the marble panels and joint sealant are in fair-to-good condition.
- More concentrated marble and joint sealant distress, previous repairs, and discoloration were observed at:
  - Rock Creek Parkway Overhang
  - Plaza Level Overhang
  - Terrace Level Overhang
- Per 2020 CBP, the last round of facade maintenance repairs were completed in 2010. At the Rock Creek Parkway Overhang, broken panels were replaced in 2005.

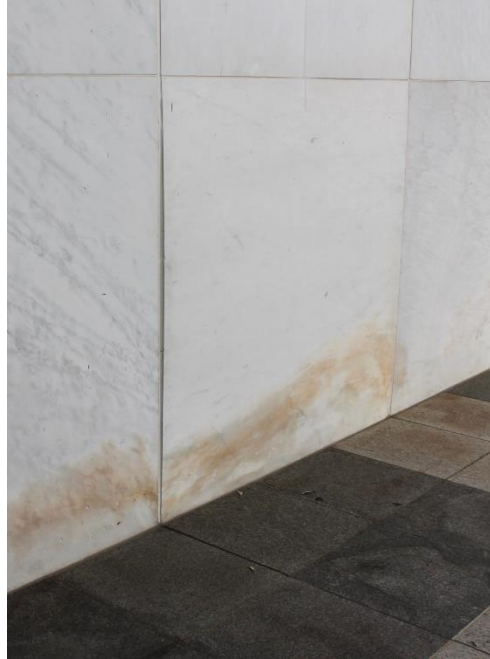
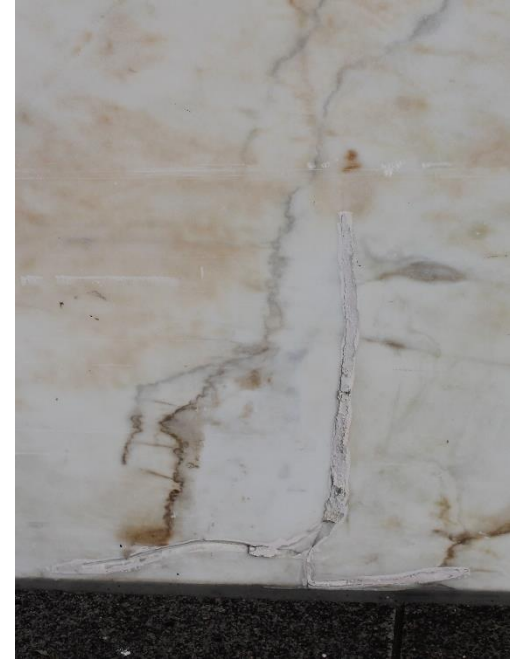
- The following distress types were noted:
  - Mild degradation or bowing due to hysteresis
  - Cracks, spalls, incipient spalls
  - Weathered veins and inclusions
  - Erosion and weathered surfaces
  - Failed previous repairs
  - Discrete adhesively failed sealant
- Previous repair types include:
  - Through-face pins
  - Crack repairs
  - Reattached fragments/dutchman
  - Small patch repairs
  - Replacement panels

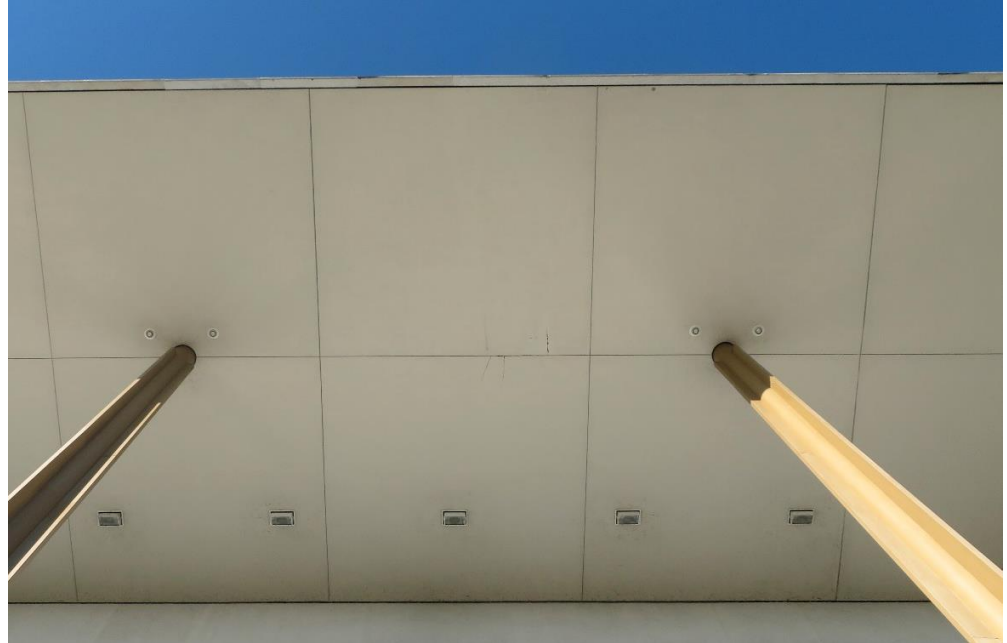
- Active leaks and staining were observed at discrete stucco panel joints around the building perimeter.

- Overall, the stucco is in fair condition and the sealant joints are in poor condition.
- The metal louvers are in generally good in condition.

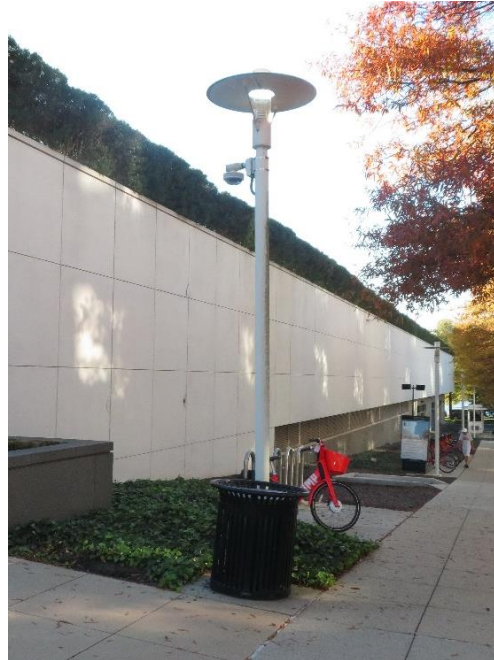
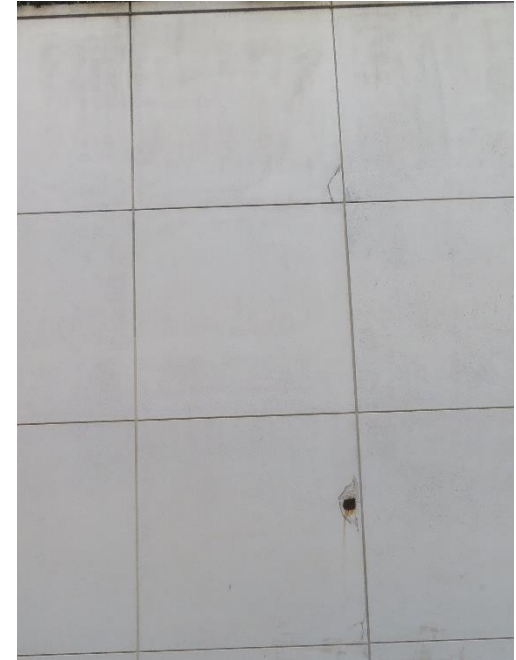
- The precast and reinforced concrete walls, retaining walls, and planter walls are generally in good condition with some cracking observed throughout.
- At the north and west facades' precast panels, there are cracks and incipient spalls coincident with anchors that are potential fall hazards.
- There is general soiling (atmospheric and biological) with areas concentrated soiling near plants, roads, and at skyward surfaces.
- There are cohesive and adhesive failures of the joint sealant. The metal louvers are in generally good condition.

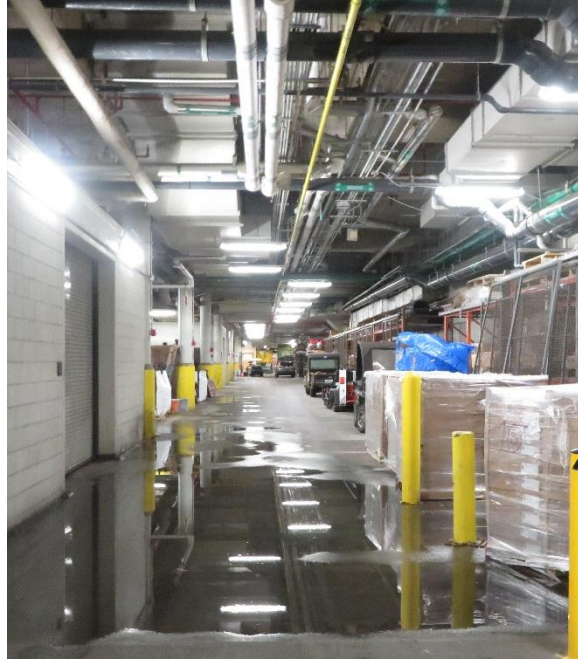
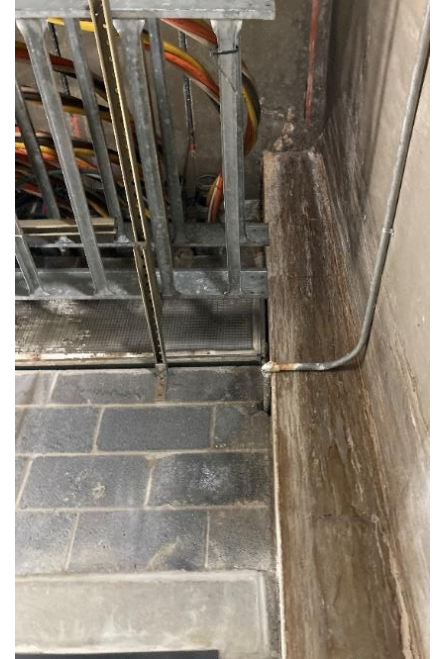
- Staining, concrete distress, corroded steel, and efflorescence indicating past and potentially ongoing water infiltration were observed. At some active leaks, there are metal pans and gutters to help redirect water.

- The east transformer vault rooms (as well as north pump rooms)
  - Staining most heavily concentrated on west wall, west ends of beams, and columns of the transformer room.
  - Spalling and cracked concrete at encased steel beams and slab.
- Garage northeast corner (Level B)
- Mechanical ducts/shafts
- Pipes and pipe penetrations
- Expansion joints

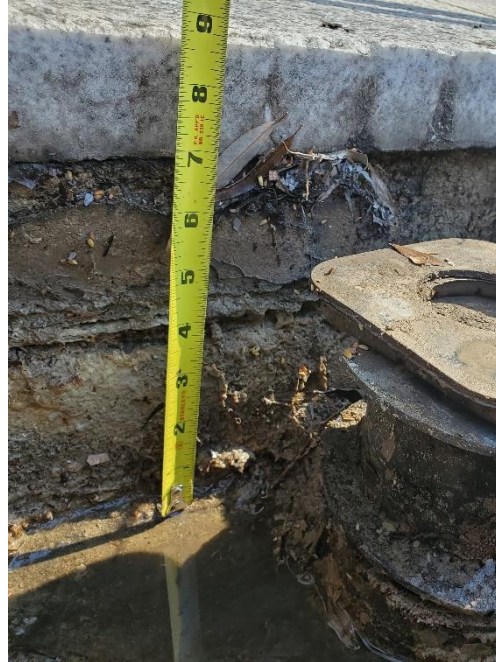
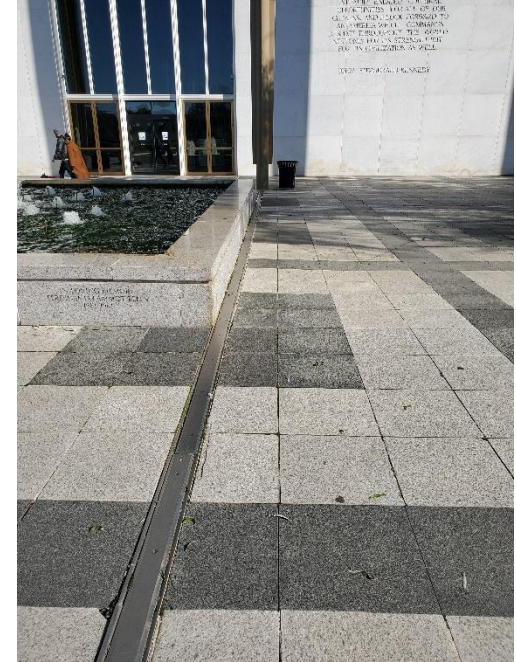
- The Hot-Fluid-Applied Reinforced Rubberized Asphalt (HRA) membrane and paver assembly was observed at discrete removable pavers (at drainage trenches).
- The paver joints were very tight (less than 1/8 inch) along the trench drains.
- Debris was observed within the trenches and around the drains.
- There are multiple expansion joint cover and filler types throughout the Plaza Level. The joint covers are typically in poor condition. The concealed joint seals at the waterproofing membrane could not be assessed visually.

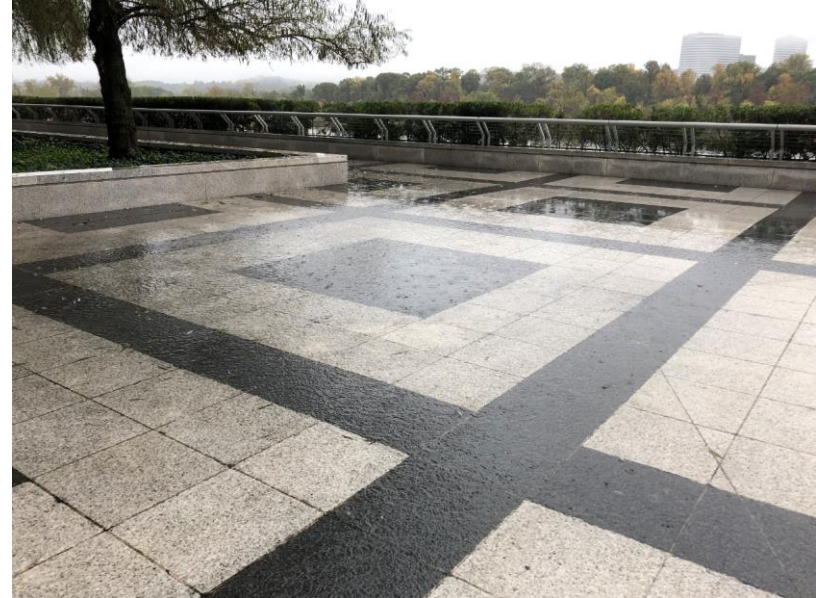
- Large areas of ponding observed between planters at River Plaza
- Depth of ponding appear to be up to approximately 3" on day of site visit, during a rain event
- Similar amount of ponding at both north and south planters

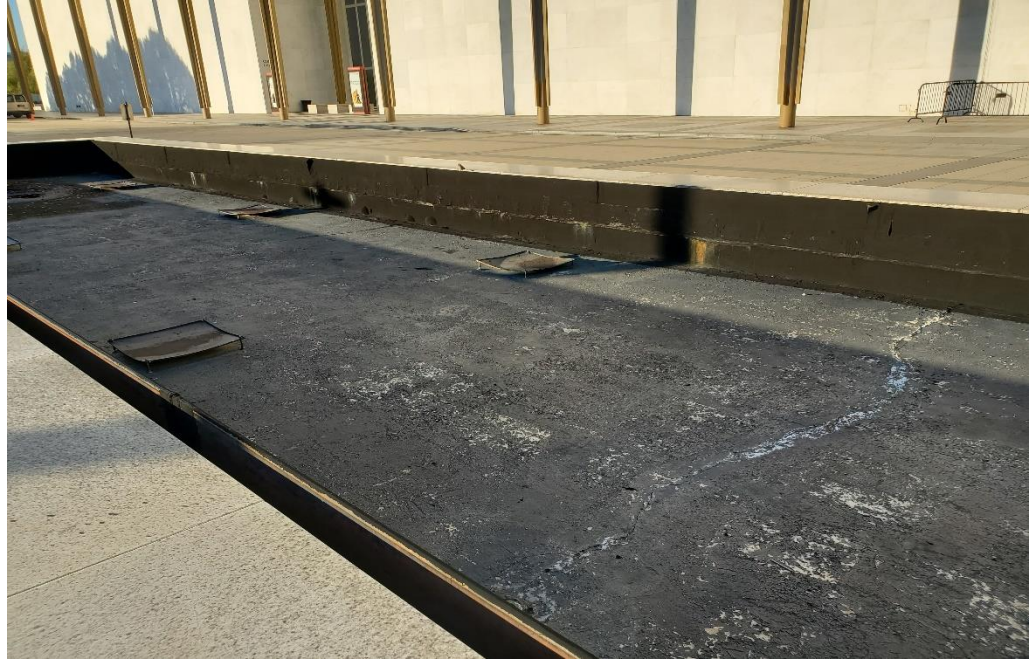
- The fountain basin liner coating is in poor condition at all five fountain basins with varying extents of adhesive failure, blistering, splitting, and pinholing evident. East fountain liner coatings are typically worse.
- At the rectangular east reflecting pool, cracks are present in the concrete topping and extend through the liner coating.
- Ferrous pipes exhibit expansive material corrosion, which creates a failure in the waterproofing flashings.
- At the west square-shaped fountains, active leaks were observed below pipe penetrations and along the structural deck expansion joints immediately adjacent to the fountains.
- At the granite units, orange-brown, black, and green discoloration, efflorescence, discrete stone distress, and failed joint sealant were observed.

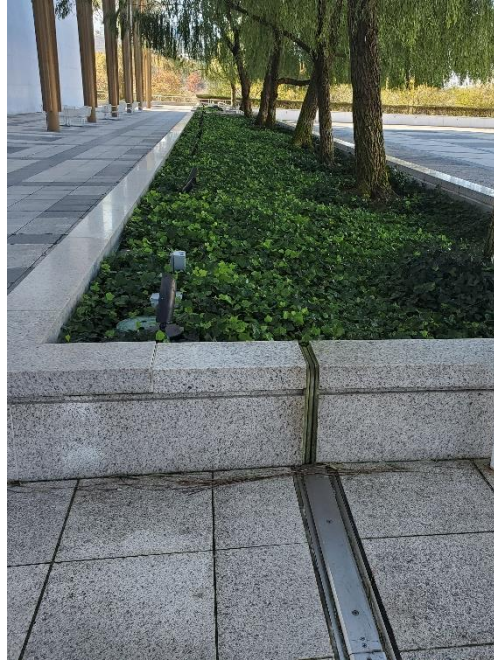
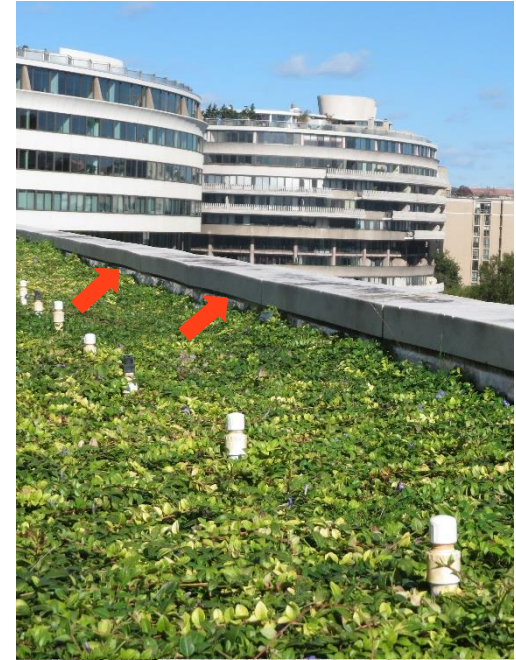
- At the granite units, discrete cracks, spalls, efflorescence, orange-brown, black, and green discoloration, and failed joint sealant were observed.
- The planters align with expansion joints.
- Drainage board is not sufficiently UV resistant and is currently at the walls of the planters.

- At the marble units, bowing, cracks, spalls, abandoned anchors, orange-brown and black discoloration, and efflorescence were observed.
- The sealant is in fair condition with localized bulging and adhesive failures primarily near expansion joints.

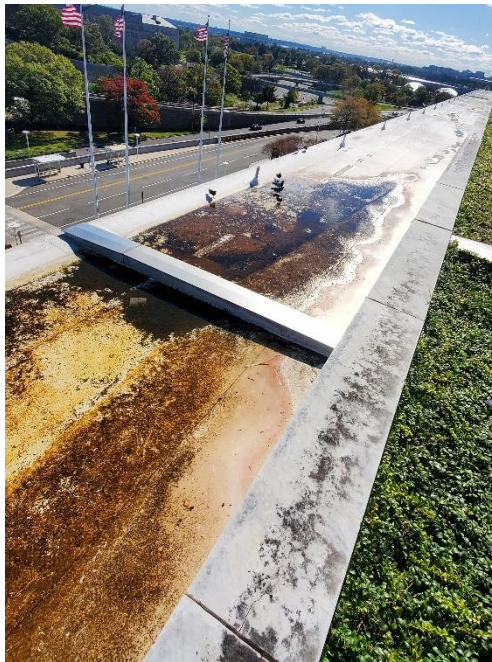
- Fair condition - Mechanically-attached thermoplastic single-ply roof membrane (ca. 1997). 2-5 years with maintenance.
- The following limited and localized distress was observed:
  - Failed and holed flashings at multiple drains
  - Seam failures
  - Membrane cracking at fastener plates
  - Cohesive and adhesive failures of the joint sealant along the sheet metal expansion joint covers and flashings

- The gravel-surfaced coal tar pitch BUR roof membrane assemblies are in fair condition overall. 10 years with maintenance.
- Approximately 15 to 20 isolated locations requiring near term maintenance include:
  - Failed lead pipe boots
  - Cracked/split membrane penetration and base flashings
  - Field of membrane blisters / brittle "soft spots"
- The joint sealants at the sheet metal expansion joint covers and perimeter flashings are cohesively failed.

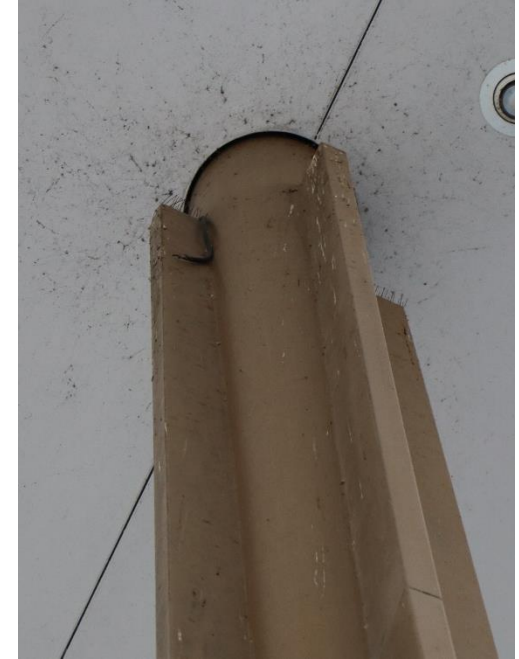
- Mild surface corrosion and flaking paint was observed at the base of approximately 50% of the columns.
- Additional distress types noted include:
  - Chipped, scratched, and missing paint
  - Chalking and discoloration
  - Cracked paint along fin joints
  - Discrete bent, separated, and corroded metal fin bases
  - Bird droppings and bird proofing

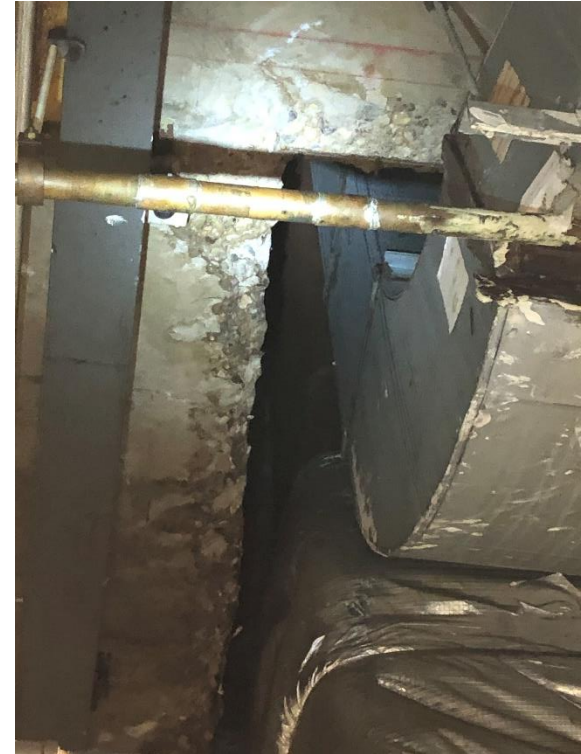
### Roof Leaks at Kitchen Exhaust

- Active water infiltration at kitchen exhaust in MER 11. Water observed dripping through on a rainy day and collecting on tarp at floor level
- Staining and spalled or loose concrete at concrete slab edge
- Minor corrosion of steel framing at opening

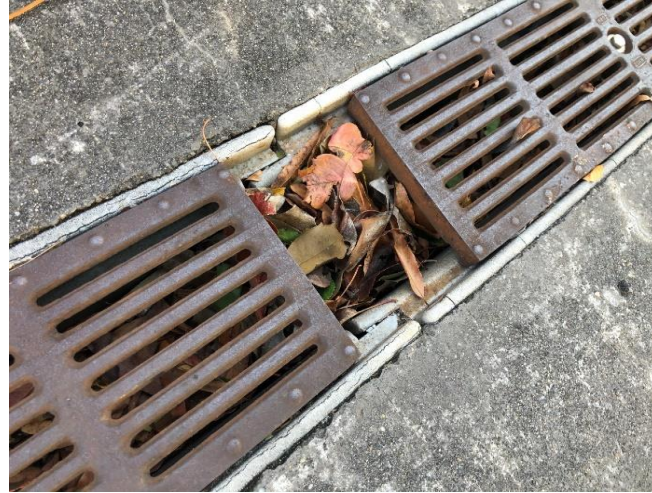
- The existing drains along the sidewalks and courtyard area were observed to have leaves and trash.
- The existing trench drains between the plaza and main road were observed to be severely broken and full of trash and debris.

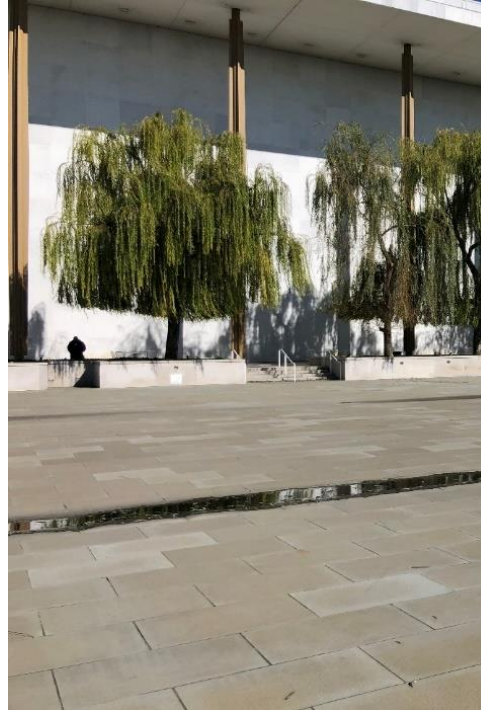
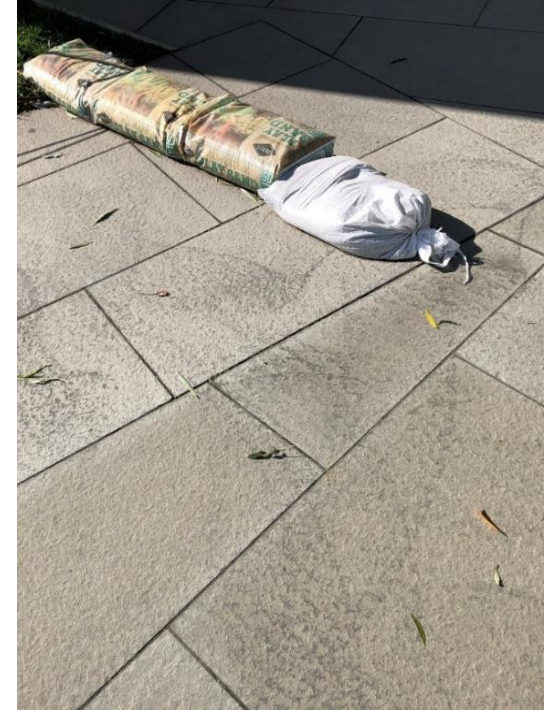
- Standing water and sedimentation observed in plaza between the main building and The Reach.
- The existing grades in this area is recommended to be analyzed for regrading to mitigate flooding and standing water after a rain event.
- A build up of foliage and debris was observed at the drain tops.
- Sandbags were placed to help redirect runoff towards the existing drains.

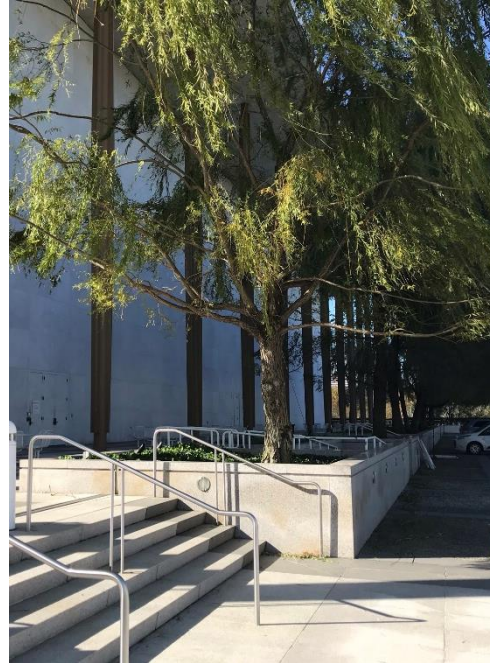
- Willows are old and in decline. Some have been severely pruned or removed already. Others have been reinforced with cables.
- Pavers in pedestrian area show signs of wear: chipped edges, staining, crumbling mortar.
- Ivy is dying back in planting area by vehicle entrance. Grass is growing through Liriope. Inkberry Hollies are over pruned and leggy.
- Railings at ramps have chipping paint and rust stains at connections to concrete.
- Concrete is cracked in multiple locations and there is general staining. There are cracks in the concrete walls at lights.

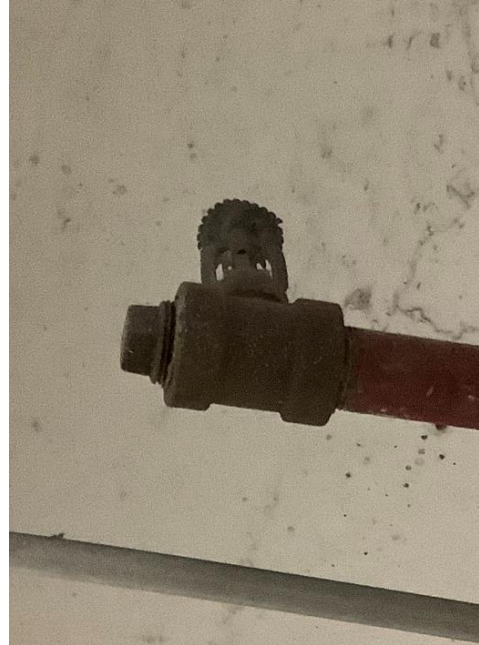
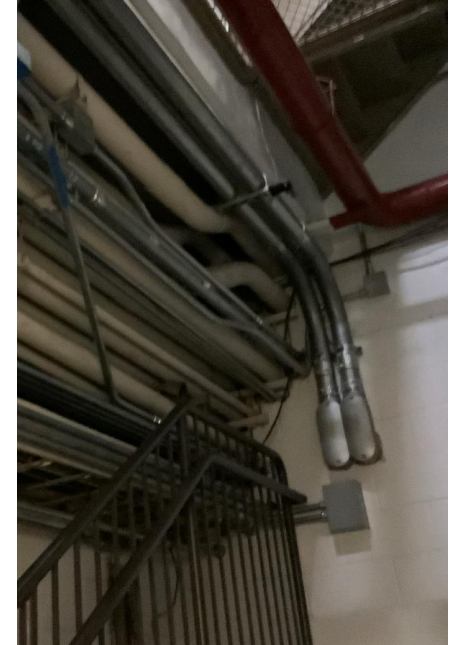
- The fire alarm system is obsolete and requires replacement – design project is currently underway to address the issue.
- Dry-pipe sprinkler system in Garage is being repaired as it begins to leak. Remediation could be adversely affecting performance of sprinkler system.
- There are non-permitted penetrations in exit enclosures.
- Various areas of the building, such as the paint spray booth, need a sprinkler system.
- Several components in existing sprinkler system need to be replaced or repaired.
- Fire pump room on Level A does not have emergency lighting – design project is underway to address the issue.

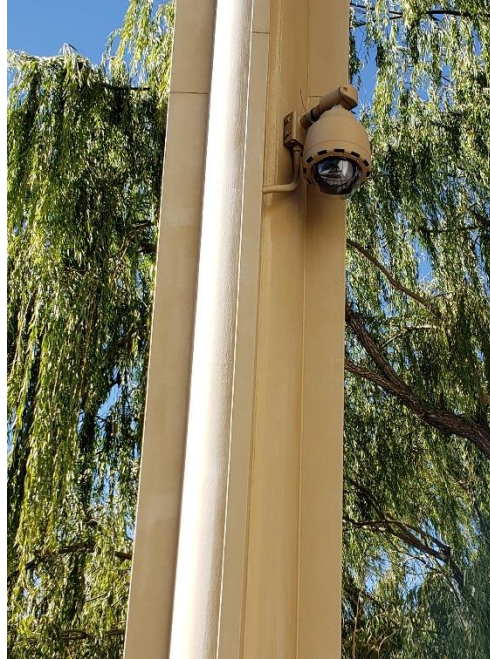
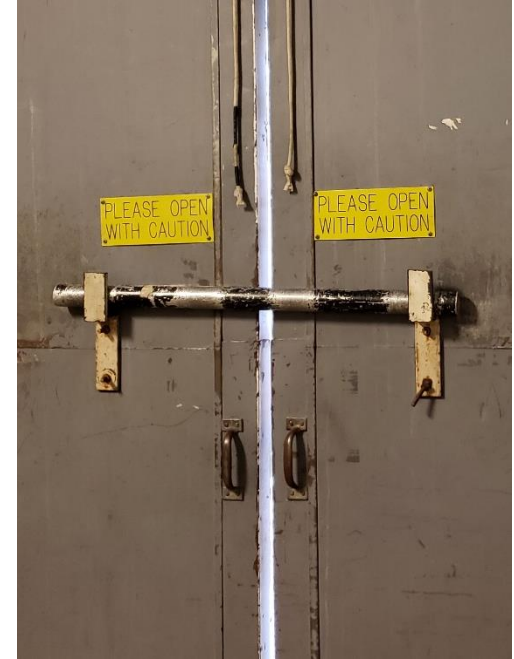
- Property and building access has limited resistance to vehicular and ballistic threats. Limited responses.
- Ballistic Hardening to SOC Level
- Video Surveillance System is inconsistent in capabilities and application
- Egress doors aren't monitored
- System lifecycle maintenance and replacement plans are insufficiently documented

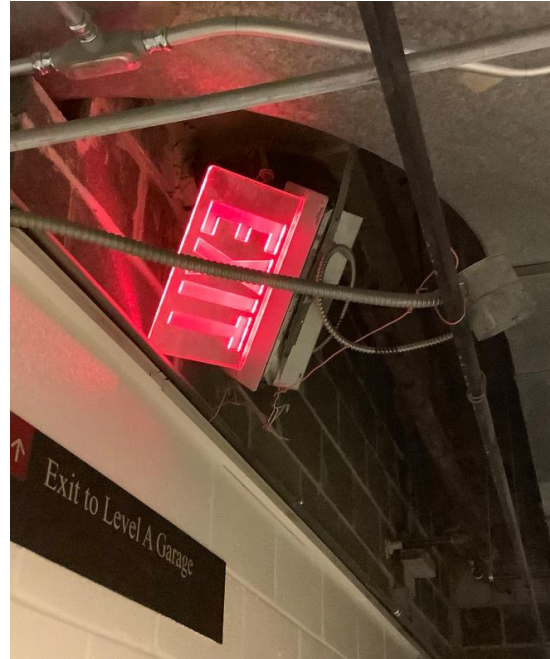
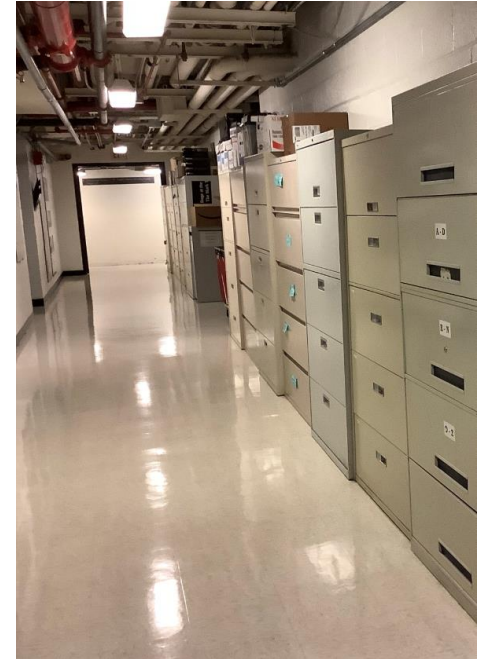
- Extent of missing/damaged fire proofing in garage levels and roof terrace level atrium needs to be investigated.
- Fireproofing needs to be provided at existing steel trusses where not currently encased or spray applied.
- There is storage in corridors that impede intended egress widths.
- There are door hardware and maintenance deficiencies.
- There are locks on intermediate egress doors in necessary egress paths.
- Exit signs need to be added, removed, or replaced in several areas.
- NFPA 80 mandated fire door assembly inspections is needed.
- There are headroom obstructions that need additional signage and marking.

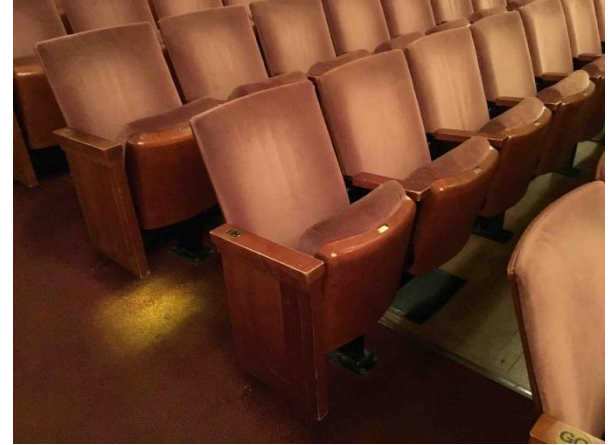
- Limited flexibility for amplified and spoken word uses – excessive reverberation and loudness on stage
- Limited space for musicians on stage, stage floor nearing end of life, can no longer be refinished.
- Riser configuration causes some on stage hearing issues, lift machinery requires replacement
- Unwanted acoustic reflections from balcony face
- Reflector canopy allows for limited flexibility and has inadequate lighting; replacement lamps are no longer available
- Fixed seating, carpet appear worn, wood panels and railings are scratched

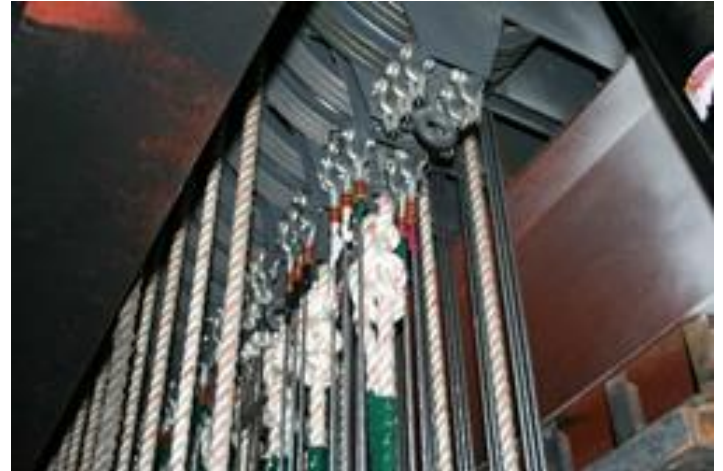
- Existing double-purchase counterweight rigging systems are aging and are time and labor-intensive to use.
- Existing orchestra pit lift controls and safety interlocks are aging, obsolete, and in some cases failing.

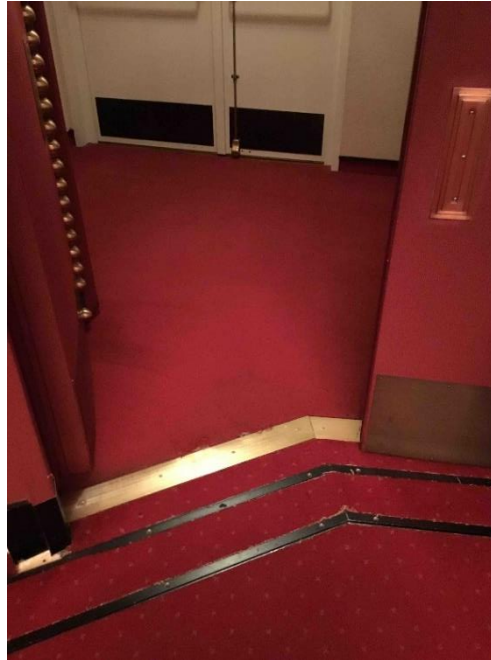
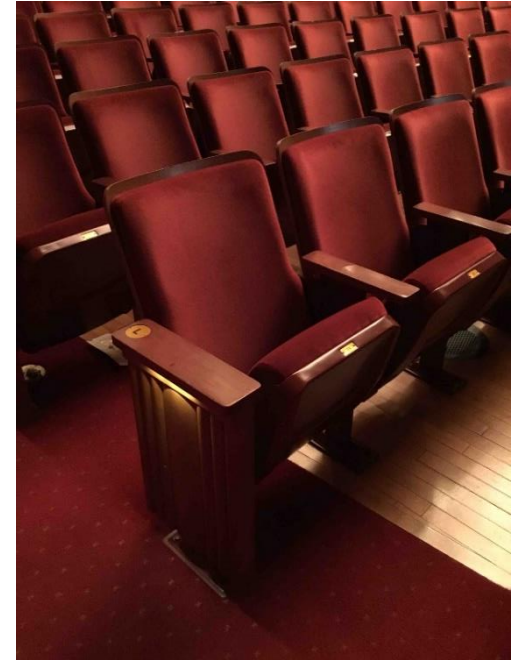
- Fixed seating appears worn
- Existing carpet is fraying, particularly at cable pathways

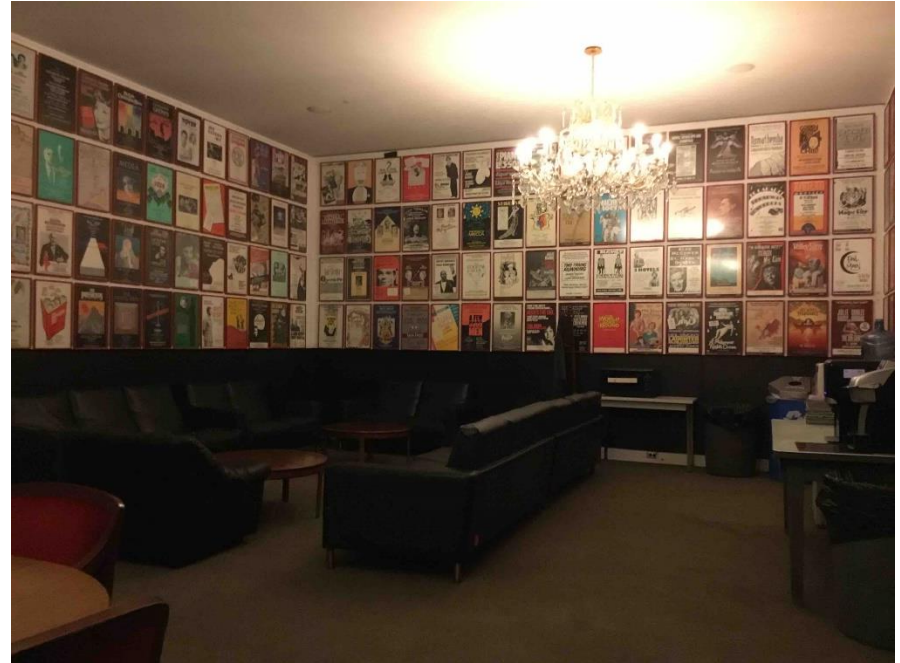
- Back-of-house and backstage space could be used more efficiently
- Eisenhower Theater Green Room:
  - finishes and furnishings are worn, appearance is not of a green room of a premier arts institution
  - Small kitchenette counter was added but space needs adequate kitchen space

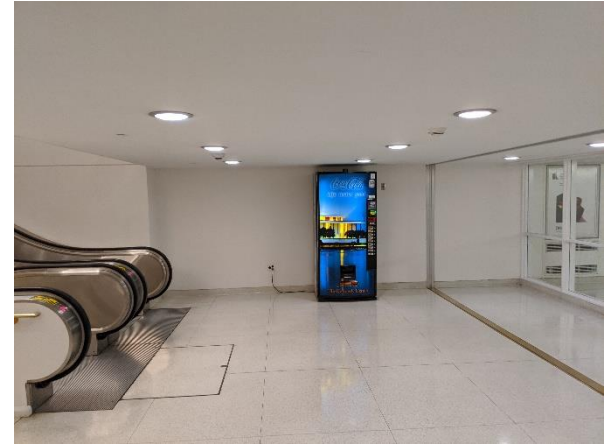
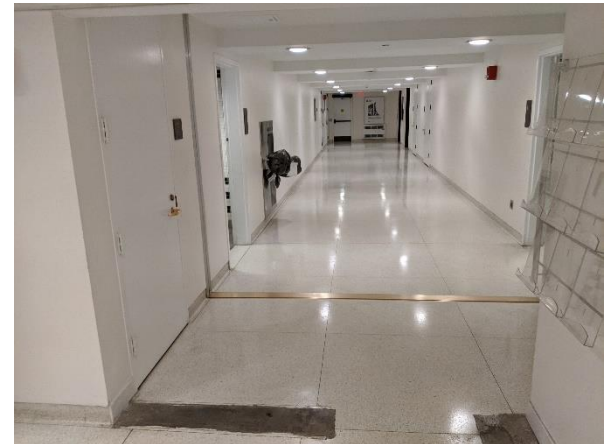
- Motor lobbies provide the first impression to JFKC patrons – they should reflect the identity of JFKC as a premier arts organization. The stairs are well designed and appropriate for main entry to the facility, but the motor lobbies are not
- Restrooms adjacent to motor lobbies are worn and dated and in need of an upgrade – design project currently underway to renovate restrooms
- Accessibility improvements include:
  - Install detectable warnings at stair landings
  - Access from garage:
    - Provide curb cuts and ramps at North and South doors
    - Access from garage: Provide railing at level changes

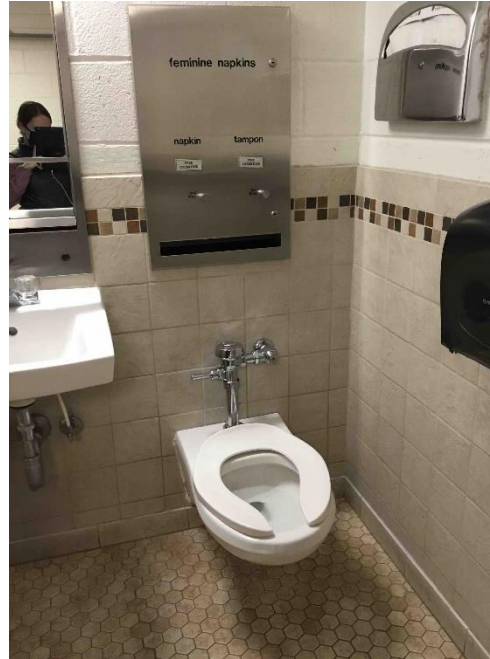
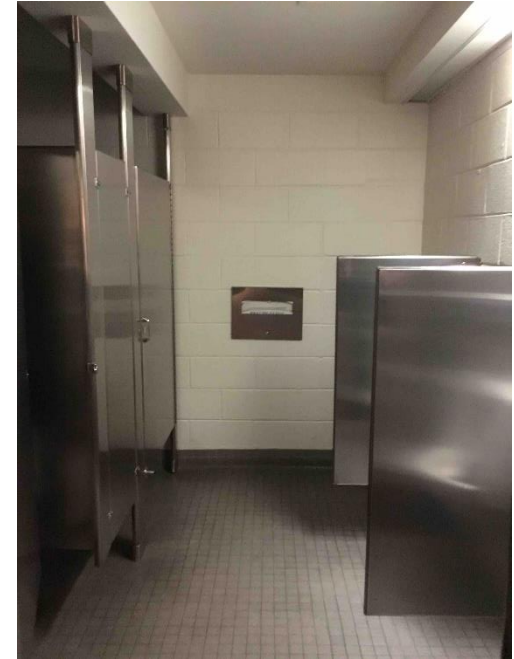
- some bathrooms throughout the facility do not meet ADA maneuvering clearances and mounting heights
- many plumbing fixtures, light fixtures, wall and floor finishes and countertops appear worn and dated
- many bathrooms are not properly ventilated

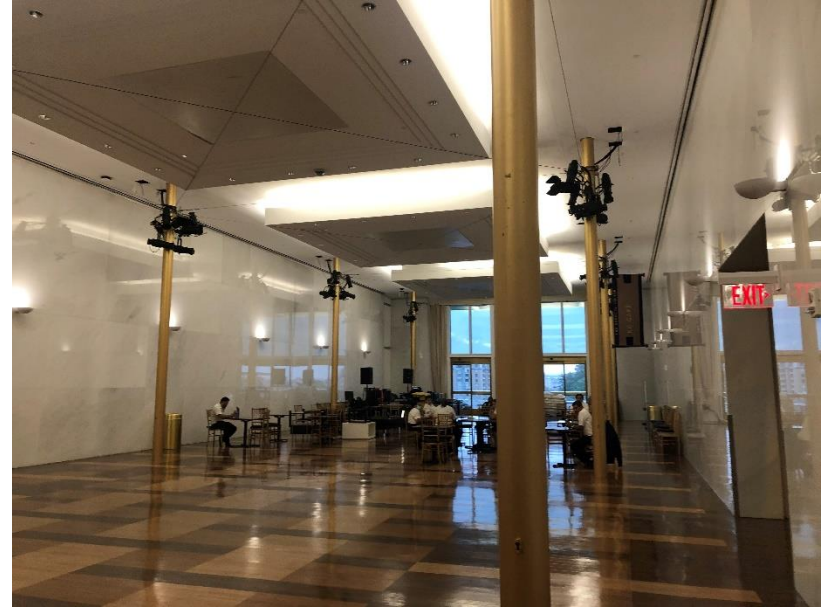
- The ceiling of the Nations Gallery has a network of fine cracks throughout the finish
- Similar cracks were not observed in the States Gallery
- No signs of large cracks or movement

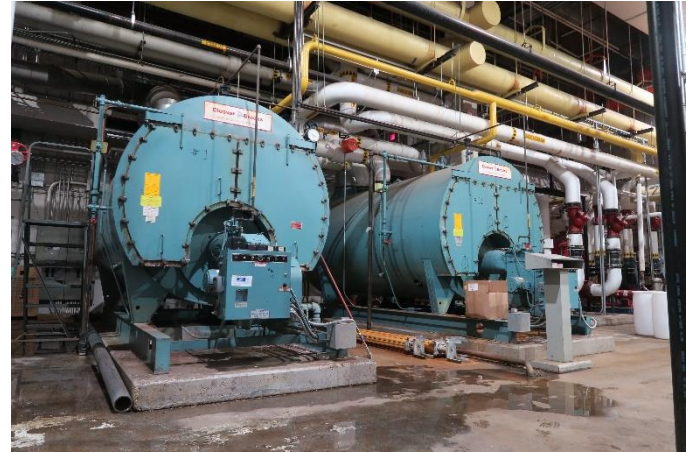
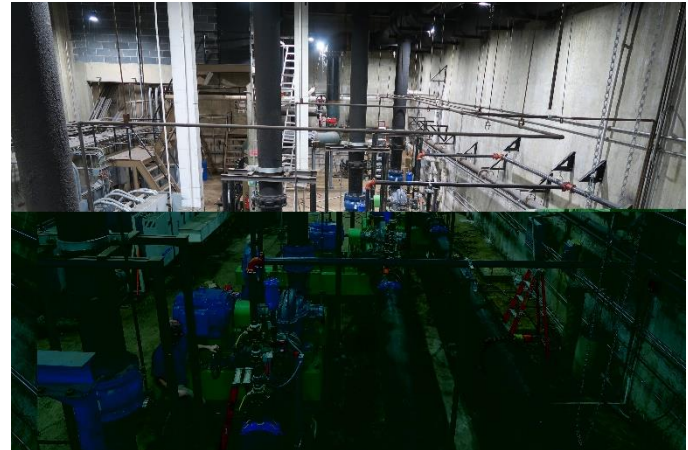
- Increased winter cooling demand requires additional plate and frame economizer capacity.
- Boiler plant flue noted to have leakage. To allow preventative maintenance, providing a smaller summer boiler allows operating flexibility.
- A dedicated cooling and dehumidification system for the main condenser water pump room will help protect newly installed equipment.

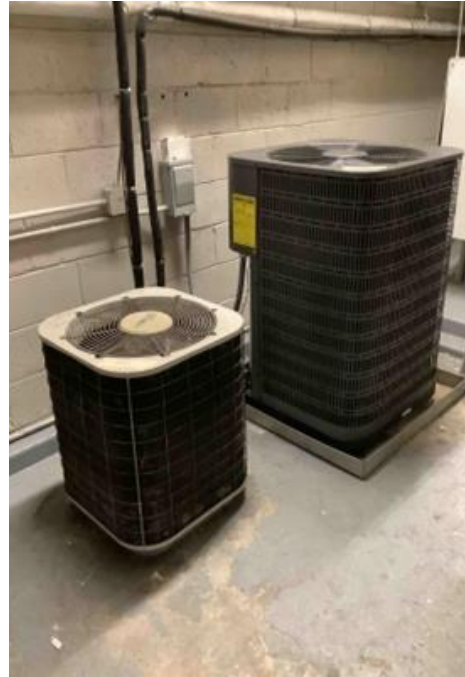
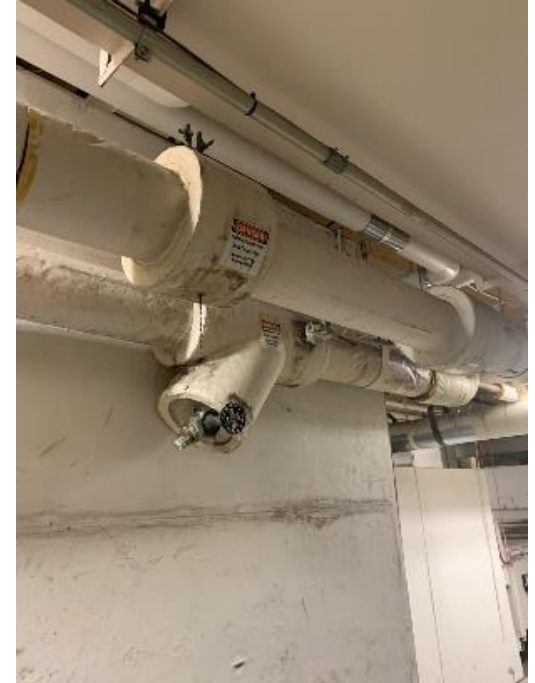
- Spot ACM remediation recommended to allow full access to piping components, like strainers.
- Allowance for replacement of DX systems, due to age.

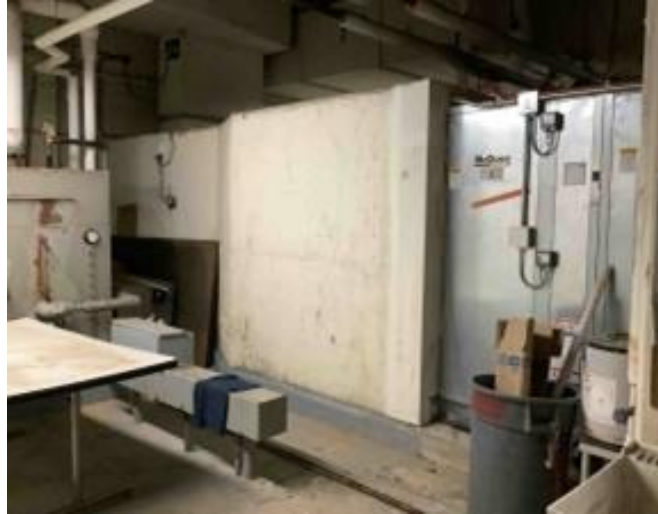
- The balance of AHU upgrade work is recommended to complement previously completed work on coil and supply fan components. Existing original return air section cabinets are in poor condition.
- No longer used electric boiler and hot water heating equipment takes up space area that can be used for other purposes, like storage.

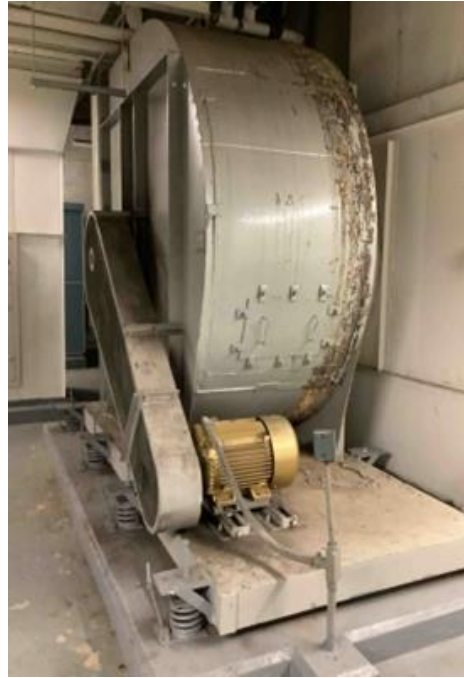
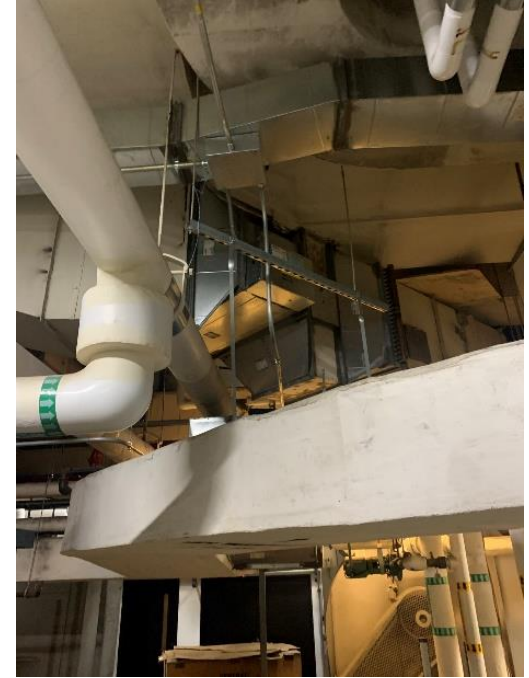
- Return fans are in fair condition – allowances for spot motor replacement are recommended.
- Existing terminal boxes are difficult to access for maintenance in some mechanical rooms.

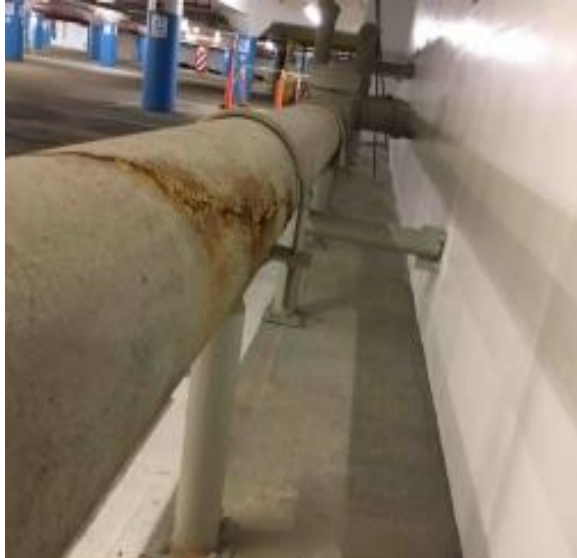
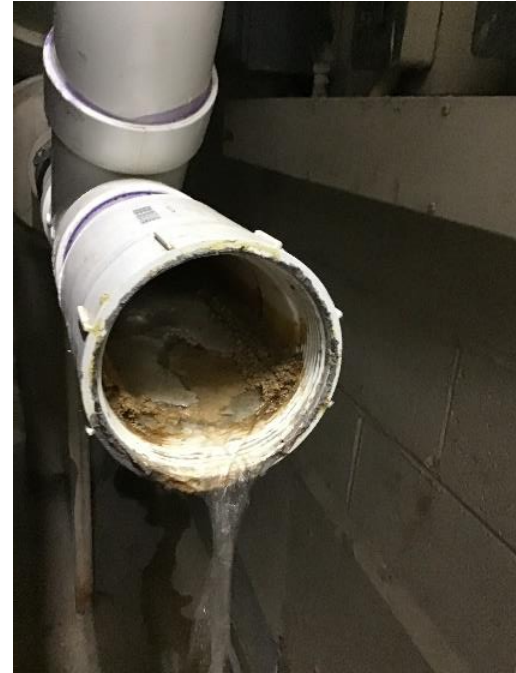
- Original sanitary system piping is at end of life and requires modernization.
- Original domestic water distribution systems are at end of life and require modernization.
- Stormwater sump pumps require replacement.

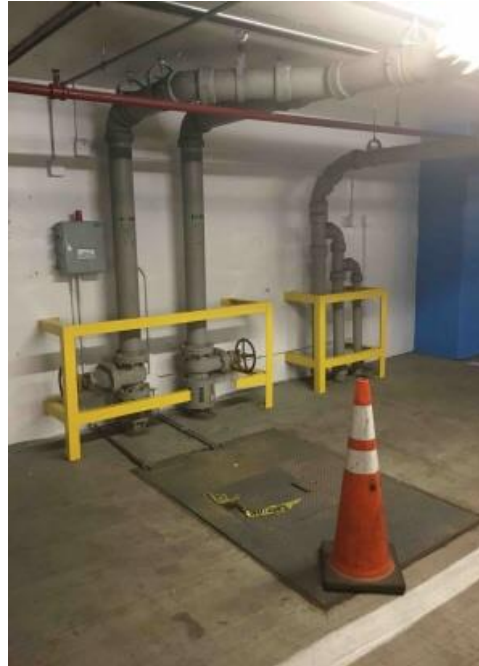
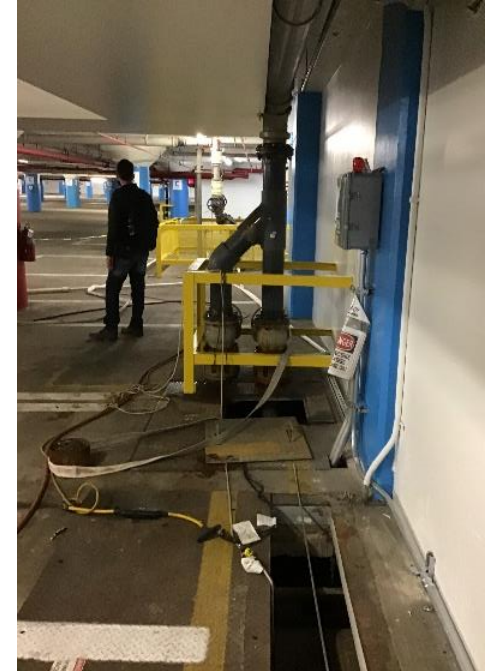
- Stormwater sump pumps require replacement.

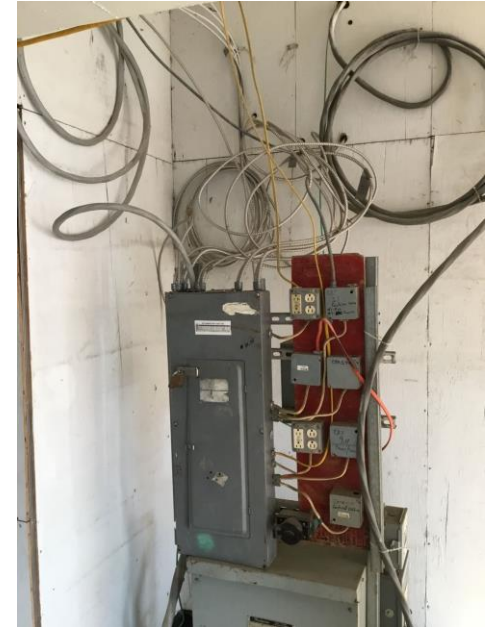
- Feeder insulation is deteriorating. Aluminum feeders are not passing the Meggar test.
- Distribution equipment (switchboards, panels, etc...) are damaged and rusted in many areas throughout the building.
- Wiring and organization of various electrical installs and electrical rooms are unordered and do not meet NEC code.
- THE REACH is powered from the JFK main building causing maintenance and voltage drop issues.

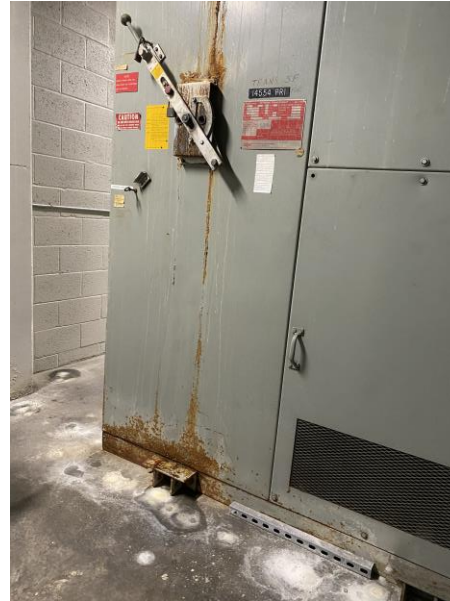
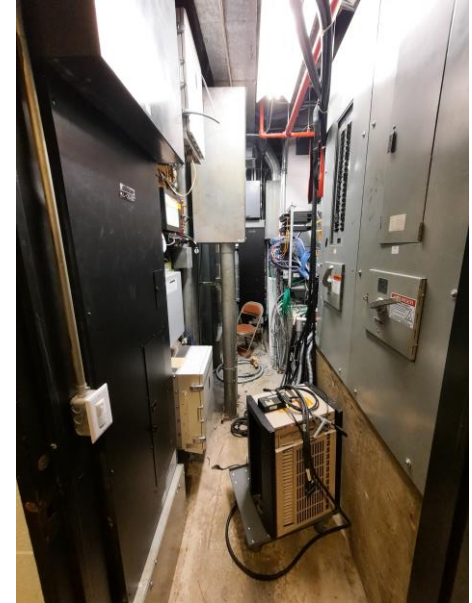
- Feeder insulation is deteriorating. Aluminum feeders are not passing the Meggar test.
- Distribution equipment (switchboards, panels, etc...) are damaged and rusted in many areas throughout the building.
- Wiring and organization of various electrical installs and electrical rooms are unorderedly and do not meet NEC code.
- THE REACH is powered from the JFK main building causing maintenance and voltage drop issues.

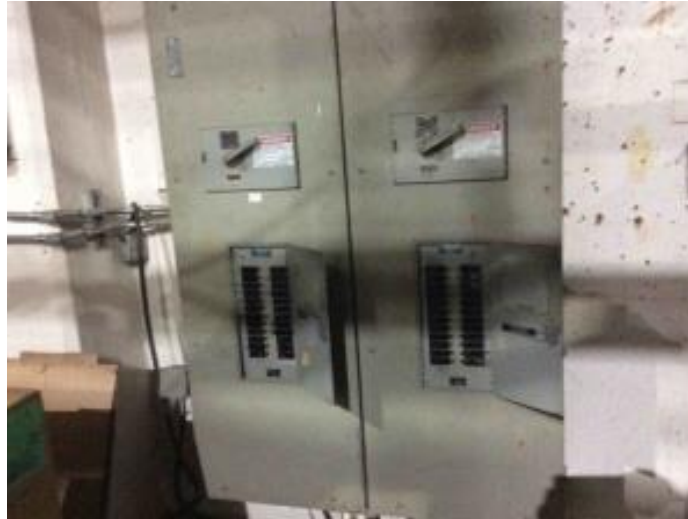
- Electrical equipment near boilers has water damage/rust. Equipment is located in an area that has danger of water sprays when boilers are undergoing maintenance.
- Exterior camlock enclosures are NEMA 1 rated.
- Some circuits on lighting control panels that are not lighting related.
- Various ground mounted transformers are not installed on top of concrete pads.

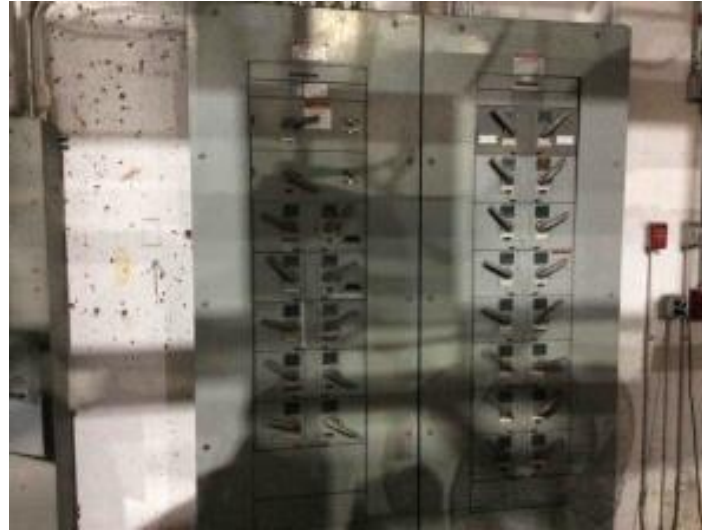
- Electrical equipment near boilers has water damage/rust. Equipment is located in an area that has danger of water sprays when boilers are undergoing maintenance.
- Exterior camlock enclosures are NEMA 1 rated.
- Some circuits on lighting control panels that are not lighting related.
- Various ground mounted transformers are not installed on top of concrete pads.
