# John F. Kennedy Center for the Performing Arts

## 2021 Comprehensive Building Plan – Presentation of Facts and Findings

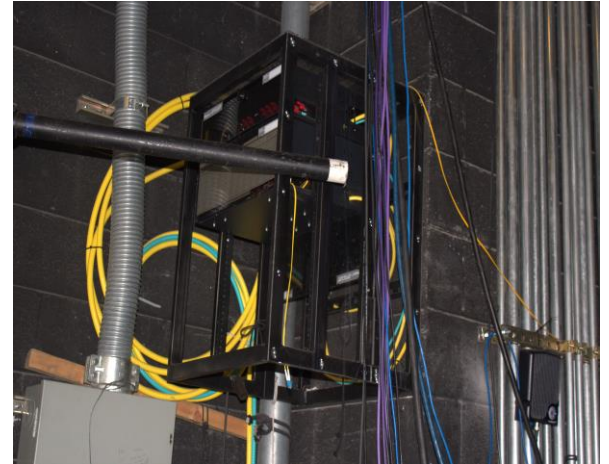
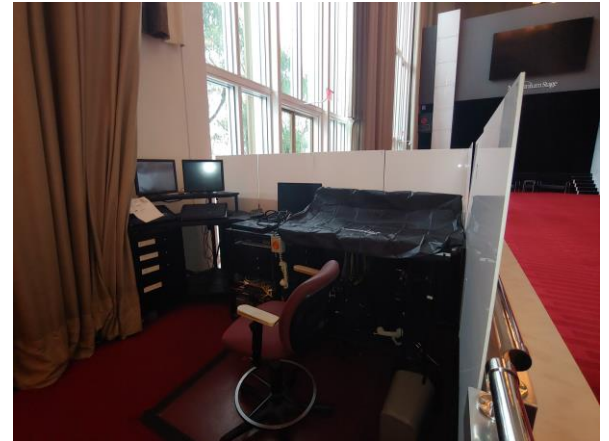
- The current projection inventory is aging and reaching end of life and better large format video solutions shall need to be addressed for future events
- The current fiber-optic infrastructure is insufficient to support the future needs of all event locations. The internal staff is not able to certify what they are able to pull and terminate for approved use by outside groups
- The Millenium Stages have temporary fiber-optic connectivity between stages and FOH, making it difficult to remove and reset the FOH position when necessary
- The existing intercom inventory is aging, and inconsistent between venues, making inter-venue production communication difficult
- Inconsistent systems are currently utilized to track and inventory miscellaneous equipment that is checked in and out for both performance and building operations

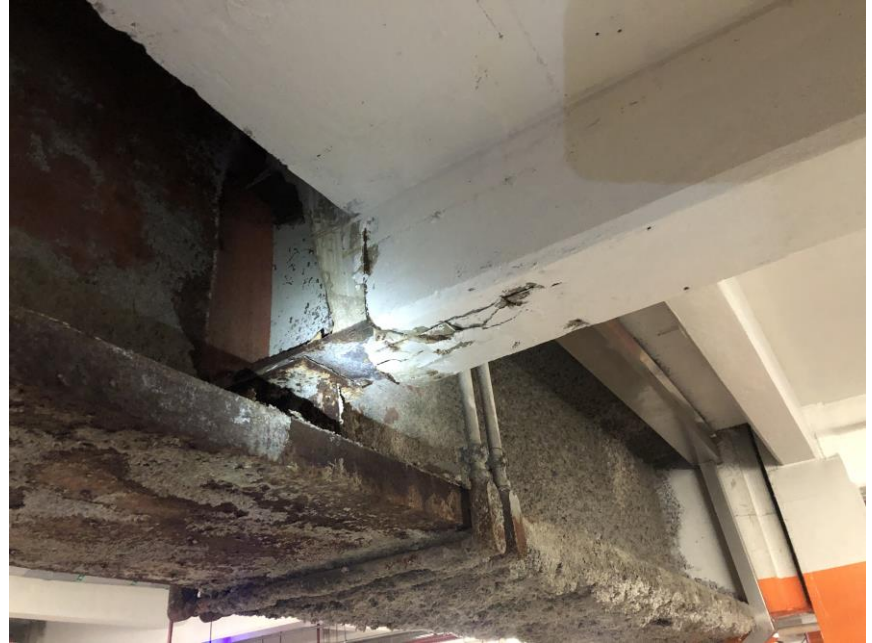
- Local areas of missing fireproofing and spalled concrete encasement
- Minor corrosion of large steel plate girders, and some corrosion of ends of infill beams framing to girders
- Deterioration primarily concentrated near expansion joints

| 6.2 | Rock Creek Overhang – Parking Garage Fireproofing Repairs | \$54,000 |

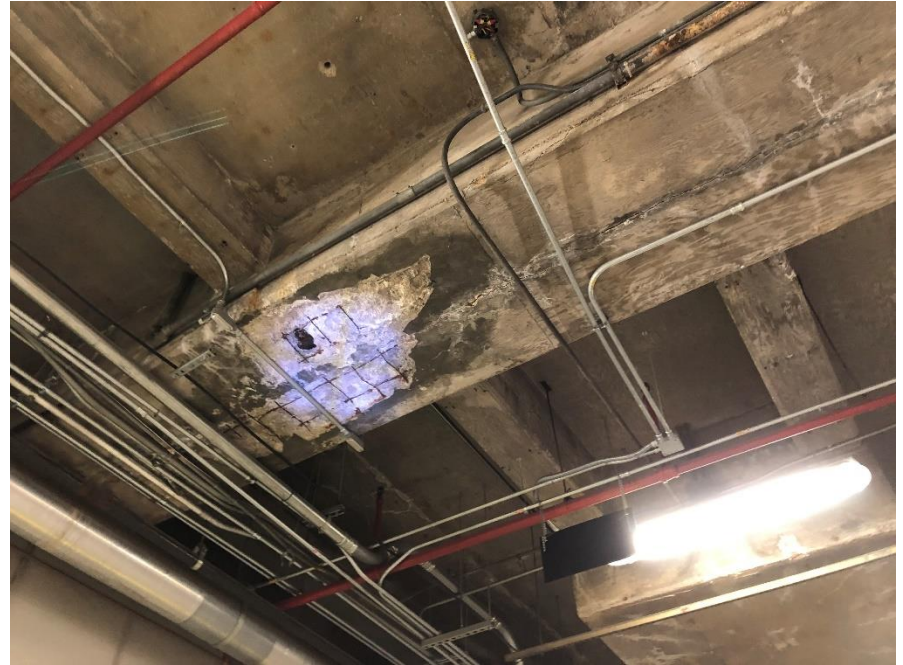
- Spalled & cracked concrete at underside of slab above loading docks
- Exposed and corroded rebar at beam encasement (concrete-encased steel beams) and concrete slabs
- Signs of water infiltration & staining
- Minor cracks/spalled observed nearby at slab above service tunnel

| 6.3 | Loading Dock #1 & #2 Concrete Repairs – Slabs and Beam Encasement | \$2,565,000 |

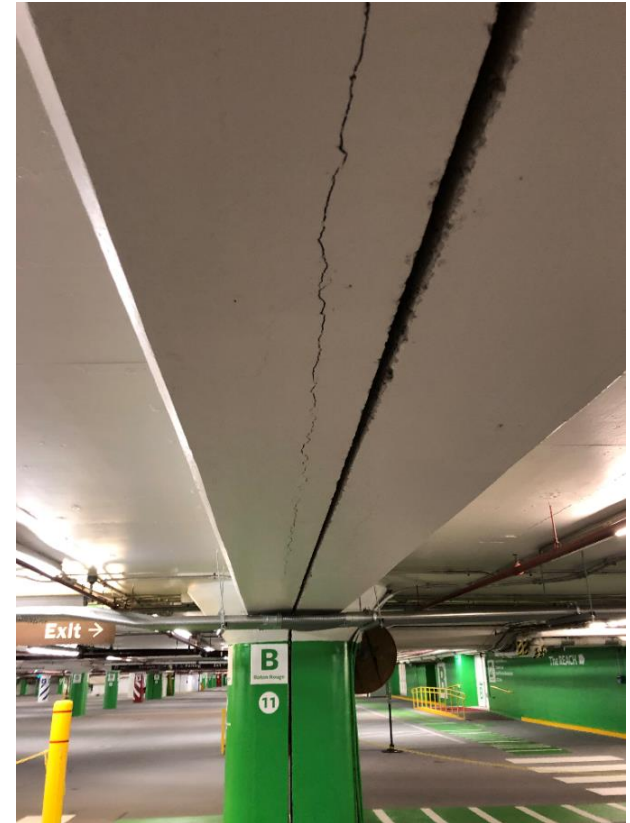
### Concrete Repair at Expansion Joints

- Concrete encasement and concrete slabs directly adjacent to expansion and isolation joints is typically cracked and/or spalled.
- Several of these locations are already marked in spray paint
- Similar cracks observed at building expansion joints and at isolation joints surrounding each theater
- Concrete cracks/spalls observed at each garage level

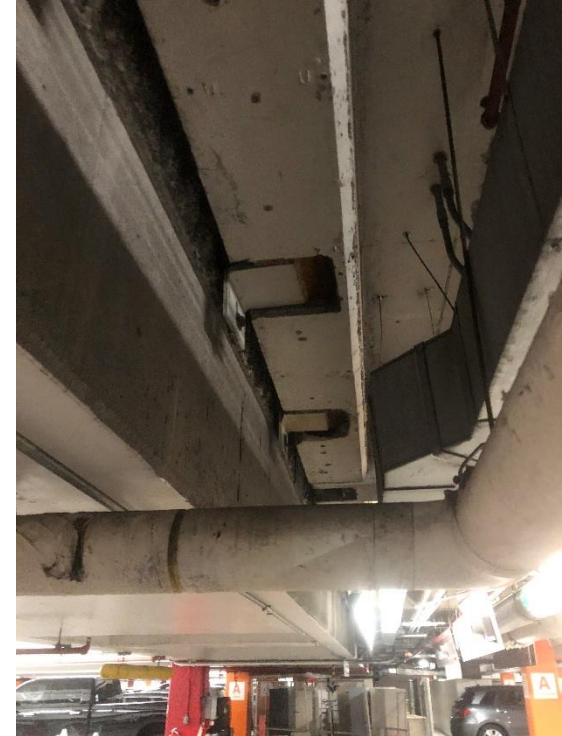
- Exposed disconnected steel clips at bottom of steel beams at original east and west foundation walls (It appears that clips originally connected to foundation wall: now expansion joint to north and south plaza)
- Clips are not serving a structural purpose anymore, but are not encased or fireproofed and are located near potential point of water infiltration at expansion joint
- Some signs of minor corrosion at bottom of steel beam near clips

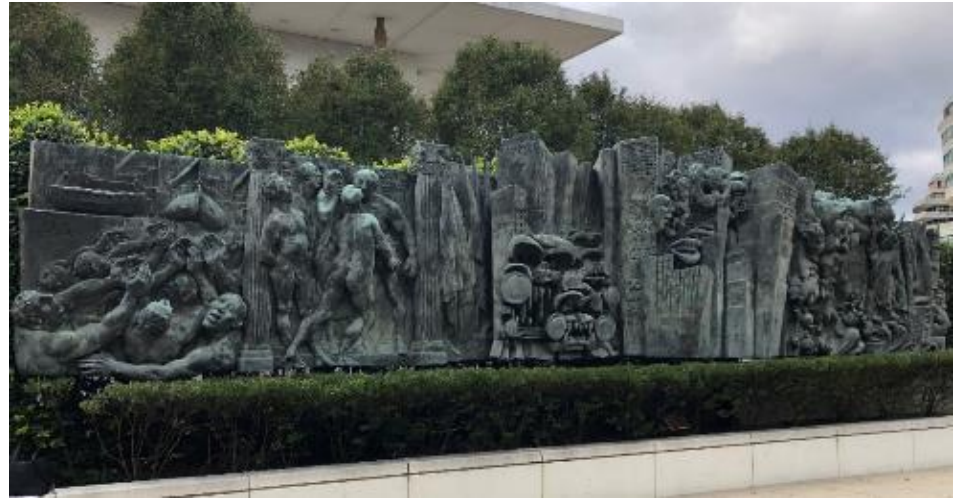
- Reviewed exterior statues *Don Quixote*, *Untitled*, *Amerika*, and *War or Peace*
- Conservation issues observed:
  - Discoloration of bronze patinas and stonework
  - Coating deterioration and failures – Bronze and Aluminum
  - Atmospheric soiling
- Recommendations:
  - Perform conservation treatments to clean and stabilize exterior sculptures

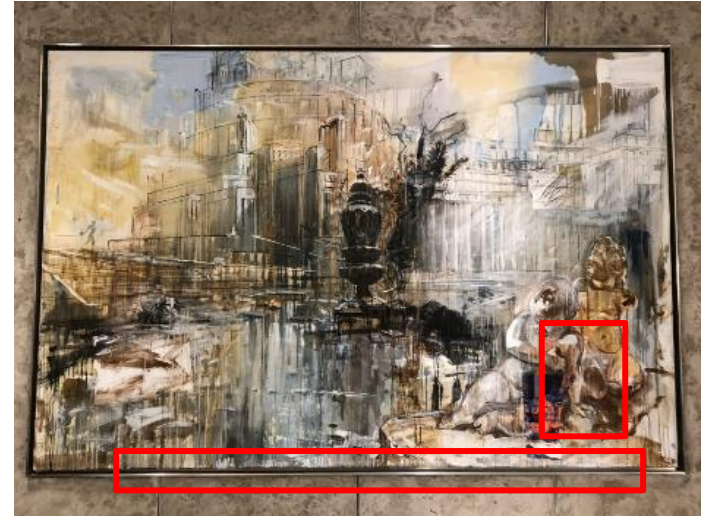
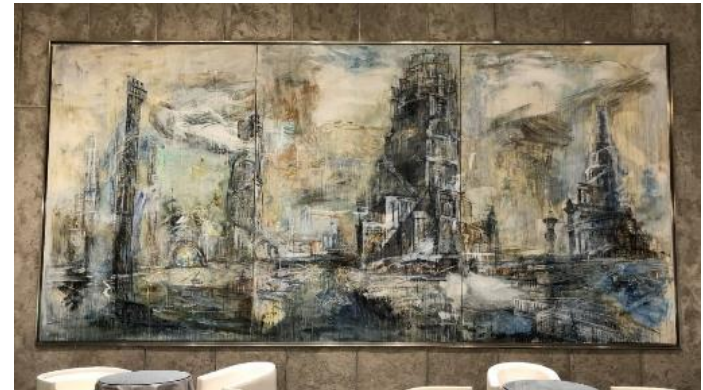
- Improper stretching of the canvas
- Recommendations:
  - Perform conservation to resolve canvas sagging

- Minor delamination of paint on center canvas
- Recommendations:
  - Assess severity of delamination and cracking and monitor cracking

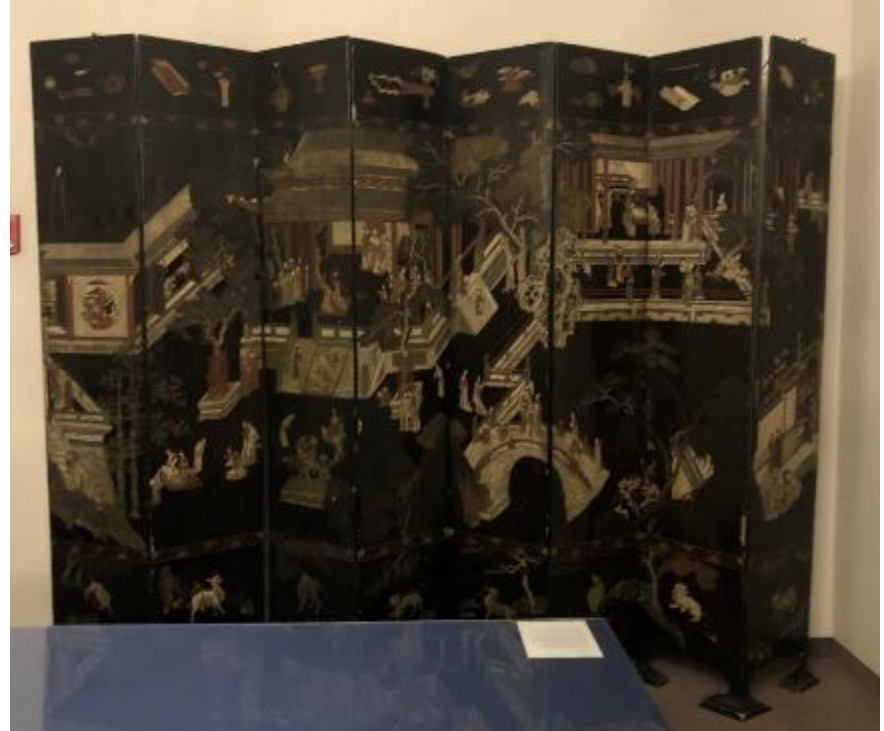
- Conservation issues observed
  - Paint loss and flaking on bottom edge, folding edge, and feet
  - Soiling
  - Broken hinge between 7<sup>th</sup> and 8<sup>th</sup> panel
- Recommendations
  - Perform conservation treatments to clean and stabilize failing paint and hinge.

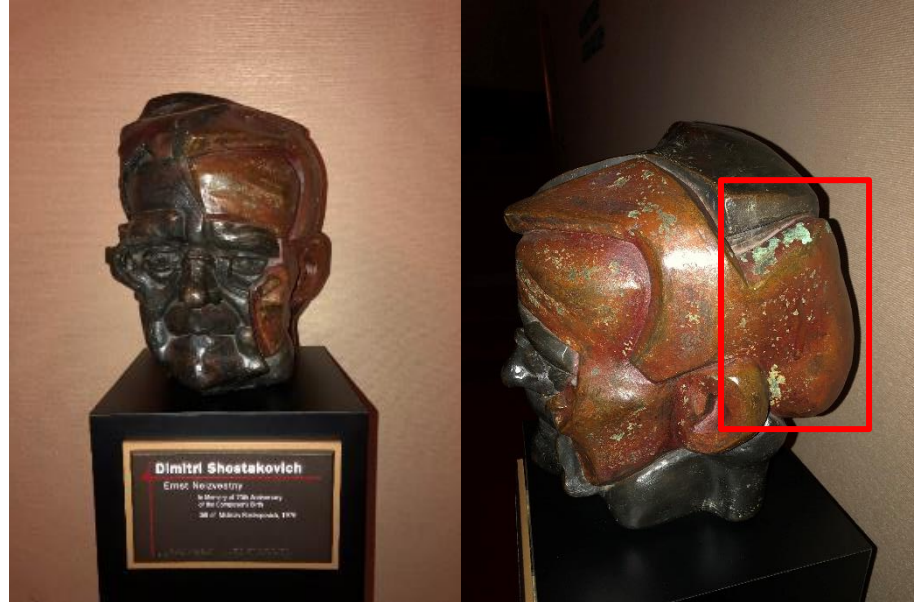
- Conservation issues observed
  - Coating failure
  - Irregular oxidation of bronze
  - Soiling
- Recommendations
  - Perform conservation treatments to clean and stabilize bronze bust

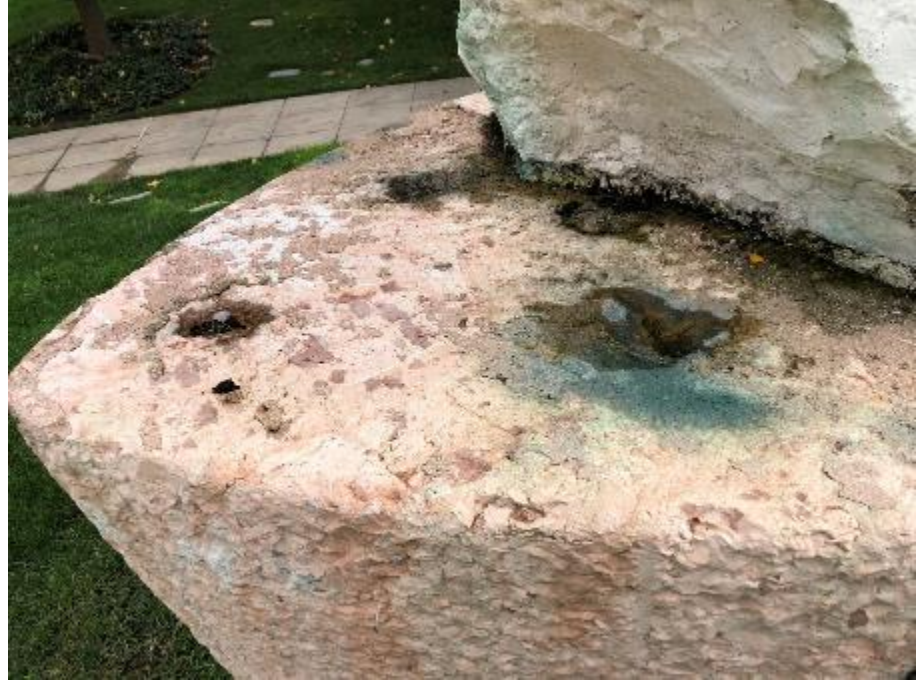
- Lack of maintenance promoted deterioration (soiling, staining, coating failure, vandalism)

- Develop an exterior art and sculpture maintenance plan
