The John F. Kennedy Center for the Performing Arts  
Washington, DC

## 2022 Comprehensive Building Plan

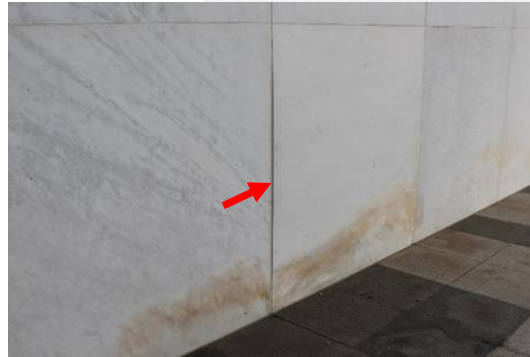
- Mild degradation or bowing due to hysteresis (throughout all levels of the facade) (see Figure 4);
- Misaligned panels (concentrated at the Plaza Level overhang fascia panels (over Rock Creek Parkway) with a few locations noted at the Plaza Level walls);

Figure 4. Bowed Plaza Level marble panel (photo taken at the west facade).

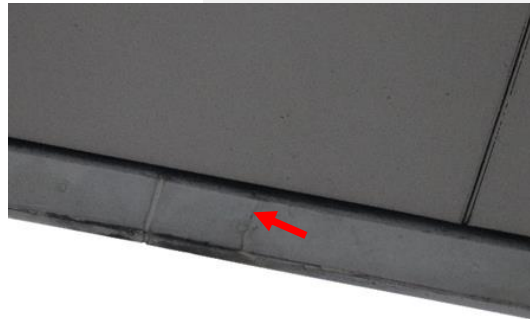
- Cracks (throughout all levels of the facade) (see Figure 5, Figure 6, and Figure 7).
- Spalls and incipient spalls (primarily at the overhangs and coping units with locations also observed at the Plaza Level walls) (Figure 5, Figure 6, and Figure 7);

Figure 5. Crack and potential incipient spall location at a Plaza Level overhang marble soffit panel (photo taken at the west facade). *Note: The crack aligns with a potential through-pin location; the stone section to the left of the arrow is a potential incipient spall location.*

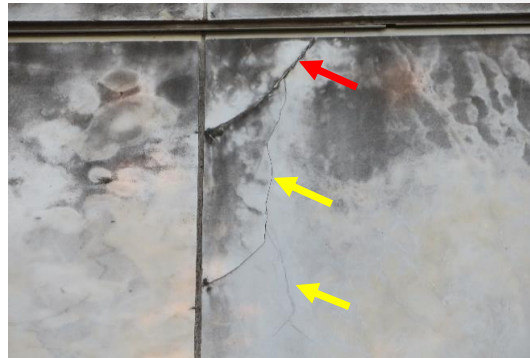
- Previous repairs (through all levels of the facade and most concentrated at the overhangs) (see Figure 5, Figure 6, and Figure 7); and
- Failed previous repairs (typically failed crack repairs and failed joint filler along reattached fragment and dutchman repairs) (see Figure 6).

Figure 6. Failed joint filler at a previous repair (red arrow) and cracks (yellow arrows) at a Rock Creek Parkway overhang marble panel (photo taken at the west facade). *Note: No existing through-pin visible at the repaired corner stone fragment, potential incipient spall location.*

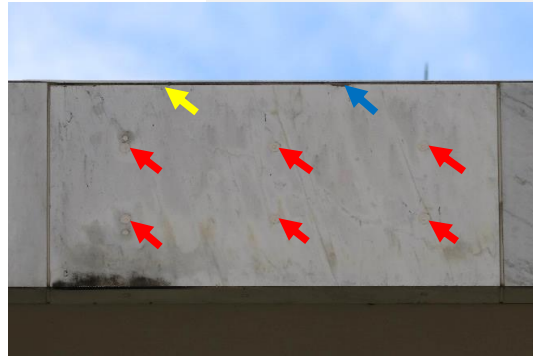
- Crack repairs (throughout all levels of the facade);
- Through-face pins (primarily at the overhangs with some locations at the Plaza Level walls) (see Figure 5 and Figure 7);
- Reattached fragments and dutchman (primarily at the Rock Creek Parkway overhang and Plaza Level walls with some locations at the Plaza and Terrace Level overhangs);
- Small patch repairs (primarily at the Plaza Level walls and overhang); and
- Replacement marble panels including replacement of the thin marble veneer (with through face pins), replacement or infill precast panels faced marble veneer (without through-face pins), and replacement marble cladding panels (without through-face pins) (primarily at the overhangs with some new and replacements observed at the Plaza Level).

Figure 7. Through-face pins (red arrows), crack (yellow arrow), and spall (blue arrow) at a Plaza Level overhang fascia marble panel (photo taken at the north facade).

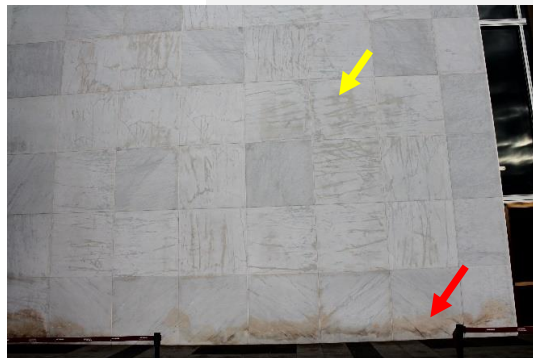
- General soiling (atmospheric and biological) throughout the facades;
- Orange-brown and gray discoloration along panel joints;
- Orange-brown and gray discoloration along veining patterns and towards the center of the panels (see Figure 8);

- Orange-brown discoloration at the panels along the base of the Plaza Level walls (see Figure 8);
- Dark black discoloration at the Rock Creek Parkway, Plaza, and Terrace Level overhang fascia panels and coping units (see Figure 9);

Figure 8. Orange-brown discoloration at the panels along the base of the Plaza Level walls (red arrow) and orange-brown and gray discoloration along veining patterns (yellow arrow) (photo taken at the west facade).

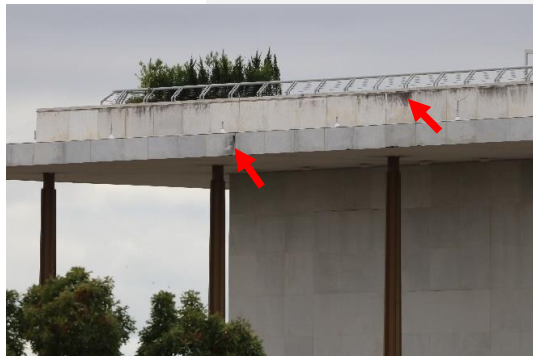
Figure 9. Dark black discoloration at the Plaza Level overhang fascia and coping units (photo taken at the east facade).

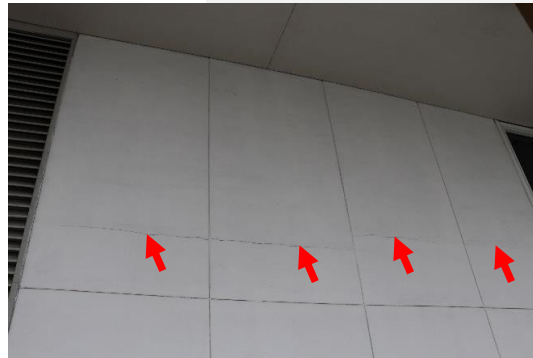
- Cracks typically horizontally and vertically oriented and some diagonal and map cracking (see Figure 11);
- Atmospheric soiling and insect nests and webs;
- Vertical cracks and gaps along each side the metal expansion joint covers at the walls;
- Shallow spalls at the soffit panels which were typically coated over;
- Slight soffit panel misalignments;
- Red discoloration of the joint sealant at the bottom of the window frame-to-stucco joints;
- Bird nests, debris, and staining at the open joints between the panels and at the panel-to-curtain wall interface (Note: The Kennedy Center reported issues with roosting each spring especially at the east facade of the building.); and
- Remnants of bird proofing spikes at some of the panel-to-panel joints.

Figure 11. Horizontal cracks at the stucco walls at the Terrace Level west facade.

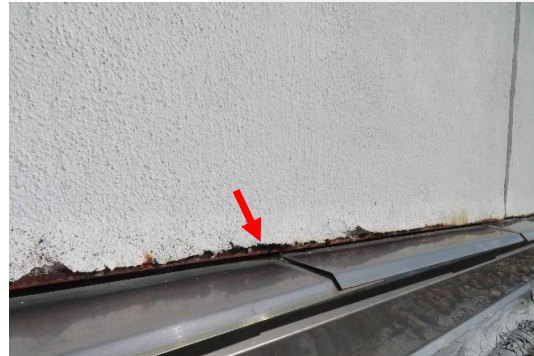
- Cracks (map cracking, horizontally and vertically oriented, and cracking at inside corners);
- Chipping, spalls, and incipient spalls typically near corrosion along the panel edges (see Figure 12);
- Slight stucco panel misalignments;
- Corrosion staining and distress along panel edges and above louvers and doors (see Figure 12);
- Corrosion of abandoned anchors and metal components;
- Discoloration including atmospheric soiling throughout, orange-brown staining along panel edges and at ferrous elements; and dark gray and green discoloration at the Penthouse north wall;
- Peeling, flaking, and missing coating;
- Typical cohesive failures and some adhesive failures of the joint sealants and sealant at filled abandoned holes throughout the stucco; and
- One location with wider cracks in the stucco adjacent to a previous support for a satellite dish (see Figure 13).

Figure 12. Chipping and corrosion along the stucco panel bottom edge (photo taken at the Penthouse south facade).

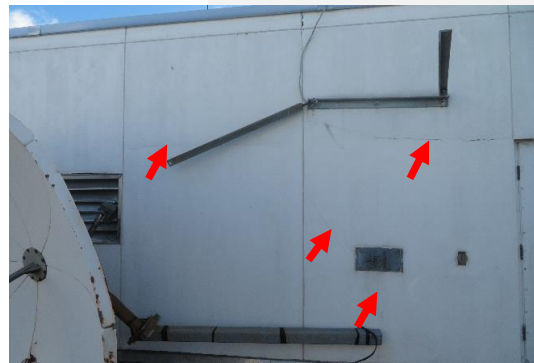
Figure 13. Wider cracks in the stucco adjacent to a previous support for a satellite dish at a Main Roof areaway.

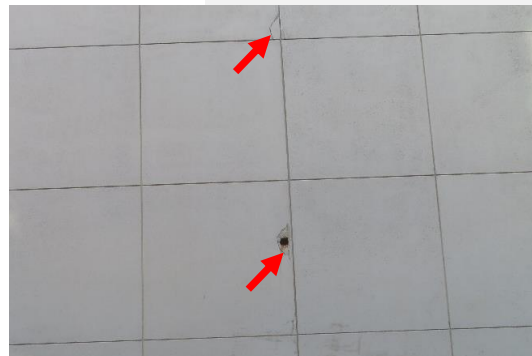
- At the north plaza planter units, there are vertical cracks in the precast units both at and away from the lights. These cracks are fairly regular and not very wide; there is no staining along the cracks or other visual indications of moisture migration from plantings or corrosion of the precast unit reinforcement.
- At the north and west facades' precast panels, there are cracks, incipient spalls, and spalls coincident with ferrous elements that are potential fall hazards (see Figure 15).

Figure 15. Incipient spall (upper arrow) and spall (lower arrow) coincident with ferrous elements.

Complete close-range survey and sounding and complete repairs at the Level A, B, and C Rock Creek Parkway Overhang.

Complete regular cycle of inspection and sounding of the concrete soffit due to risk of spalls hitting vehicles below.

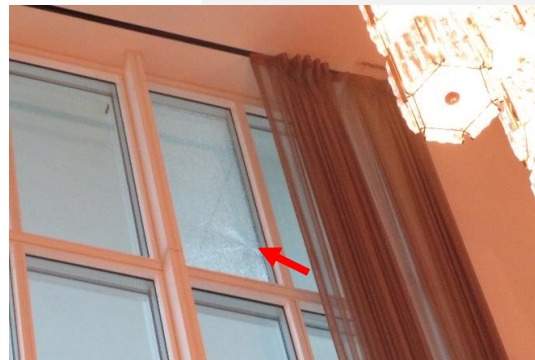
Overall, the 2010 curtain walls are in good condition. At the Plaza Level, there is some light surface corrosion present on the cable components and one broken IGU on the west facade (see Figure 17). The three Terrace Level bays of curtain wall that were not replaced in 2010 are experiencing deterioration and bleeding of the exterior black glazing seal material as well as migration and streaking of the black glazing seals that appears to be on the interior face of both the exterior and interior pane of glass (see Figure 18)<sup>7</sup>.

Figure 17. Broken IGU at the Plaza Level west facade.

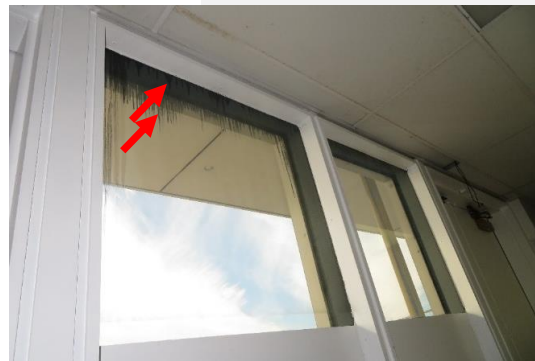
Figure 18. Migration and streaking of the black glazing seals that appears to be on the interior face of both the exterior and interior pane of glass at the Terrace Level (photo taken at the south facade).

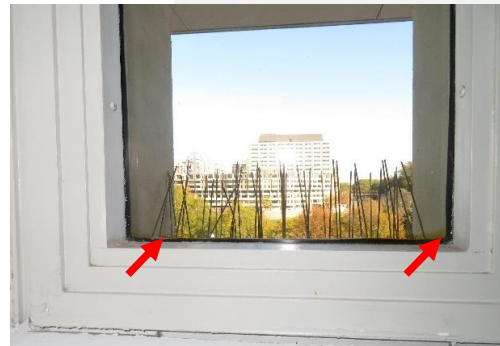
- Deterioration and bleeding of the black glazing seal material with some red-brown staining on the adjacent glass panes (see Figure 20);
- Cracked paint at the exterior of the windows;

The existing single-pane windows are in fair to good condition; the deterioration of the black glazing seals and the light streaking and staining observed at the base of some windows are indications that the original glazing seals are past their service lives. Based on the measurements recorded; these windows are likely original.

Figure 20. Light bleeding of the exterior black glazing seal material with red-brown staining on the adjacent glass panes.

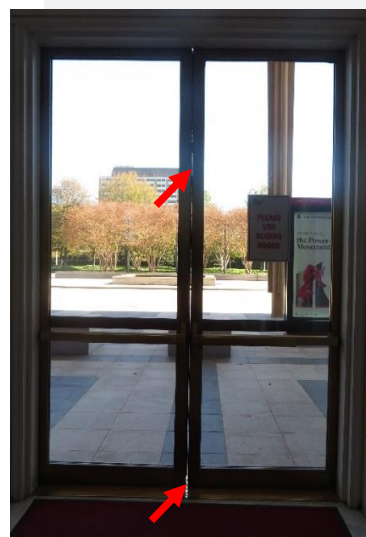
- Gaps and missing weatherstripping resulting in visible daylight at the intersection of the operable door panels (see Figure 22 and Figure 23);
- Loose gaskets around the perimeter of the lites;
- Misaligned and ajar doors;
- Loose, damaged, and missing components (primarily thresholds and sliding door bronze cladding pieces);
- Discolored bronze surfaces (white-gray and brown-black discoloration including atmospheric soiling, grime, and light corrosion product) (see Figure 23); and
- Tape and tape residue on the exterior of the west elevation Plaza Level doors.

Figure 22. Daylight visible at the intersection of the operable door panels.

At the automatic sliding and bronze hinged double doors, review door preservation as well as thermal efficiency and air/water infiltration goals in coordination with HVAC design and performance.

At the automatic sliding and bronze hinged double doors, investigate options for restoration and addressing gaskets and air leakage of the doors and entryways throughout the building as part of any overall HVAC improvement projects. Complete mockups and testing of the preferred options during this phase.

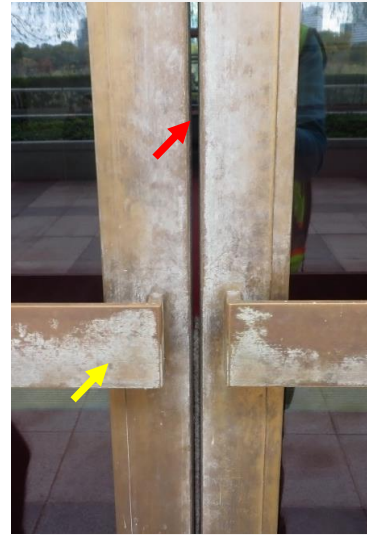
Figure 23. Missing weatherstripping (red arrow) and white-gray discoloration of the bronze surface (yellow arrow).

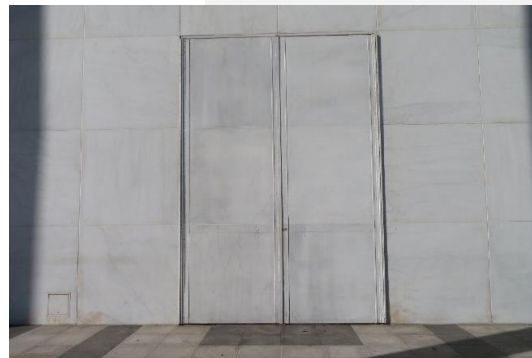
The hollow metal doors at the exterior of the building include garage and support space doors at Levels A and B, large backstage load-in doors at the Plaza Level east facade (see Figure 24), support space and stairwell exit doors at the Terrace and Plaza Levels, and support space and stairwell exit doors at the Main Roof and Penthouse. The exterior metal doors are functional and in good condition with the exception of weatherstripping, missing components, and some surface corrosion. The following typical distress types were noted at the hollow metal doors:

- Gaps and missing weatherstripping;
- Misaligned and ajar doors;
- Loose, damaged, and missing components (primarily thresholds pieces);
- Corrosion especially at the door bases; and
- Cracked, chipped, and missing paint.

Figure 24. Plaza Level east facade load-in doors with faux marble finish.

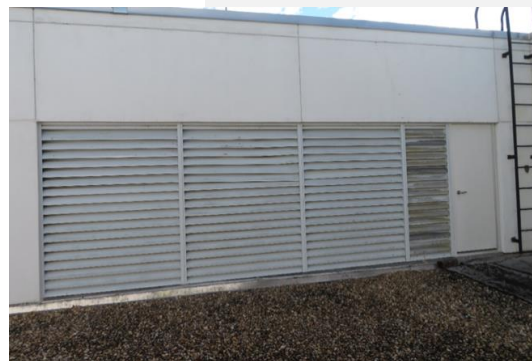
Figure 25. Chalked and missing paint (red arrows) as well as bent blades (yellow arrow) at a Main Roof areaway louver.

There is chalking paint and missing paint throughout the Main Roof and Penthouse louvers. There are some bent and displaced blades (see Figure 25). There is typical cohesive and some adhesive failures at the exterior joint sealant at these Levels.

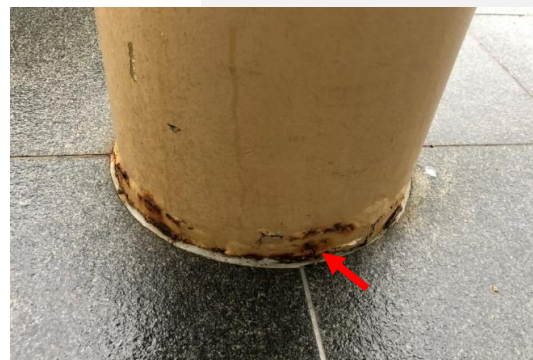
- Chipped, scratched, and missing paint;
- Chalking of the paint, discoloration, and markings;
- Cracked paint and open joints along fin joints;
- Some bent, separated, and corroded metal fin bases;
- Joint sealant cohesive and adhesive failures at the column bases;
- Black cable hanging down from the stucco panel joints at the tops of four columns on the east facade;
- Bird droppings at the top of the columns; and
- Bird proofing at the tops of the column fins.

Figure 27. Typical mild corrosion and flaking paint at the base of the Plaza Level columns.

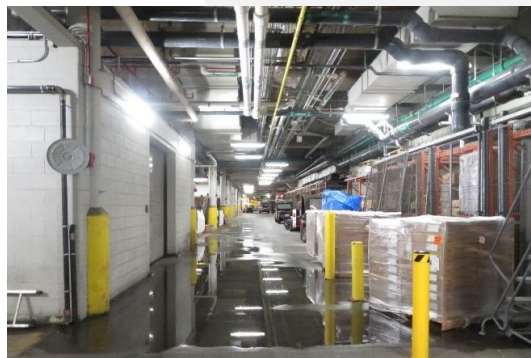
- Level B/A Service Corridor & Support Spaces (see Figure 28),
- Level B Garage Northeast Corner,
- Below Plaza Level Expansion Joints,
- Below Plaza Level Fountains, and
- Discrete Locations on Levels A & B.

Staining, concrete distress, corroded steel, and efflorescence indicating past and potentially ongoing water infiltration were observed at each of these potential leak locations. Additionally, there are metal pans and gutters installed to help redirect water at active leak locations.

Figure 28. Water collected at the service corridor roadway.

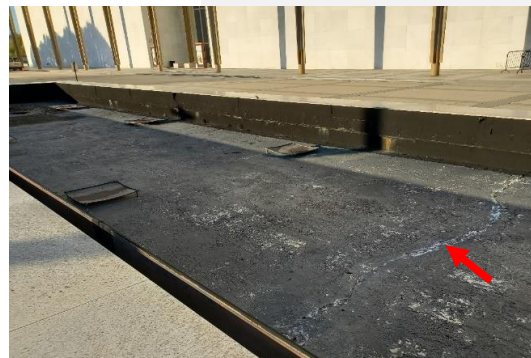
Figure 32. Rectangular reflecting pool basin at the east side of the Plaza Level. Note the crack in the concrete topping that extends through the liner coating.

At the rectangular east reflecting pool, cracks are present in the concrete topping and extend through the liner coating (see Figure 32). At the west square-shaped fountains, active leaks were observed below pipe penetrations and along the structural deck expansion joints immediately adjacent to the fountains (see Figure 31 and Figure 33).

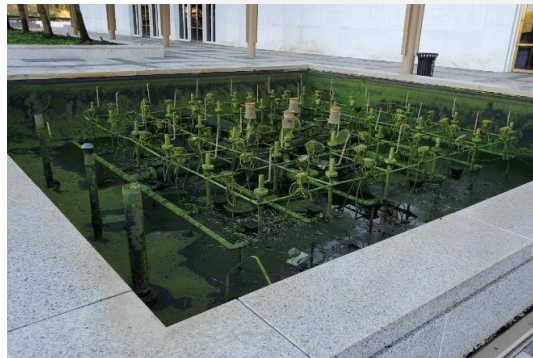
Figure 33. Square fountain at the west side of the Plaza Level with active leaks observed below the pipe penetrations at the Level A parking area below.

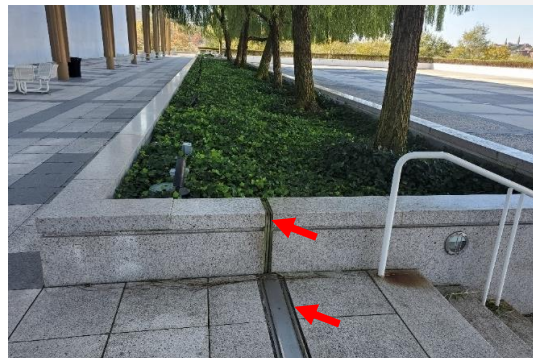
There are granite clad planters around the perimeter of the building at the Plaza Level. The planters often align with expansion joints in the Plaza Level structure (see Figure 34). Within the planters, the drainage board, which is not sufficiently ultraviolet (UV) resistant, is exposed at the walls of the planters. At the granite units, cracks, spalls, efflorescence, orange-brown, black, and green discoloration, and failed joint sealant were observed. Adhesive and cohesive failures were observed at the planter joint sealant.

Figure 34. Granite clad planter at the north side of the Plaza Level. Note the expansion joint running through the planter.

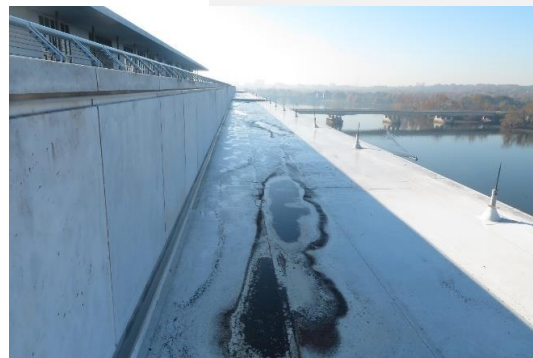
The Plaza and Terrace Level overhang roofs are mechanically-attached thermoplastic single-ply membrane assemblies which were installed as part of the Roof Replacement project completed in 1999<sup>13</sup> (see Figure 35). The membrane is in fair to poor condition and near the end of its expected useful lifespan; each overhang roof has several urgent maintenance repairs. The overhang roofs service lives can likely be extended for up to five more years with higher annual maintenance expenditures and maintenance inspections per year until replacement.

Figure 35. Plaza Level overhang mechanically-attached thermoplastic single-ply membrane roof assembly (west facade shown).

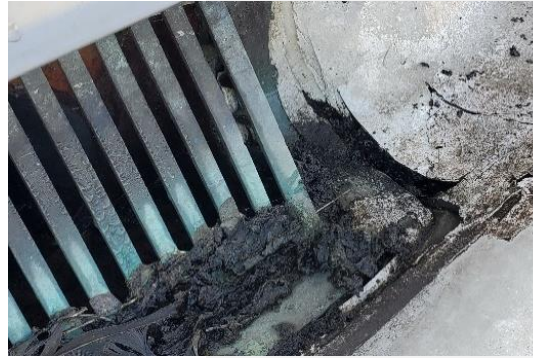
Additionally, at the limited Plaza Level overhang roof drains observed at close-range, it was noted that the northernmost drain flashing at the west facade is failed and the westernmost drain flashing at south facade is holed (see Figure 36). Notable ponding water occurs at the northwest expansion joint curb.

Figure 36. Failed drain flashing at the northmost drain on the west facade.

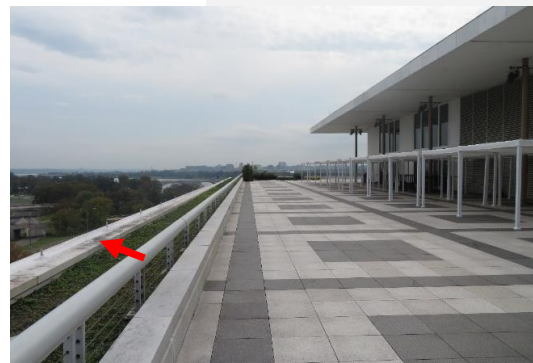
- Bowing, cracks, spalls, abandoned anchors, orange-brown and black discoloration, and efflorescence (see Figure 37).
- The joint sealant at the marble-to-marble joints is in fair condition with bulging and adhesive failure near the expansion joints.
- Adhesive and cohesive failures of the joint filler at the paver-to-planter and paver-to-wall joints were observed.

Figure 37. Terrace Level hot-fluid-applied reinforced rubberized asphalt (HRA) membrane and paver assembly roof and marble clad planter. Note the black discoloration on the planter marble coping units (red arrow).

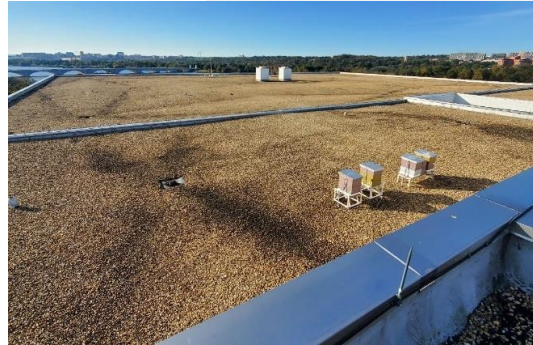
- During the on-site survey, fifteen to twenty isolated locations requiring near term maintenance were noted; these locations included: failed lead pipe boots, cracked/split membrane penetration and base flashings, and field of membrane blisters/brittle "soft spots".
- The joint sealants at the sheet metal expansion joint covers and perimeter flashings are cohesively failed. At the Penthouse Kitchen Exhaust (MER 11, Room 7501), active water infiltration and staining were observed below the exhaust penetrations after a rain event.
- Plastic sheeting has been placed on the floor and over equipment in this area due to the water infiltration. Water stains are visible on the floor slab, roof slab and beams and there is spalled concrete. The water infiltration pattern suggests a base flashing issue or water traveling below the membrane.

Figure 38. Main Roof gravel-surfaced coal tar pitch BUR roof membrane assembly with stainless steel coping and counterflashing's.

The Main Roof and Penthouse roofs are in fair to good condition with several urgent maintenance needs. The roof assembly can likely be maintained for another ten years with some targeted repairs and maintenance focused on known leaks, penetrations, and expansion joints. Following the targeted repairs, a structural assessment of the framing at the opening should be undertaken in conjunction with cleaning and coating any corroded steel and patching any cracked or spalled concrete.

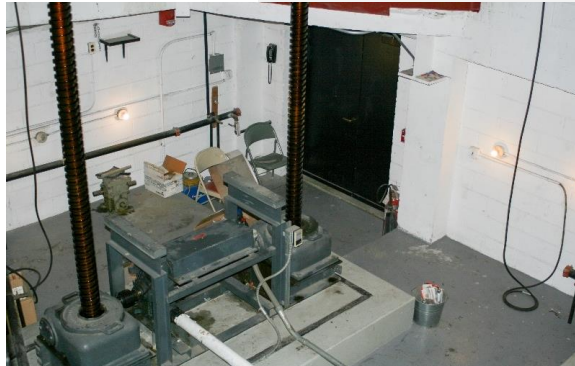
The existing motorized orchestra pit lifts are reaching the end of their usable life, the astragal safety shear switches are unreliable, and there are no interlocks on the entry doors into the orchestra pit. It is recommended that the existing screw-jack type orchestra pit lifts be replaced with motorized pit lifts such as that installed in the Eisenhower Theater.

Figure 45. Opera House Pit Lift

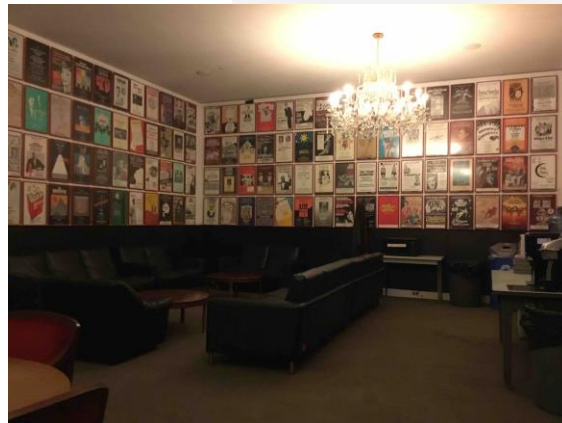
Figure 47. Eisenhower Theater Green Room

The Eisenhower Theater Green Room finishes and furnishings are worn and no longer appropriately represent Kennedy Center’s identity as a premier arts institution. The Green Room also lacks a prep kitchen. A kitchenette has been provided in the adjacent corridor but does not adequately serve the space. The Green Room will be renovated, and a new catering kitchen will be provided during this planning period.

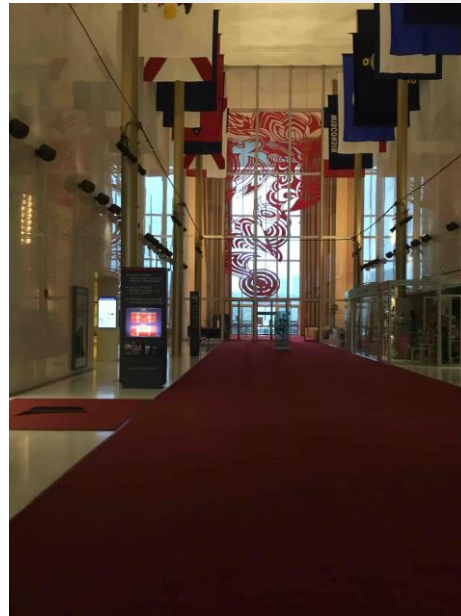
Figure 50. Hall of States

The floors are finished with polished white marble. A red broadloom carpet at the center of each Hall runs the full length of the spaces to meet the red carpet of the Grand Foyer. The carpet is set into a depression within the floor so that the top of the carpet is level with the adjacent polished marble floor surface. The carpet pile is cut into a pattern that is raised from the surrounding field, rather than being level as is required by current accessibility guidelines. The carpet is beginning to show wear and given its age and issues with the raised pattern, it is recommended that it be replaced during this planning period.

The freestanding sofas in the Halls were replaced in 2011 and are in good condition. However, seating is insufficient at times of peak visitor occupancy.

Work in the Halls within the 2022-2027 CBP planning period will be undertaken as part of the Memorial Interpretation project. The planned work for FY 2023 includes replacement of the carpeting and improvements to the electrical floor boxes and floor air grills and replacement of the existing furniture.

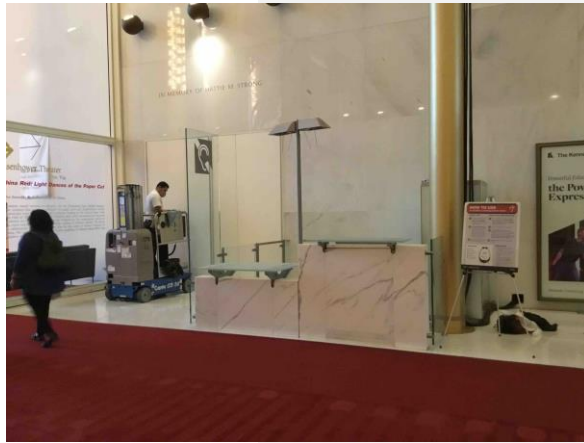
Figure 51. Assisted Listening Device Desk in Hall of States

Visitor services in the Hall of States include the Information Desk and the Assisted Listening Device Desk. The Information Desk and the adjacent television display to the east were completed as part of the Public Space Improvements project in 2004 and are in good condition, although the hinges and locking devices of the heavy glass-clad doors of the storage units behind the desk require frequent maintenance. The Assisted Listening Device Desk was completed as part of the same project and is also in good condition. Memorial interpretation is limited to a small television display of videos concerning Kennedy Center programming.

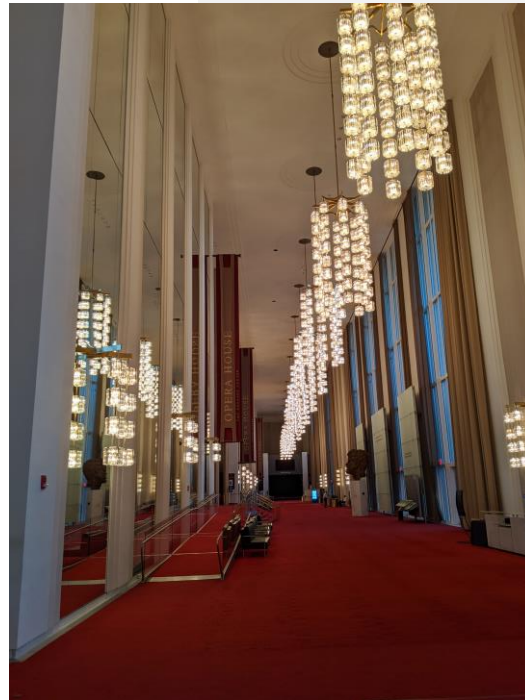
Figure 52. Grand Foyer

The finishes are in fair condition, but they are showing signs of ordinary wear and tear expected for a heavily used public lobby space. The majority of these finishes were replaced as part of a multi-phase Public Space Improvements capital project in 2001. New finishes installed at that time included the carpet and drapes. The drapes are stained along the bottom and are planned to be replaced as part of the Memorial Interpretation Plaza Level projects. The carpet is also recommended to be replaced within the planning period. The

The lower portions of the fabric-covered acoustical panels near the intermission service bars were replaced in 2007 due to staining and damage. The panels appear stained at the top edges. Replacement is planned as part of the Memorial Interpretation project for the plaza level improvements.

Ramps were added as part of the Public Space Improvements project in 2001. These are the accessible means of entering the three major venues. The ramps and their railings are in good condition; however, the carpeted surface is fairly worn and in need of replacement. The bottom half of the ramps are too close to the floor vents and create an obstruction to ventilation that should also be addressed in the planning period.

The lighting fixtures within the Grand Foyer currently use incandescent lamps. This area receives an abundant amount of natural light. In 2010, new dimmers were installed for the chandeliers with photocell dimming capability. The photocells dim the Grand Foyer lights to a very low level during the day when natural light is at an adequate level. Upgrading to more energy efficient lamps is recommended within the planning period.

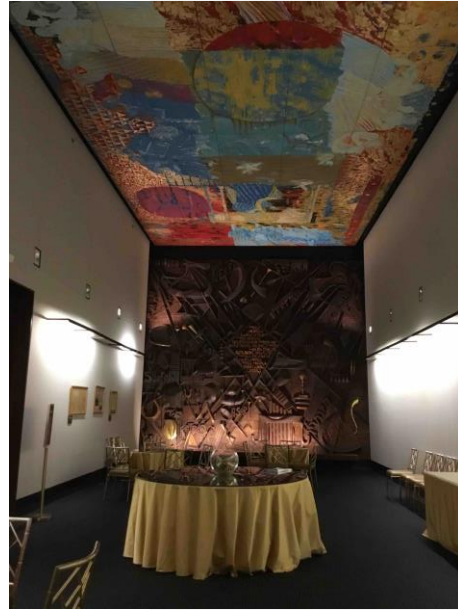
Figure 55. Israeli Lounge

The Israeli Lounge was renovated in 2010 with all new finishes. As a result, the space is in fair condition; however, some of the linear downlight ballasts have begun to fail and the fabric panels show signs of wear.

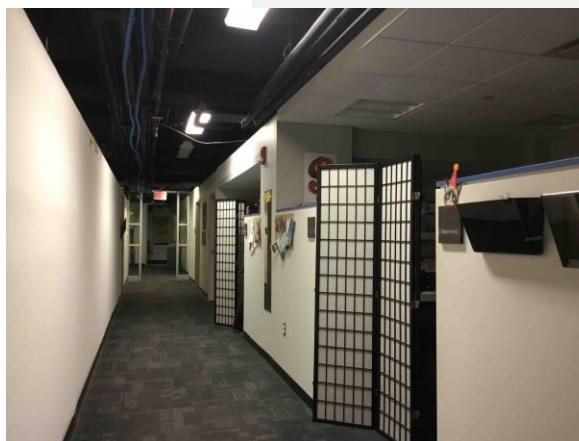
Figure 59. Office Space

time. Because office space was not considered to be a significant need for the facility in the original design, such space is extremely limited, with nearly every possible space that could be converted to offices utilized for that purpose. Converted locations include theater lobby space, attic space, garage space, closets, and other miscellaneous locations. As a consequence of limited office space in the original design, very few offices have access to natural light. Additionally, many of the office “cubicles” throughout the building are built with permanent construction as opposed to systems furniture. As a result, the space is inflexible, and it is difficult and costly to reconfigure space to accommodate periodic changes in staff size or staff functions. Acoustical privacy and thermal comfort are also a concern in most office areas, as is lack of meeting space. Ceilings in some office areas are low, and lighting levels are inconsistent.

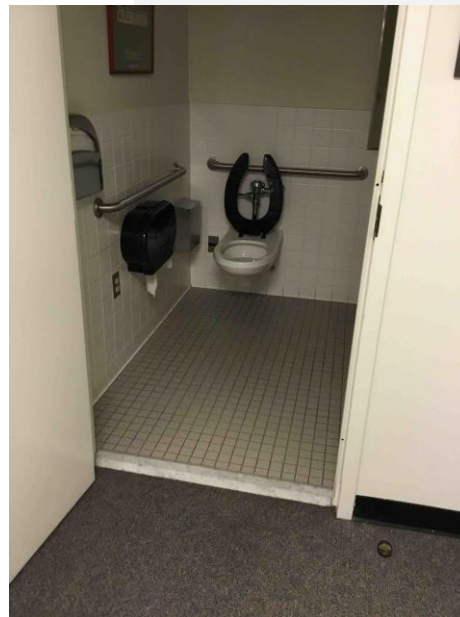
The restrooms in the Kennedy Center consist of theater restrooms, public restrooms in the Motor Lobbies, Atrium, and Galleries, and a variety of staff and back-of-house restrooms. As a result of a series of capital projects including the Eisenhower Theater Renovation in 2008, the Toilet Room Renovations in 2009, and the South Block Renovations in 2010, most of the Center's restrooms are compliant with accessibility standards. However, many of the restrooms, especially the ones that were last renovated in 1998, are starting to show their age and are in need of renovation. As a result of their heavy use the plumbing fixtures are starting to fail and require frequent maintenance. The finishes are also starting to become worn and dated.

Figure 62. Back-of-house Unisex Restroom

Back-of-house and public restrooms should be renovated in phased approach that aligns with the sanitary piping and domestic water system upgrades. First phase of the renovations, which will include full renovation of public and back-of-house restrooms in the Eisenhower Theater block, is planned during this planning period. In all remaining restrooms throughout the Kennedy Center, all manually operated faucets, flush valves, soap dispensers and paper towel dispensers will be replaced with automatic fixtures and accessories.

Replace manually operated faucets, flush valves, soap dispensers and paper towel dispensers in all remaining restrooms with automatic fixtures and accessories.

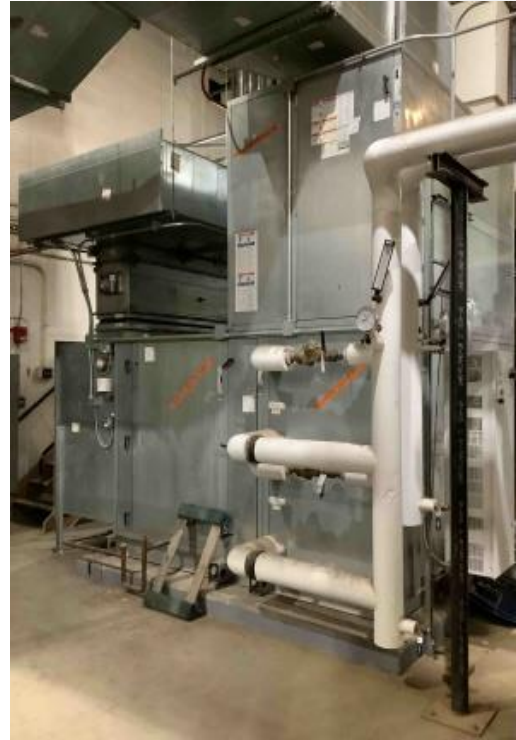
Figure 65. Newer Modular Replacement AHU

The scope of the Mechanical Systems Modernization Project addressed all of the critical deficiencies in the air handling systems identified as high priority work in prior surveys and CBP implementation plans and provided new component and control strategies for more efficient system operation. With the completion of the 2012-2015 MEP Modernizations project, each of the Center's air handling units will have received critical upgrades to the supply air fan and heating and cooling coils. However, not all of the air handling unit return sections or fans have been refurbished or replaced. These sections are functional, but exhibit exterior surface degradation which should be monitored.

Continue to monitor the condition of air-handling unit casing sections that have not previously been upgraded.

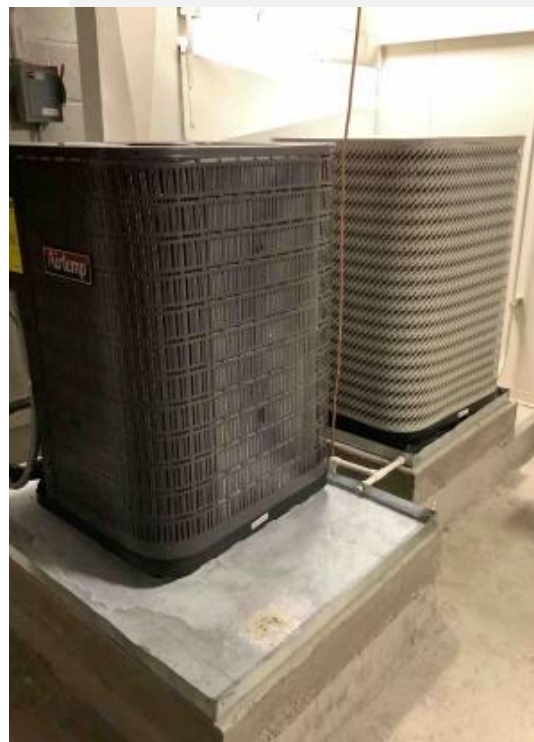
Figure 66. Typical Existing DX Condensing Unit Located in Mechanical Room

Of the forty-six original total DX units, fifteen were removed and as part of the 2012 Mechanical Systems Modernization project. In the future, twenty five of the remaining thirty-one units should be assessed for replacement. Detailed design work is necessary to determine the feasibility of replacement, as some of the units may not be removable without extraordinary cost that may not be offset by the operational and maintenance savings. The remaining six units are not recommended for replacement due to the infeasibility of running piping to the necessary locations or due to the specific dedicated need for the DX unit.

Continue to monitor the condition of remaining DX units. Add additional DX conditioning to electrical switchgear rooms, to improve longevity of components.

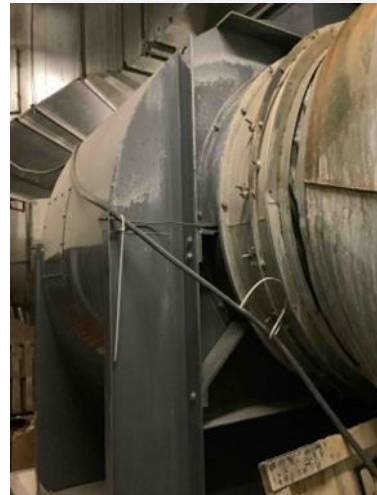
All fans are constant volume single-speed fans. Modification of the fans to variable frequency drives would increase energy efficiency by allowing each fan to run at the lowest speed necessary to ventilate the garages. In addition, variable frequency drives would provide a “soft start” for the fan motors, which would extend the equipment life. The fan speed would be automatically adjusted based on actual monitored carbon monoxide levels in the parking garage, providing the minimum amount of fan energy required to exhaust air properly.

Figure 67. Existing Garage Exhaust Fan

Convert twenty-three existing large constant volume garage exhaust fans to variable speed systems to save fan energy. Due to age, begin replacement of these units to coincide with controls upgrades. Integrate remaining garage exhaust fans to the building automation system to allow synchronized demand-controlled ventilation operation.

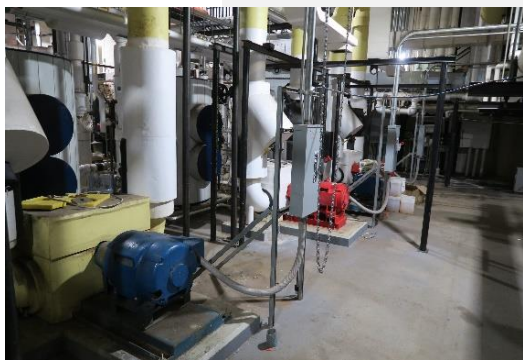
Figure 69. Existing Central Plant Pumps

Although the chilled water pumps are relatively new, their casings are corroded due to condensation caused by insufficient insulation. While the pump casings appear to need replacement, the need is not urgent as the corrosion is superficial at this point. The condition of the casing should be monitored as part of regular maintenance. The pumps appear to be in good working order and could provide an additional 10-15 years of life. However, additional energy savings would result if two of the three chilled water pumps were upgraded to better match the system demands.

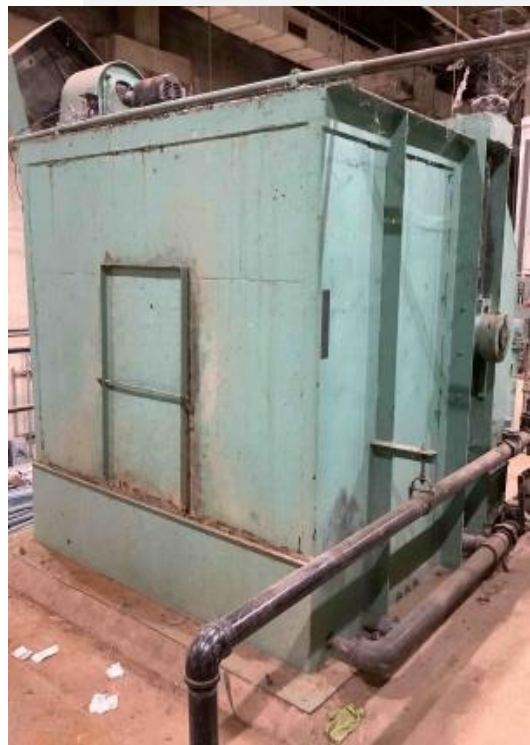
This open river water system provides significant energy efficiency and water conservation advantages as compared to cooling towers but is a source of deposits and marine growth in chiller tubes that reduce efficiency. There is no existing isolation provided to protect the chiller condenser water tubes from increased minute particles and debris that bypass the existing filtration in the condenser water system. As a result, the chillers have required increased condenser tube maintenance and repair. Nonetheless, this additional maintenance effort generally represents a worthwhile tradeoff to avoid the installation and operation of cooling towers.

Figure 70. Existing Traveling Screen Unit in Condenser Water River Pump Room

During the summer of 2018 the Center experienced a failure of the Condenser Water system. The immediate cause of the failure was an accumulation of sediment in the condenser water tank following historic flooding of the Potomac River. In addition, there is no way to perform periodic cleaning of the piping, since the system was built assuming that chlorination would prevent biologic fouling of the system. Since current EPA regulations do not allow chlorine to be discharged to the river, mechanical cleaning must be performed.

Based on deficiencies identified during the Phase 1 repair project funds were obligated to make additional repairs in 2020/2021. Improvements include:

- A. Installation of new automatic vents
- B. Installation of a new condenser water pump priming system
- C. Additional cleaning of the river inlet tank
- D. Replacement of one condenser water pump

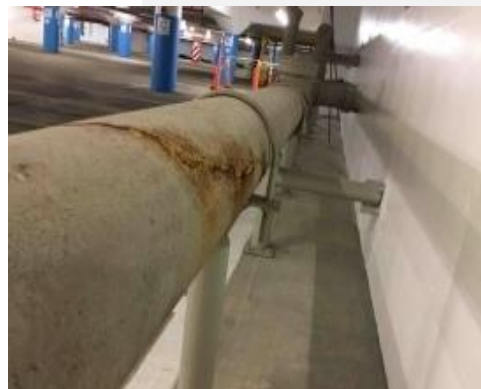
The original sanitary and storm system piping installed when the building was constructed has reached the end of its useful service life. Floor flanges are failing, causing cracks and leaks in bell and spigot joints. A large crack was observed in the main, 10-inch, combination storm and sewer pipe in the Level C garage. Leaks have also occurred where newer piping has been connected to the original piping with no-hub bands. Storm drain piping frequently clogs due to infiltration for soil and sand from tree beds.

Figure 73. Existing Sanitary Main with Crack

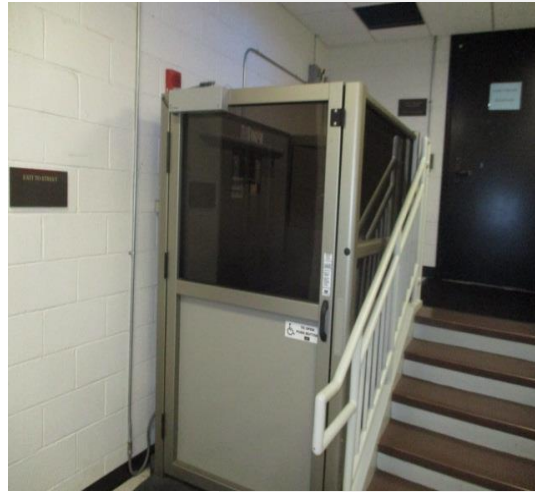
Accessibility and material lifts are difficult to maintain, as they are typically used by the public and receive extensive wear and tear. To make matters worse, often the manufacturers of these lifts will go out of business without warning, making it increasingly difficult to source parts. The lifts onsite appear to be receiving adequate maintenance and worked accordingly during the surveys.

Figure 80. Accessible Lift at Family Theater Backstage

Most lifts on site have been replaced or newly installed within the last decade, apart from the North and South Opera House lifts. These lifts were manufactured by Porch Lift who is no longer in business. It is recommended to replace each of the Opera House lifts in the current planning period, to eliminate potential extended downtime in case of a component failure.

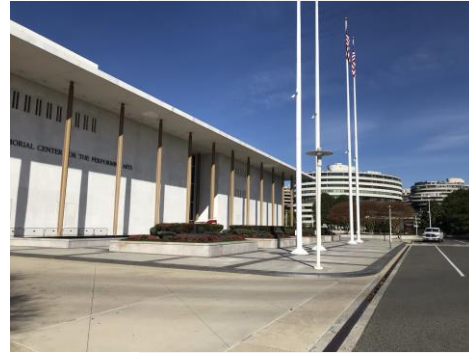
The concrete driving aisles and pedestrian areas at the East Plaza have cracked concrete in multiple locations. This should be monitored for further cracking and decline. There are two locations in the drive aisles where cement has spilled and hardened. There is also general staining of the concrete throughout. Pavers in the pedestrian areas are showing signs of wear (staining, chipped corners, crumbling mortar). Repairs and cleaning methods for the concrete and pavers should be evaluated within the context of long-term improvements. Plantings in the East Plaza are showing signs of decline and should be evaluated within the context of long-term improvements.

Figure 82. East Plaza

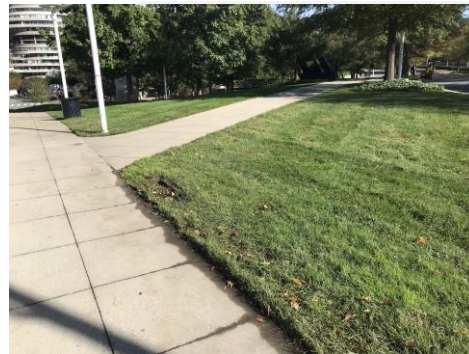
Figure 83. Concrete Sidewalk and Lawn Area

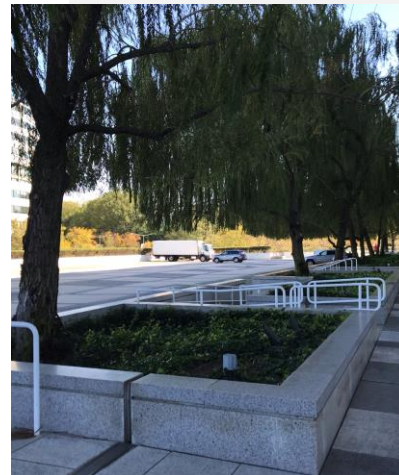
Figure 84. Planters at North Plaza

The North Plaza hardscape is showing signs of wear/decline. Cracks have formed in the concrete planter walls where the lights are located. Pavers in the pedestrian area are showing signs of wear (chipped edges, staining). These items should be monitored and evaluated within the context of long-term improvements. A section of pavers in the parking area is broken and should be replaced more immediately as part of minor repair projects. The ADA ramps should be cleaned, and railings repainted. The plantings are generally showing signs of decline and should be monitored.

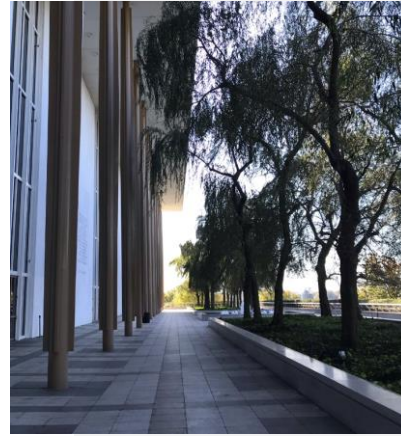
The River Plaza pavers are showing signs of wear (chipped edges, staining). The railings have chipped paint and rust. The plant material is generally overgrown and in decline, and should be monitored and evaluated within the context of long-term improvements. These items should be monitored and evaluated within the context of scheduled long-term improvements.

Figure 85. River Plaza

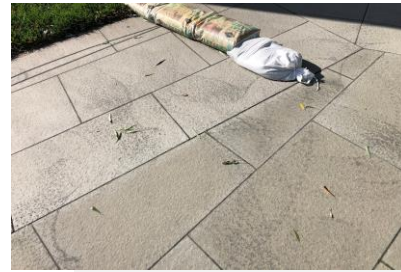
The REACH Plaza was observed to have standing water and sedimentation was observed in the plaza between the main Kennedy Center building and The Reach. It is recommended to clean the drain tops to avoid buildup of foliage and to ensure proper drainage. Existing grades in this area (roughly 12,000 SF) should be analyzed. Sandbags were observed during a site walk. These sandbags were placed to help direct runoff towards the drains

Figure 86. Sandbags at REACH Plaza

Replace Plaza trench drains

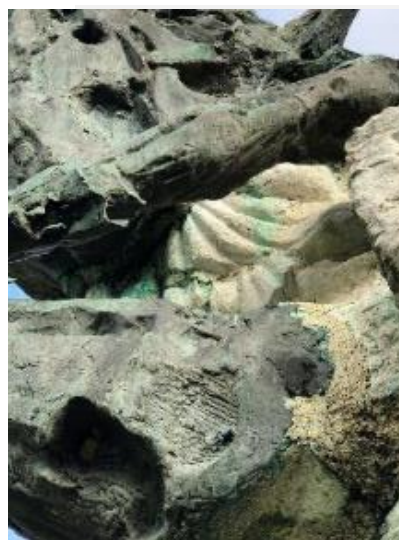
The protective wax coating on *Don Quixote* has deteriorated and is no longer providing a protective barrier. As a result, the bronze surface has dulled, and the patina has oxidized in an undesired and irregular manner. Also, the lack of protective coating caused the white limestone to develop copper staining caused from water run-off from the bronze

Figure 92: Evidence of bronze oxidation and blanching wax on the surface of *Don Quixote*.

Individual conservation work for *Don Quixote*, *Untitled*, *War or Peace* and *Amerika* to restore the protective coatings and prevent further deterioration from occurring on the sculptures.

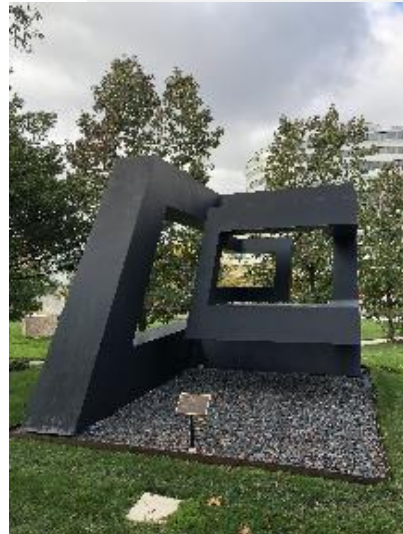
There is no record of previous work being performed to the statue. *Untitled* was not included in previous iterations of the CBP. The sculpture is in fair condition. While the metallic substrate is sound with no visible signs of corrosion, the paint system has reached the end of its service life.

The black coating is beginning to discolor, oxidize, crack and blister. Coating deterioration is more prominent in areas where water pools, especially on the exposed horizontal components. There is heavy soiling on all surfaces.

Figure 93: *Untitled* located on the north lawn of the Kennedy Center.

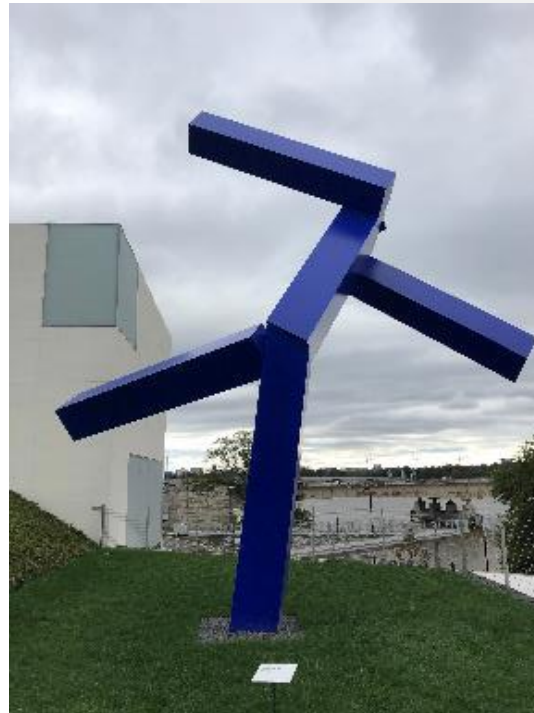
*Blue* is in fair condition, but vandalism occurred that damaged the surface of the sculpture. The painted surfaces of the statue have multiple scratches on all four sides of the square base. The scratches vary in depth. The scratches are not deep enough to affect the metallic substrate, but the lifespan of the blue coating will be significantly reduced if left untreated. Lastly, there surface is lightly soiled, which is consistent with its recent installation date and exterior placement.

Figure 95: *Blue* located on the north lawn of the REACH.

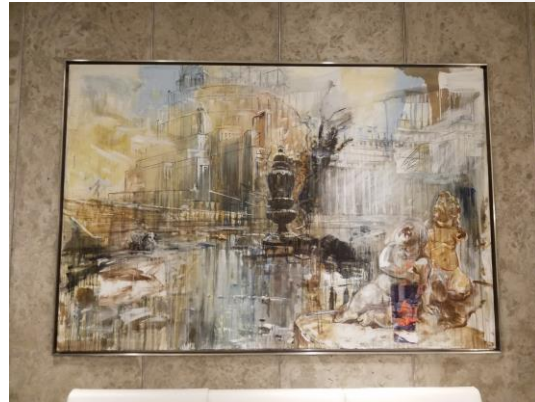
Figure 96: *Pastoral* located in the Russian Lounge of the Opera House.

*Pastoral* was not stretched properly and has a noticeable sag along the bottom edge of the canvas. The deformation appears at the lower register and bows inward, creating a lip of the wooden canvas frames edge. This sag needs to be addressed immediately to avoid permanent damage to the painting's canvas and acrylic paint.

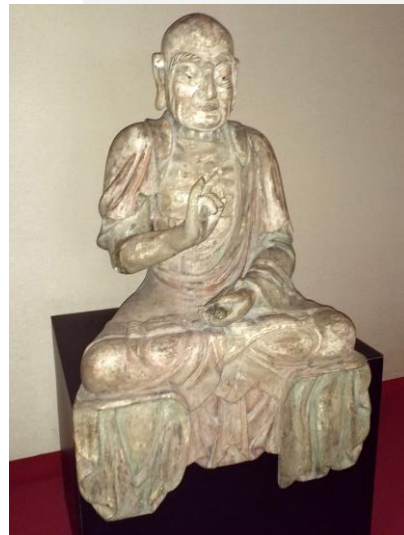
*Ahrat in Seated Lotus Position* is located in the lobby on the Second Tier of the Concert Hall. The sculpture is made of carved and painted wood and is in fair condition. There is considerable soiling across the surface and an incompatible repair is visible on the statue's right arm. In the 2003 catalogue, the repair is listed as needing further consultation. It does not appear that any further consultation work was completed.

Figure 97: *Ahrat in Seated Lotus Position* located on the second Tier Lobby of the Concert Hall.

The repair on the statue was an attempt to reattach the right arm at the elbow. The repair treatment was performed with an incompatible material, which has yellowed and hardened over time. Additionally, a small cavity was observed on the rear of the statue's torso where a section of surface coating chipped off.

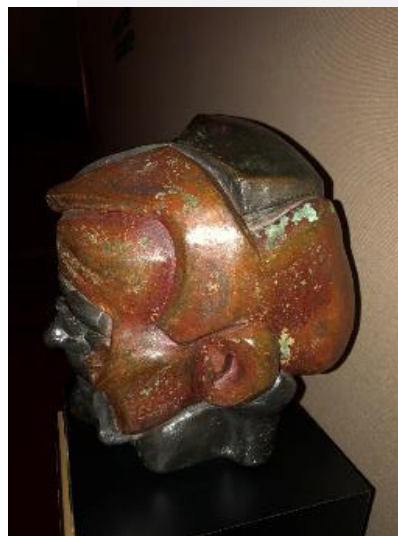
Figure 98: *Dimitri Shostakovich* located in the lobby of the box tier of the concert hall.

The bust has a heavy layer of soiling. Additionally, the lacquer coating on the left side of the bust is failing. The lacquer has blistered and flaked, resulting in spots of green-grey oxidized surface.
