The John F. Kennedy Center for the Performing Arts  
Washington, DC

## 2022 Comprehensive Building Plan

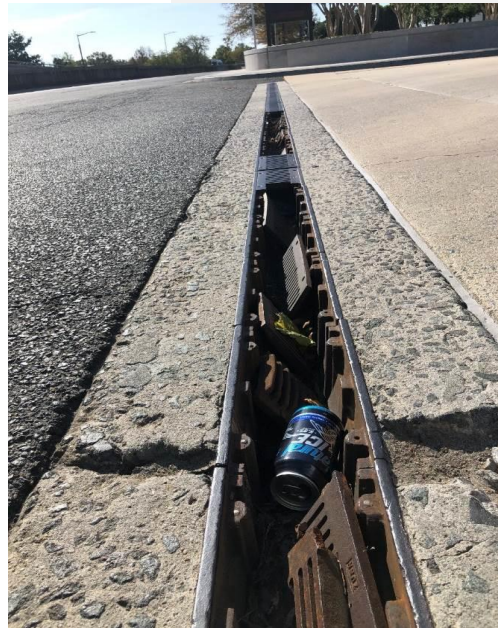
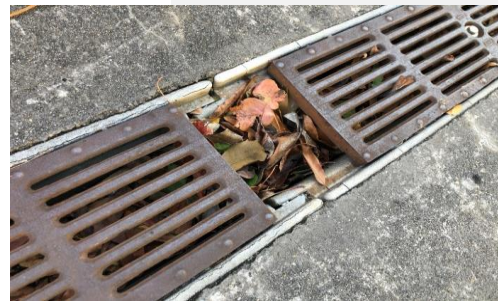
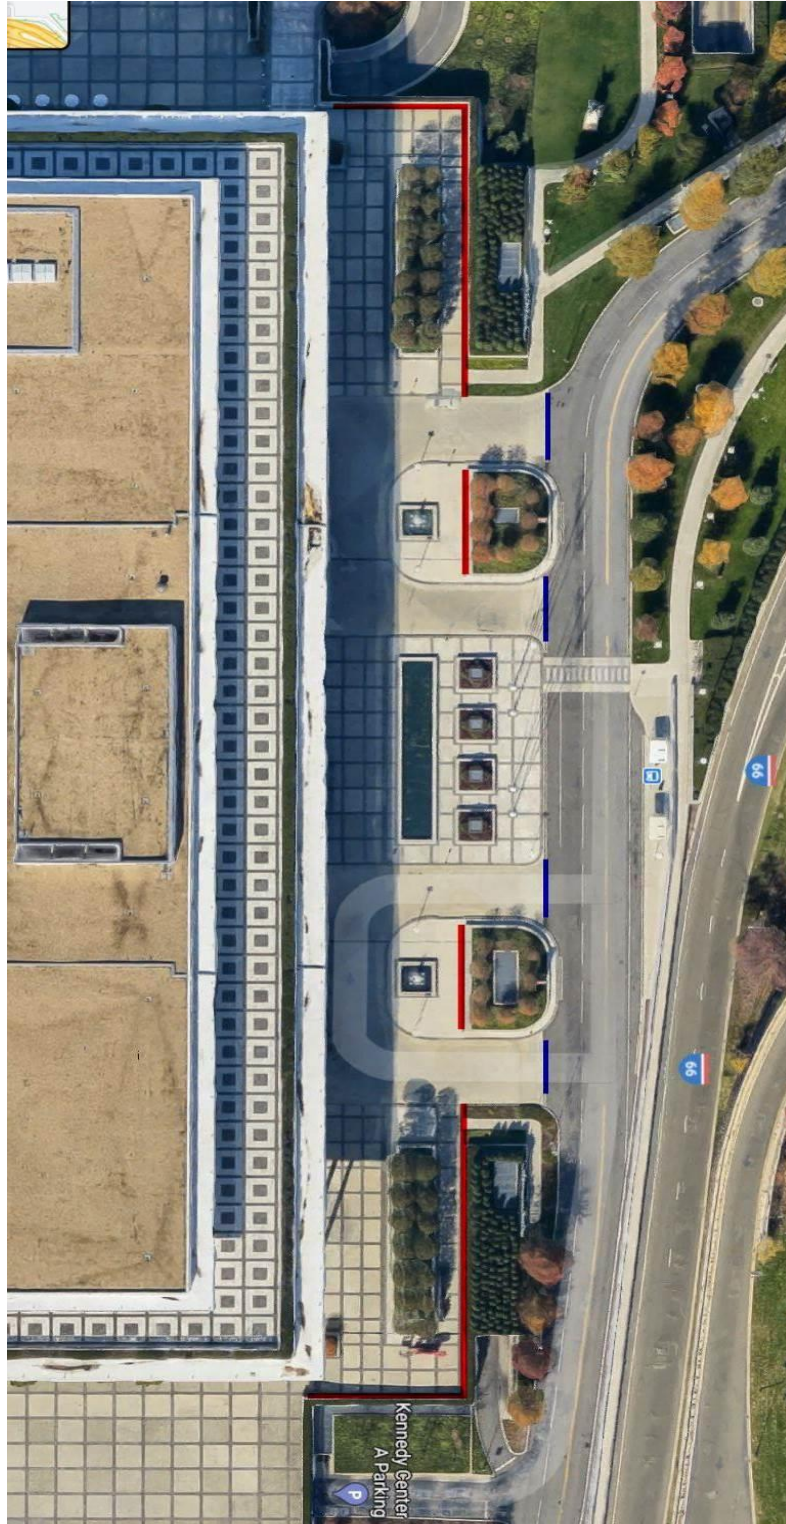
The existing trench drains in the plaza were inspected for overall condition and quality. During the site visit, the existing trench drains adjacent to the main road were found to be damaged. Portions of the trench drain tops have fallen off and exposed the trench drain bodies. It is recommended that these damaged trench drains be replaced with HS-20 loading/traffic rated drain tops to prevent flooding and maintenance issues in the trench drains. Approximately 140 LF of trench drain is recommended to be replaced. See blue markings in attached aerial site markup.

The existing trench drains closer to the interior plaza were found to be full of foliage, trash, and debris. It is recommended these trench drains be removed of all items within the drain body to prevent flooding and maintenance issues. Approximately 610 LF of trench drains is recommended to be cleaned out. See red markings in attached aerial site markup.

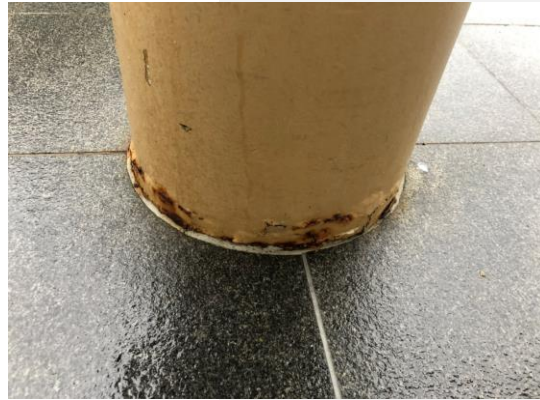
The as-built columns are painted with a bronze-colored paint. At most of the columns, surface level corrosion and rust staining has occurred near the base. Given the presence of rust staining and paint, it is assumed that the alternate option for ornamental metal covers was selected in lieu of the original bronze. Further investigation is recommended in order to confirm the as-built condition of the column base and the existing paver and waterproofing condition.

This project includes scope to repair all corroded steel and repair damaged existing flashing at column bases. Pavers shall be locally removed to investigate condition of existing HRA waterproofing flashings at column bases to assess membrane damage due to steel substrate corrosion and review steel condition to determine if structural repair is required, and repair membrane flashings as necessary. It is assumed that no structural repair will be required. Cosmetic repairs to prevent further deterioration shall include cleaning and repainting columns with corrosion-inhibiting primer, epoxy intermediate coat, and high-performance topcoat and repair at discrete cracked, detached, and bent column fin bases. Installation new bird-proofing system at the tops of the columns is recommended.

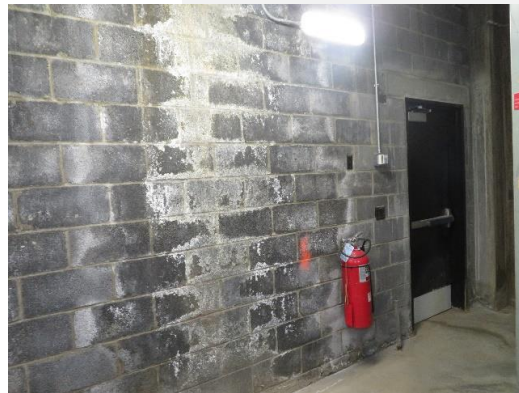
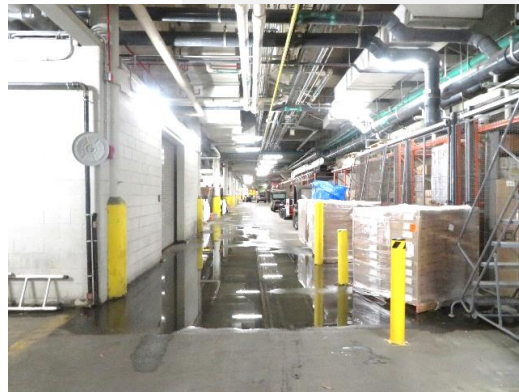
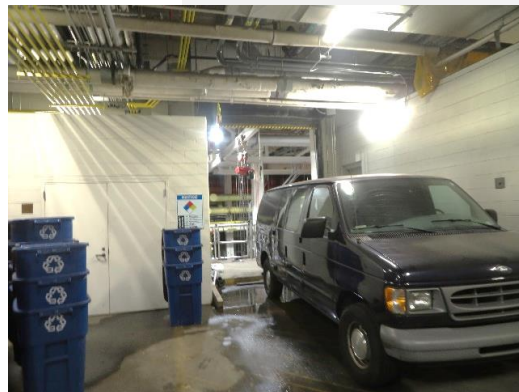
During the on-site survey, active leaks were observed at the following locations:

Staining, concrete distress, corroded steel, and efflorescence indicating past and potentially ongoing water infiltration were observed at each of active and potential leak locations. Starting points for the investigation efforts include: 1) developing an active Leak Log and 2) confirming the active versus dormant leak locations that have already been addressed by previous repair campaigns. As part of investigation, water testing will likely be necessary to identify the source of active leaks.

Engage qualified consultant to investigate active water infiltration through Level B/Level A service corridor and support spaces (below grade along east Level B service corridor) and the Level B garage northeast corner and to develop appropriate water infiltration mitigation strategies.

Engage qualified consultant to review and investigate all other reported leak locations as determined by the Leak Log. Based on the records provided by the Kennedy Center for this study and the project team's on-site observations, the following known potential leaks are not otherwise included in investigations listed above:

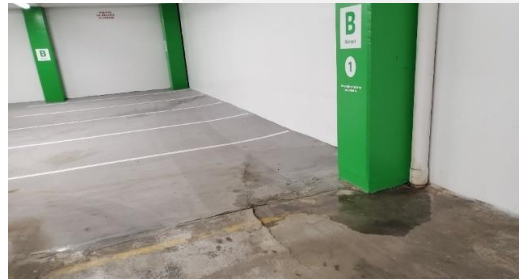
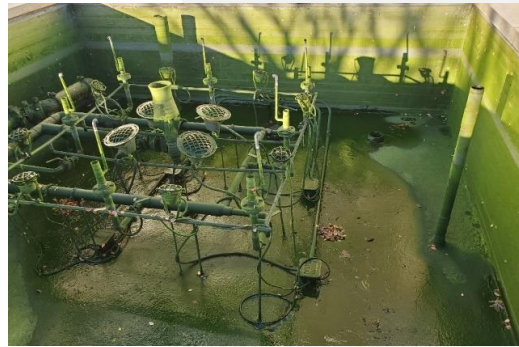
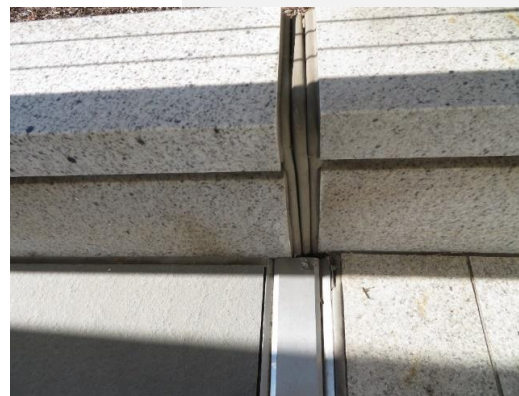
This budgetary item is dependent upon the results of the investigations into the sources of the leaking (1.6 Waterproofing and Leak Investigation) and is centered on repairs to waterproofing elements that are likely contributing to active water infiltration.

- Implement appropriate water infiltration mitigation strategies to address ongoing leakage Level B/Level A service corridor and support spaces based upon consultant investigation. Sound full extents of vault ceiling concrete slab. Remove loose concrete and patch spalls and cracks. Clean and paint ends of encased steel beams where corrosion has occurred and patch encasement.

- Implement waterproofing repairs, as developed by consultant investigation, to address ongoing water infiltration at the northeast corner of parking garage Level B.

- Replace failed Plaza Level waterproofing expansion joint assemblies, tie-in with adjacent HRA waterproofing membrane to remain alongside the joints. Work scope not to be confused with paver surface level joint covers, though replacement of exposed silicone-faced pre-compressed joint seals at planter walls should also be replaced during the work.

- Replace corroded in-fountain piping. Repair piping penetration flashings through HRA structural waterproofing beneath concrete fountain basins; consider full structural waterproofing replacement within the fountain footprint and tie-in with adjacent Plaza structural waterproofing to remain. Replace failed Plaza Level fountain basin waterproofing liner coating after structural

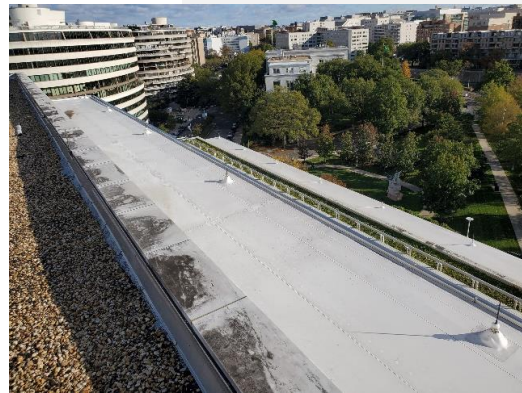
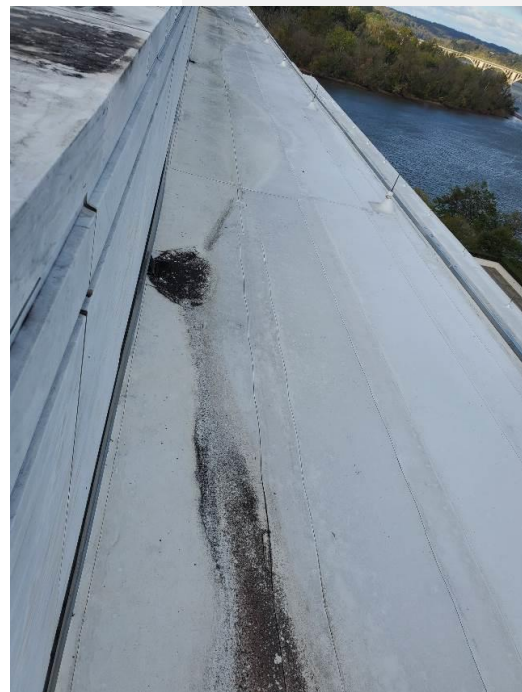
The membrane is in fair condition and near the end of its expected useful lifespan; each overhang roof has several urgent maintenance repairs. The overhang roofs service lives can likely be extended for up to five more years with higher annual maintenance expenditures and maintenance inspections per year until replacement.

Repair drain flashings at white single ply overhang roofs at multiple drains (inspect all and repair as needed) to extend service life of roofs.

At end of extended service life, remove and replace white thermoplastic single-ply roof membrane assemblies at Plaza and Terrace Level overhangs due to age-related deterioration. Include snow/ice retention system and/or raised roof edge with roof membrane assembly replacement to mitigate wind-blown falling snow/ice over roof edge.

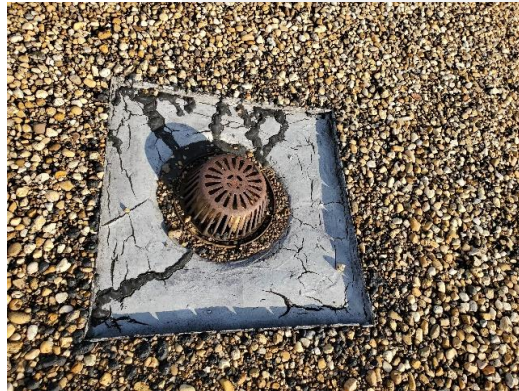
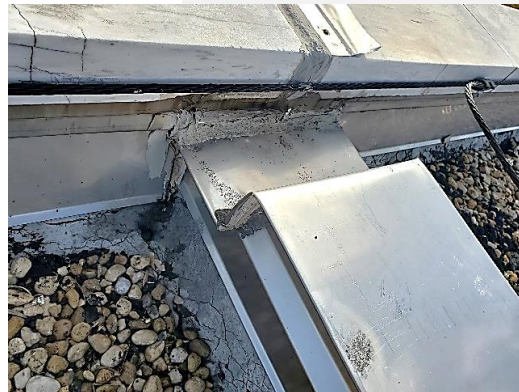
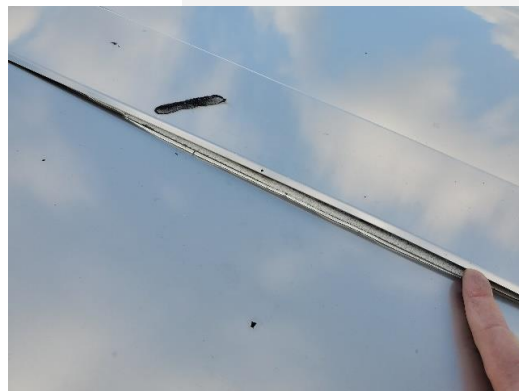
There are a number of conditions that need maintenance and targeted repairs. This will extend the service life of these roofs to beyond the 5-year projection of this study. Existing coal tar pitch BUR assembly should retain sufficient integrity and durability to persist for another decade or more, with proper localized maintenance.

Engage a qualified roof consultant and contractor to conduct comprehensive maintenance survey of in-situ coal tar pitch BUR roof membrane assemblies to identify all lead pipe boots, penetration flashings, and membrane blisters that require maintenance repair/replacement. Complete necessary repairs to BUR assembly in-kind and replace all exposed joint sealants at sheet metal expansion joint covers and perimeter flashing conditions.

Engage qualified consultant to investigate active water infiltration at kitchen exhaust penetrations. Engage qualified consultant to design and contractor to complete scope. Implement roofing repairs, as developed by consultant investigation, to address ongoing water infiltration. Patch edge of concrete slab at rough opening. Repair existing steel beams framing opening where corrosion has occurred.

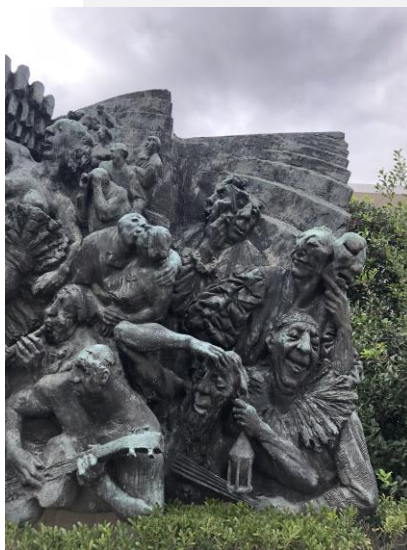
All the sculptures in the central grounds require a conservation campaign to clean soiled surfaces, remove staining, and repair and renew lost and deteriorated coatings. Treatments which should be addressed include: cleaning to remove atmospheric soiling (all sculptures), renewal of wax coating on bronze sculptures (*Don Quixote*, *Amerika*, and *War or Peace*), patina correction on bronze sculptures (*Don Quixote*, *Amerika*, and *War or Peace*), paint repair or recoating on the aluminum sculptures (*Untitled*), copper stain removal on the stonework (*Don Quixote*), and coating stabilization (*Untitled*).

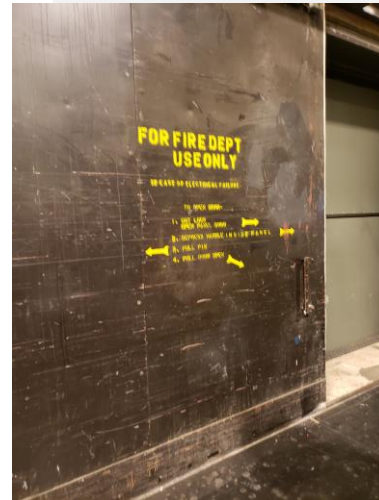
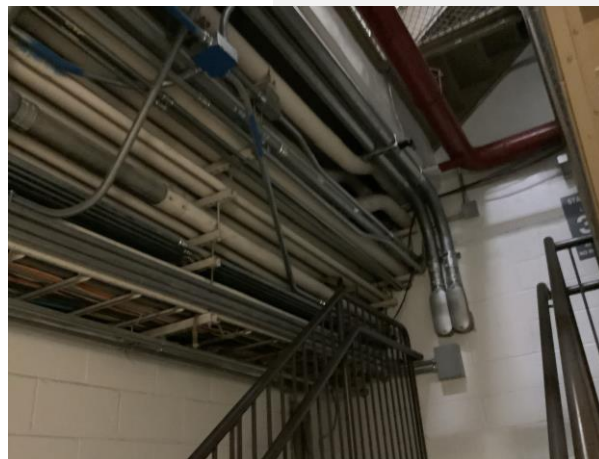
The building consists of many fire doors in fire -resistance rated assemblies. The Kennedy Center is to perform a NFPA 80 mandated fire door assembly inspection with a written record. During survey, fire doors were observed with broken latches and deficiencies. Each door assembly investigation must be performed by a qualified person in accordance with NFPA 80. This includes a visual inspection before testing and the closing of all fire doors by means of activation during testing.

Penetrations in rated walls must be sealed in order to maintain the fire-resistance rated capabilities intended. There are several rated walls that have unsealed penetrations. These areas include the exit passageways on Level B, the fire pump room, Stair 2-10, and Stair 4-8. For purposes of this estimate assume 10 unsealed penetrations in the Level B exit passageway, Level A generator room, pump room, and in stair 4-8. Stair 2-10 contains approximately one hundred conduit runs through the enclosure.

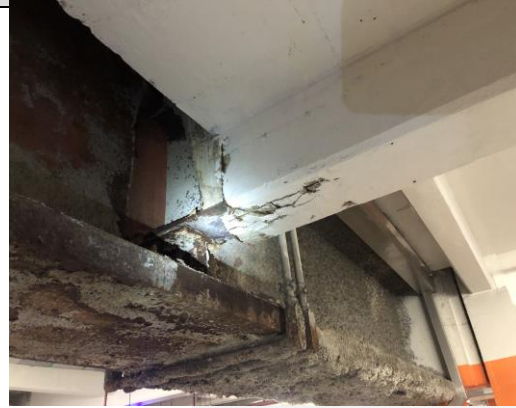
Spray applied fireproofing and concrete fireproofing was found to be in deteriorating condition in several locations during site investigation. Assess the condition and application of the existing spray applied fireproofing throughout the building, particularly mechanical spaces and the garage. Note locations and document where fireproofing is damaged and produce an estimated cost for remediation.

Within the main building, local areas of missing fireproofing encasement have been identified at the roof terrace level. This project will investigate the extent of missing fireproofing at roof terrace level atrium and identify required repairs. Repairs assumed to include patching fireproofing where existing concrete encasement at steel beams has been locally chipped out to facilitate installation of hung pipes or conduit and providing fireproofing at existing steel trusses where not currently encased or spray applied, east of the atrium.

The scope represents the likely effort involved at a minimum of 10 individual locations, but not all locations could be identified during the CBP assessment. A dedicated analysis of the affected areas in the mechanical spaces and garage should be included in the scope of work to ensure the scope of the remediation is accurate and specific.

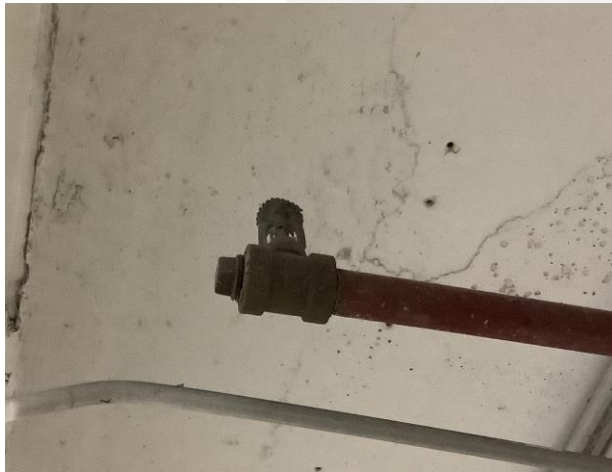
The sprinkler system is past typical life span. Repairs to the system will be necessary to ensure adequate protection in case of a fire emergency.

Perform a piping investigation of the dry-pipe sprinkler systems. Investigation shall include an inspection of the dry-pipe valves and a survey of the interior of the dry-pipe sprinkler piping at a sprinkler main, a sprinkler cross main, and a sprinkler branch line. Each dry-pipe sprinkler zone on all garage levels will be sampled.

Samples of piping, including a main section, a cross main section, and branch line section shall be taken and submitted for metallurgical testing to determine the condition of the pipe. Sprinkler system shall be restored for operation at the end of each survey. Sprinkler contractor shall be on hand to drain system, to access the interior of piping, to take samples, and to restore system to operation.

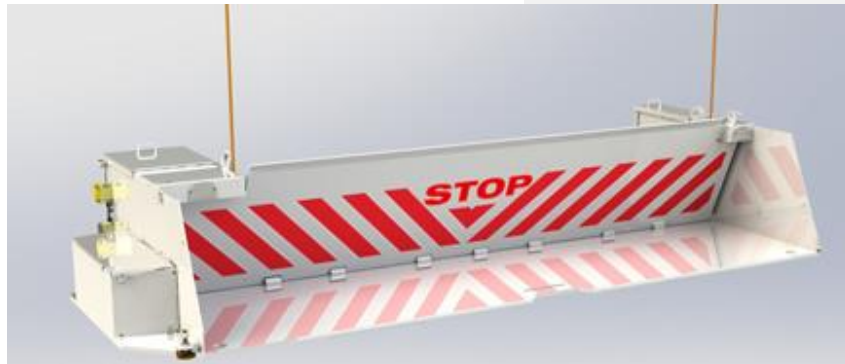
During assessment of the condition of the security systems and posture of the Kennedy Center it was noted that there is little in the way of perimeter reinforcement, like fences. Of particular note was the lack of vehicle control, like bollards and barriers.

The scope of this recommendation is to install retractable wedge barriers at control points along the access roads for the center. These barriers will restrict access along intended access routes and make identification of threats more actionable as they circumvent the obstructions.

Provide vehicle (wedge) barriers to enhance vehicular access control to the site in an emergency. The budget estimate includes 4 wedge barriers, intended for installation across all lanes of traffic on 25th street and F Street. The cost estimate also includes installation of actuating controls at the location of the stakeholders' preference. Likely in the Security Operations Center.

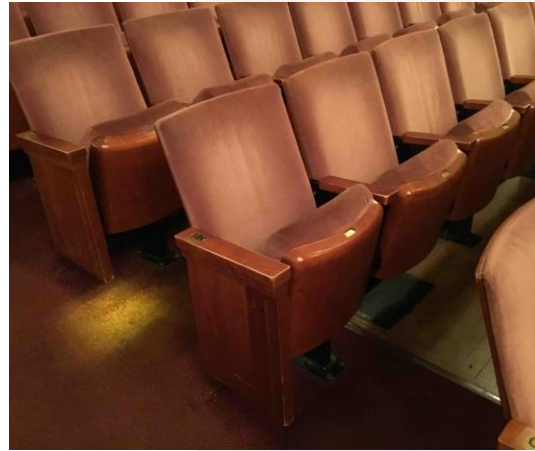
The existing seats are beyond their useful life, require constant maintenance to keep operable, and should be replaced. The carpet is worn and recommended for replacement. Several railings do not match typical handrails used throughout the hall - non-matching railings will be replaced to standardize handrails throughout hall. Improvements also include repair and refinishing of wood railings at cross aisles and painting of perimeter walls and painted partial height walls in audience chamber.

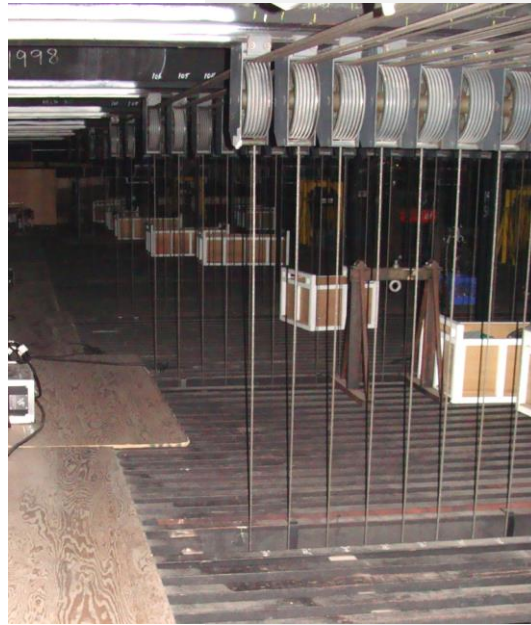
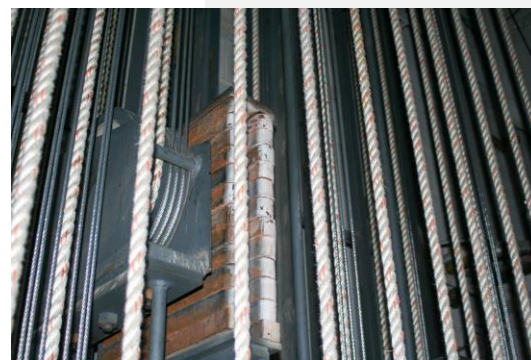
The manual double-purchase counterweight rigging systems in the Opera House and Eisenhower Theater are aging, inefficient, and potentially unsafe. The systems do not meet the rigorous technical expectations of contemporary performances and are in need of replacement with motorized automated rigging systems.

A detailed study and cost justification, including implementation strategy and impact of venue closure and lost revenue, is planned in FY 2023. This study will fully explore the spacing and arrangement of new automated rigging hoists as well as structural and electrical impact of the upgrades.

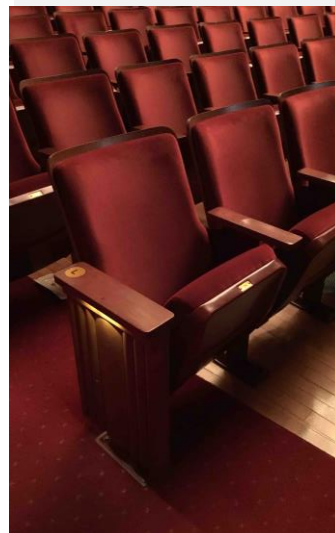
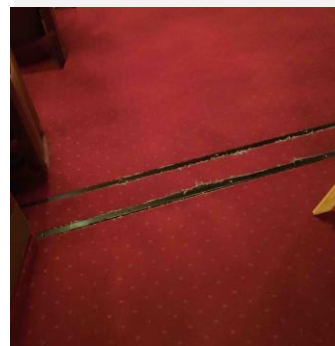
The Opera House interior improvement needs are limited. Most finishes are still in good condition except for the wear of the fixed seating since a renovation in 2003. The carpet is showing signs of wear, and frayed edges were observed throughout, particularly at cable tray paths.

Renovations include replacement of fixed seating and carpet. Fixed seating will be removed and replaced and new broadloom carpet with wood wall base and cable pathway covers will be installed throughout the hall.

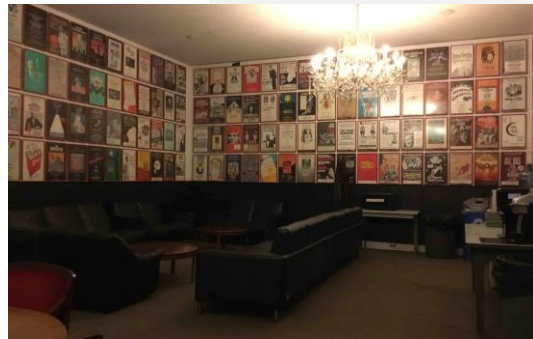
The Eisenhower Theater Green Room finishes and furnishings are worn and no longer appropriately represent Kennedy Center's identity as a premier arts institution. The Green Room lacked an adjacent kitchen, and this need was previously addressed by incorporating a kitchenette in the adjacent corridor. Additionally, a table with coffee makers and a freestanding small fridge with a microwave were added in the Green Room. These solutions appear provisory and do not fully address the need for a catering kitchen.

The Eisenhower Theater Green Room will be fully renovated. Improvements will include replacement of carpet, new wall and ceiling finishes, lighting, and new furniture. A new dedicated 250 sf catering kitchen will be provided directly adjacent to the Green Room. Equipment will include commercial refrigerator, commercial ice machine, commercial dishwasher. Plumbing equipment will include commercial double compartment sink, hand sink, and mop sink. A new built-in millwork with built-in small undercounter refrigerator and beverage cooler, small sink and water line for coffee maker will be provided in the Green Room.

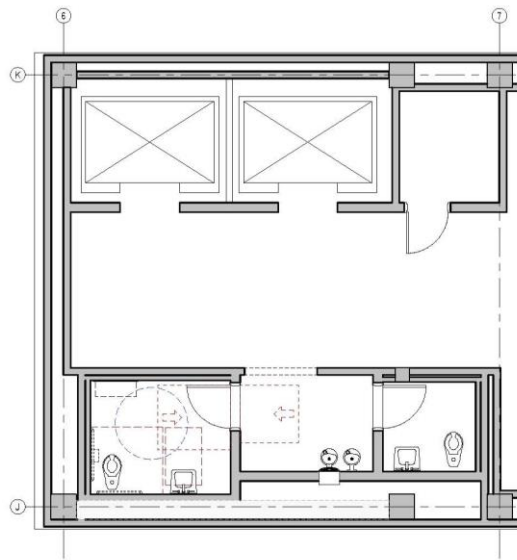
The purpose of the project is to renovate and upgrade the existing public restrooms located in the Motor Lobbies of Parking Level A, B and C. There are 4 single use restrooms (2 men's and 2 women's) located on each of the parking levels B & C. There are 4 multi-use restrooms (2 men's and 2 women's) located on parking Level A. The restrooms received a minor upgrade in 2008 but, except for the women's restrooms on Level A, the existing finishes have not been replaced. The existing restrooms finishes are dated and in poor condition.

The proposed design shall renovate the existing restrooms to provide new fixtures, toilet accessories, finishes, light fixtures and replace existing deteriorating domestic water and sanitary piping. The new design shall comply with current building code and meet or exceed the requirements for accessibility.

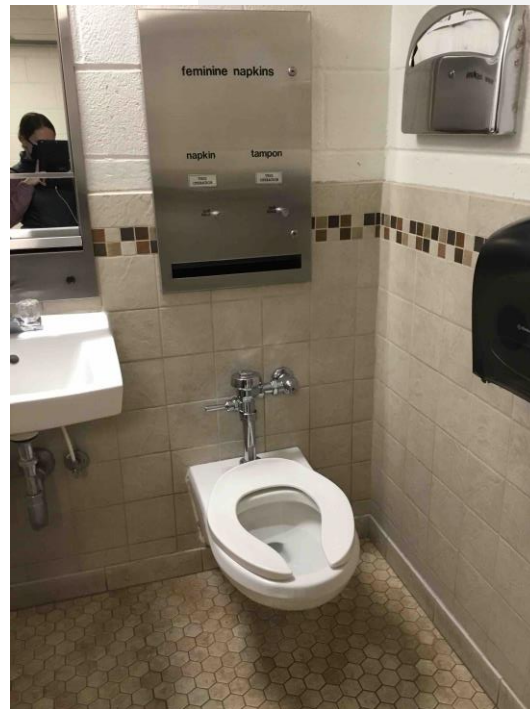
Some back-of-house and staff area bathrooms do not meet current ADA maneuvering clearances and mounting heights of fixtures and accessories. Many public and back-of-house bathrooms have plumbing fixtures, light fixtures, wall and floor finishes and countertops that are aging and appear worn.

Back-of-house and public bathrooms should be renovated in phased approach that aligns with the sanitary piping and domestic water system upgrades. First phase will include full renovation of public and back-of-house bathrooms in the Eisenhower Theater block. In all remaining bathrooms throughout the Kennedy Center, all manually operated faucets, flush valves, soap dispensers and paper towel dispensers will be replaced with automatic fixtures and accessories.

Full renovation scope includes replacement of existing finishes, fixtures, accessories, and toilet partitions. Each group toilet room will include at a minimum one large wheelchair toilet compartment and one ambulatory toilet compartment with all required grab bars. All unisex toilets will be fully accessible with grab bars and clearances as required by ADA.

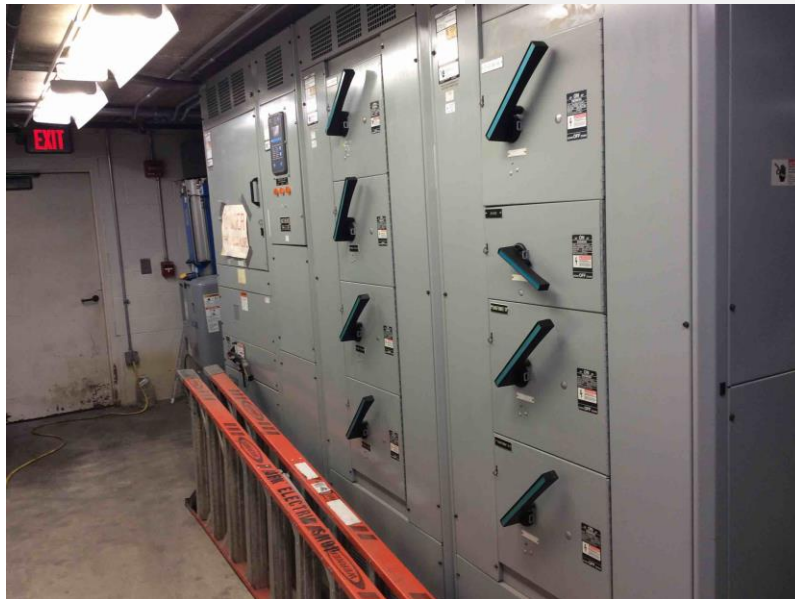
The primary switchboard rooms on the 17' level are noted as needing additional temperature and humidity control to protect equipment. This includes seven separate rooms. The scope includes provisions for new split-system DX cooling, with condensing units located in the garage. The estimated sizing is two-tons per room.

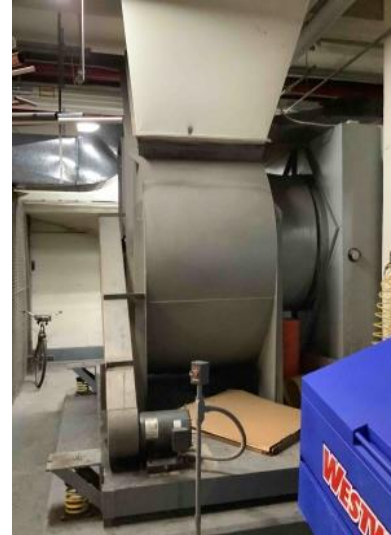
The majority of existing fans are original, with spot replacement of components over their lifetime. This proposed scope includes work originated in the 2015 CBP and includes replacement or refurbishment of return, general exhaust, and garage exhaust fans, with the exception of fans flanking MER 3 (E-1, 2, 3, 8, 9, 10, 34, 38), which are newer. The scope includes 55 utility return fans, 56 utility exhaust fans, 11 inline exhaust fans, and 29 wall mounted propeller fans (vent/exhaust). For this work, prioritization should be given to utility exhaust fans. Return fan utility sets should be replaced in conjunction with remaining work on associated air-handling units.

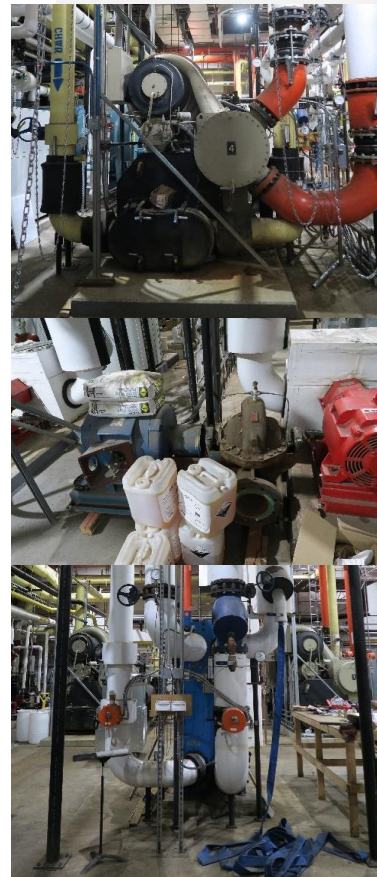
4.4.4 – Waterside Economizer Upgrade. Due to the increased cooling demand of the REACH project, additional waterside economizer capability is necessary. The existing plate and frame heat exchanger should have additional plates added up to an additional 150 ton capacity.

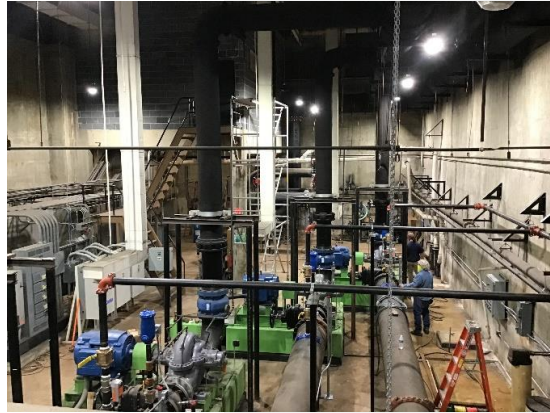
4.9.5 – River Pump Room Conditioning. The existing river pump room is currently only served by a heating and ventilation unit. With significant equipment upgrades in 2020, enhanced conditioning is recommended to prevent excessive temperature and humidity conditions for equipment life and operator maintenance. The existing pump room is 5,500 sf with an estimated 10 tons of cooling capacity. Provide split-system unit with condensing unit located in garage (Option 1) or chilled water AHU with branch piping from central plant (2") @ 500 ft run (Option 2). Indoor unit shall be ceiling hung with ducted supply air distribution system.

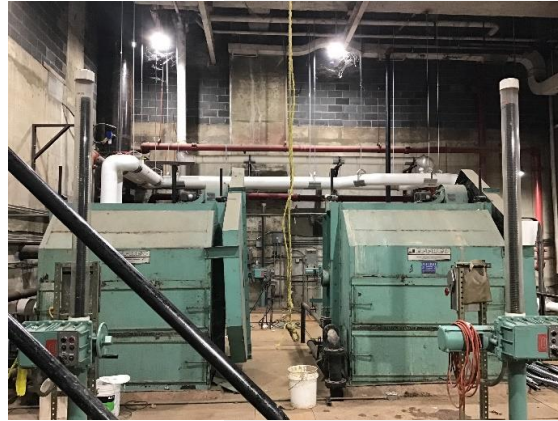
4.9.6 – Condenser Water Filtration Updates. Significant upgrades to the river pump room condenser water equipment were made in 2020, including replacement of pumps, piping, system fill/priming, and controls. While the system's duplex strainer was replaced, the traveling screen system, which acts as a first stage of filtration, has not yet been upgraded. This scope completes work required for the condenser water pump system, with replacement of two traveling screen units.
