# John F. Kennedy Center for the Performing Arts

## 2021 Comprehensive Building Plan – Presentation of Facts and Findings

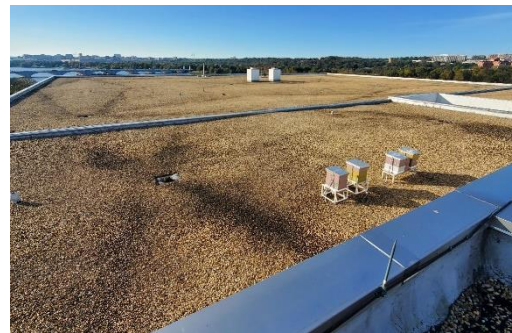
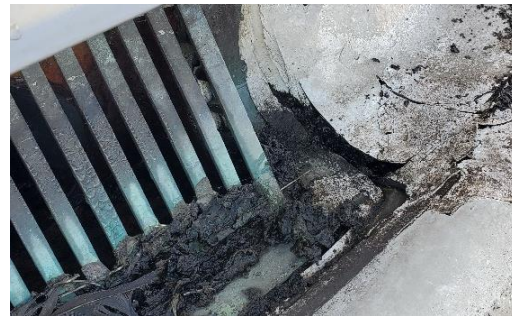
#### Main Roof

- The gravel-surfaced coal tar pitch BUR roof membrane assemblies are in fair condition overall. 10 years with maintenance.
- Approximately 15 to 20 isolated locations requiring near term maintenance include:
  - Failed lead pipe boots
  - Cracked/split membrane penetration and base flashings
  - Field of membrane blisters / brittle "soft spots"
- The joint sealants at the sheet metal expansion joint covers and perimeter flashings are cohesively failed.

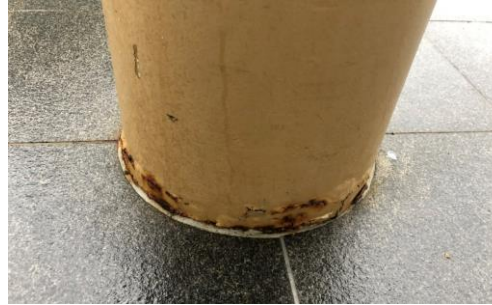
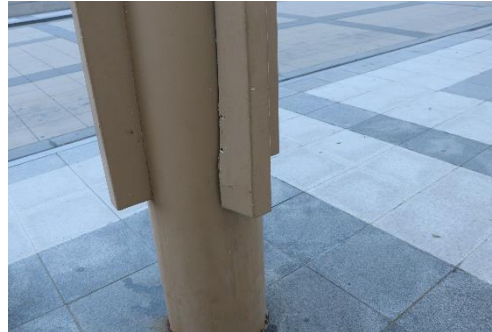
#### Plaza Level

- Mild surface corrosion and flaking paint was observed at the base of approximately 50% of the columns.
- Additional distress types noted include:
  - Chipped, scratched, and missing paint
  - Chalking and discoloration
  - Cracked paint along fin joints
  - Discrete bent, separated, and corroded metal fin bases
  - Bird droppings and bird proofing

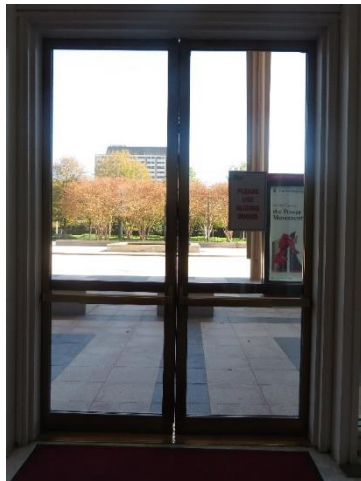
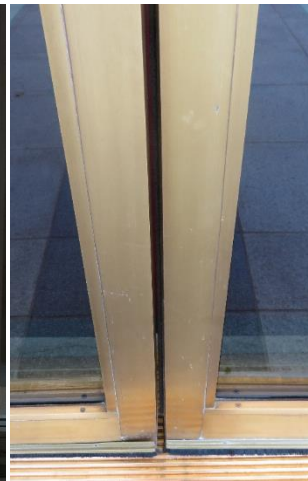
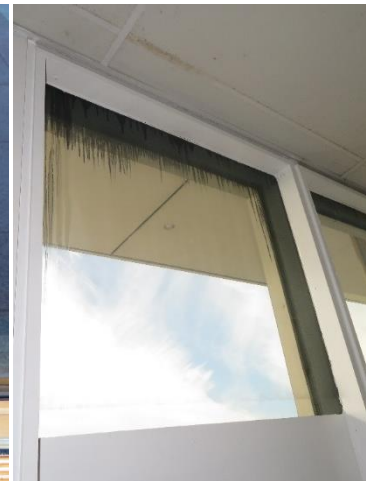
#### Exterior Metal Doors

- The doors are functional and are in good condition except for weatherstripping, discrete missing components, and some surface corrosion.

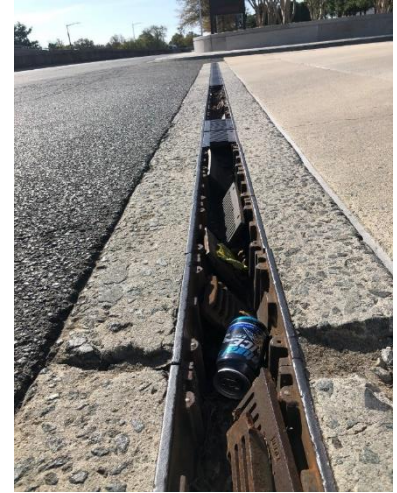
### Existing trench drains

- The existing drains along the sidewalks and courtyard area were observed to have leaves and trash.
- The existing trench drains between the plaza and main road were observed to be severely broken and full of trash and debris.

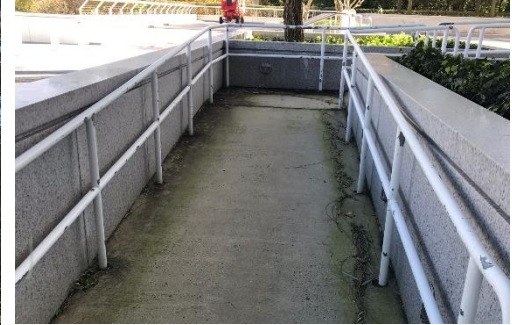
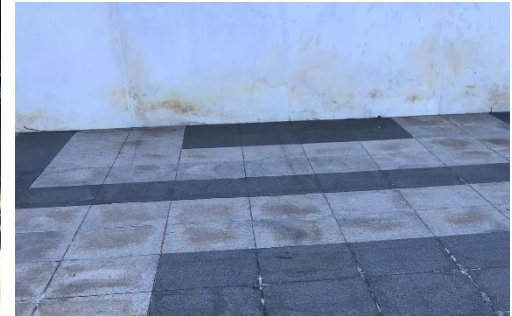
### North Plaza, East Plaza and River Plaza

- Willows are old and in decline. Some have been severely pruned or removed already. Others have been reinforced with cables.
- Pavers in pedestrian area show signs of wear: chipped edges, staining, crumbling mortar.
- Ivy is dying back in planting area by vehicle entrance. Grass is growing through Liriope. Inkberry Hollies are over pruned and leggy.
- Railings at ramps have chipping paint and rust stains at connections to concrete.
- Concrete is cracked in multiple locations and there is general staining. There are cracks in the concrete walls at lights.

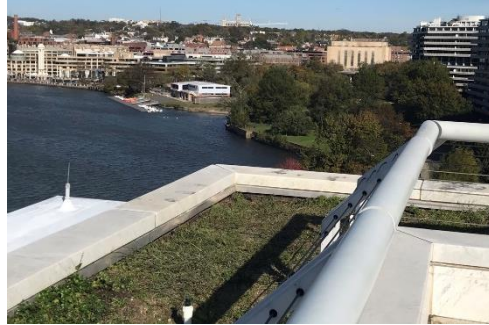
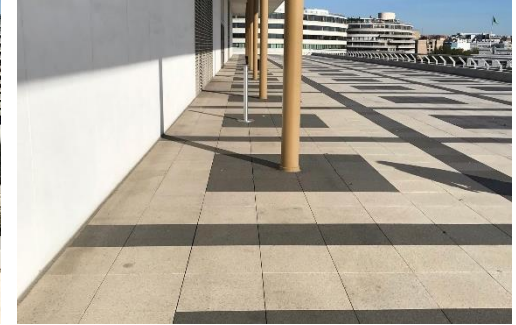
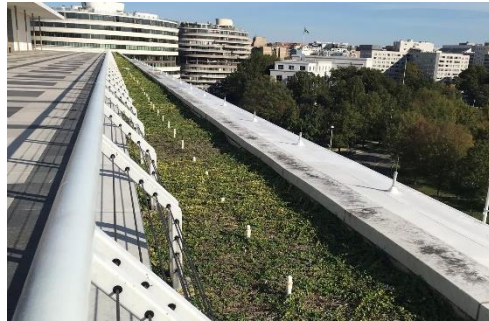
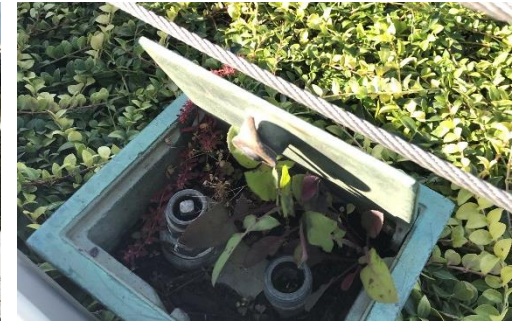
### Roof Terrace

- The paint on the railings is chippings and showing signs of wear.
- Terrace pavers are stained near building and air vents.
- Some pavers on the roof terrace have uneven gap spaces.
- Vinca in the northwest corner planter is struggling, probably because of wind and harsh conditions. Weeds have grown in.
- Irrigation valves in the roof terrace perimeter planter have broken or missing covers.

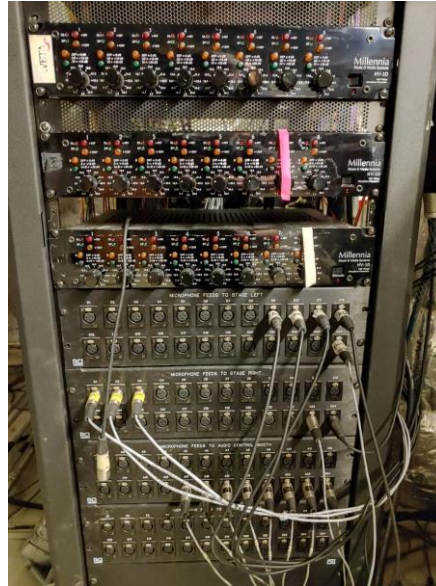
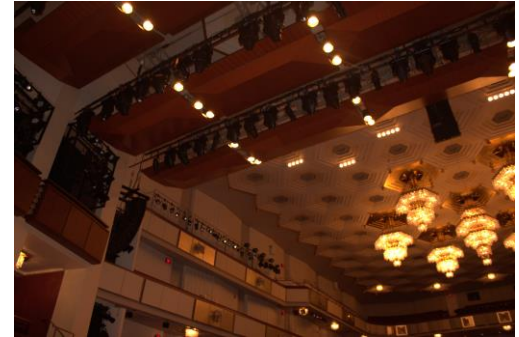
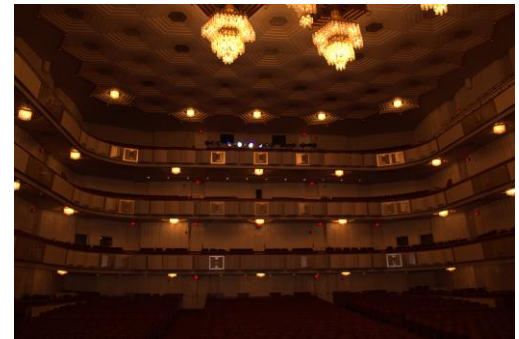
### Concert Hall Audiovisual and Theatrical Items

- The existing recording rack in the attic space is difficult to access, and should be in a clean and better controlled environment to preserve the life of the electronics
- The Box Front of House Mix Position is inadequate for large-scale live sound events
- The Central Line Array Speaker Assembly is currently positioned to fire into the chandeliers blocking coverage to upper seating areas

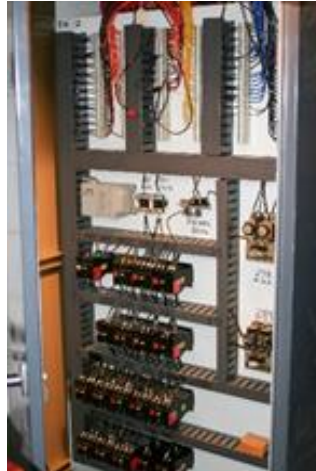
### Opera House

- Existing double-purchase counterweight rigging systems are aging and are time and labor-intensive to use.
- Existing orchestra pit lift controls and safety interlocks are aging, obsolete, and in some cases failing.

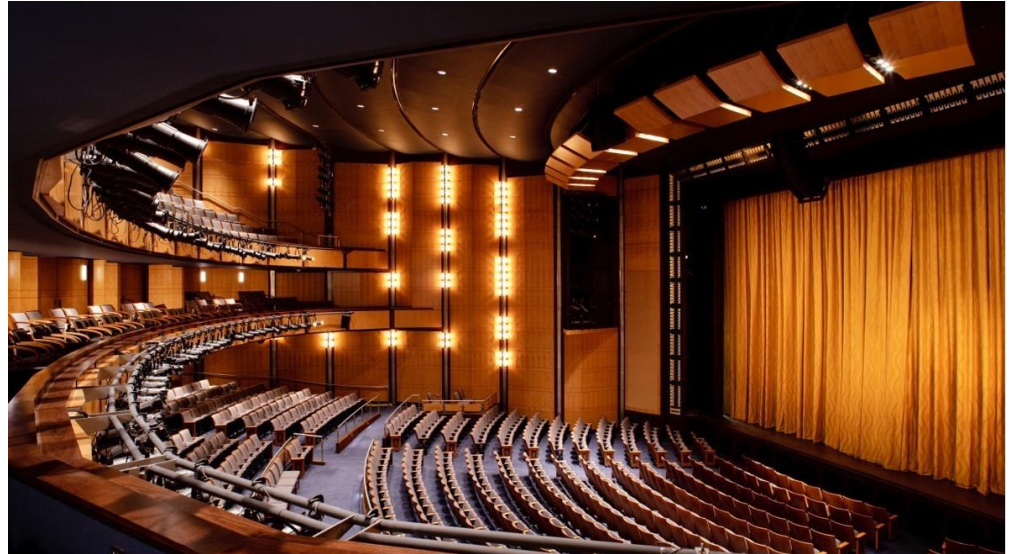
### Eisenhower Theater

- Existing double-purchase counterweight rigging systems are aging and are time and labor-intensive to use.
- Limited flexibility for music performance, space is acoustically too "dry"

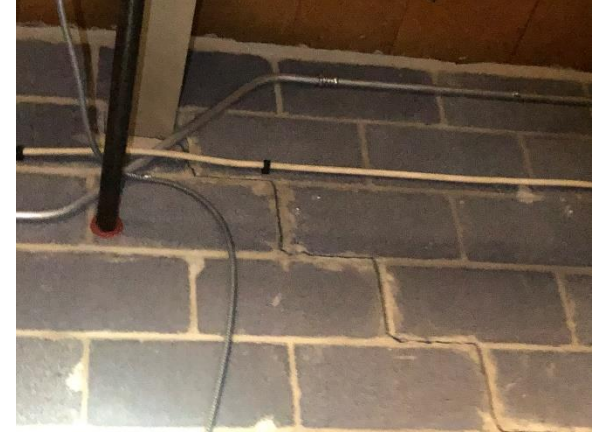
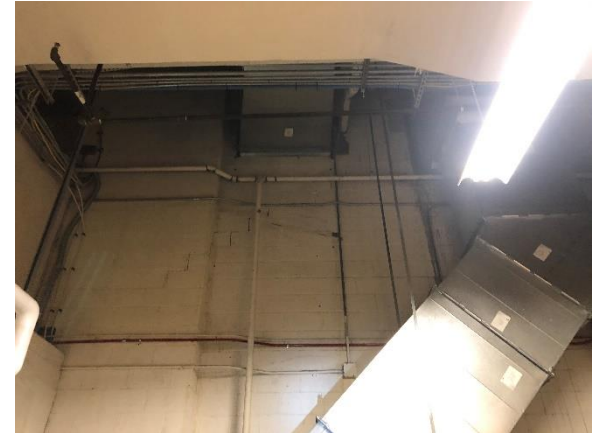
### Interior CMU Partition Cracks

- Mechanical rooms and backstage areas typically have exposed CMU partitions, which are non-load bearing walls
- At many locations where beams pass through walls, the gap between the beam and wall has been grouted or sealed, resulting in load transfer and cracking through the wall
- Several duct penetrations through the CMU walls in MER spaces are unframed (no lintel) and have step cracks forming near opening

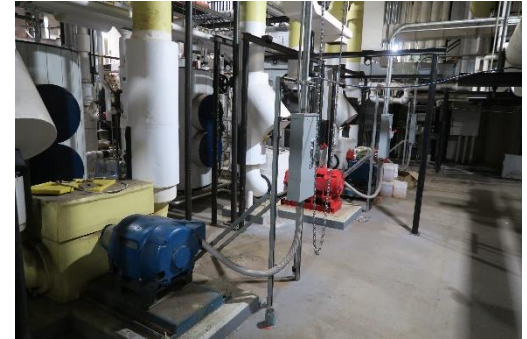
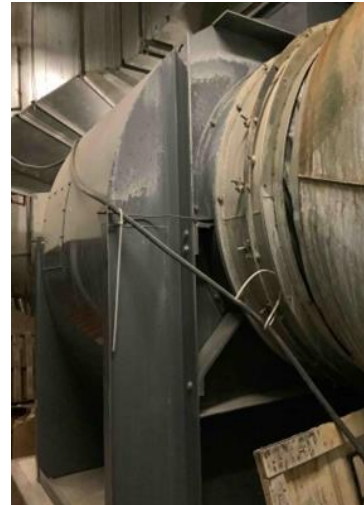
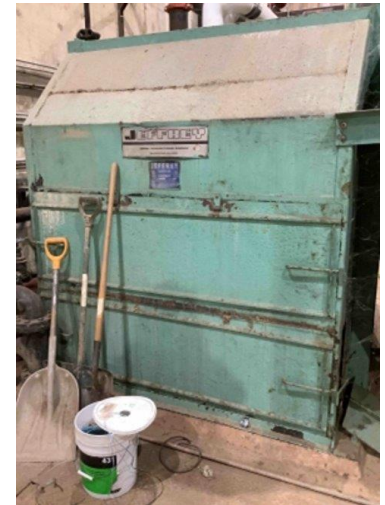
- Garage exhaust fan refurbishment needed, including variable speed drive work
- Continued work required on heating and cooling plant due to aging equipment, including eventual chiller and condenser water filtration component replacement.

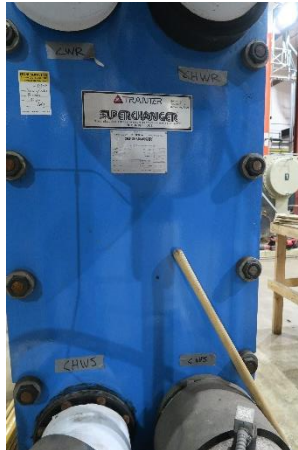
- Increased winter cooling demand requires additional plate and frame economizer capacity.
- Boiler plant flue noted to have leakage. To allow preventative maintenance, providing a smaller summer boiler allows operating flexibility.
- A dedicated cooling and dehumidification system for the main condenser water pump room will help protect newly installed equipment.

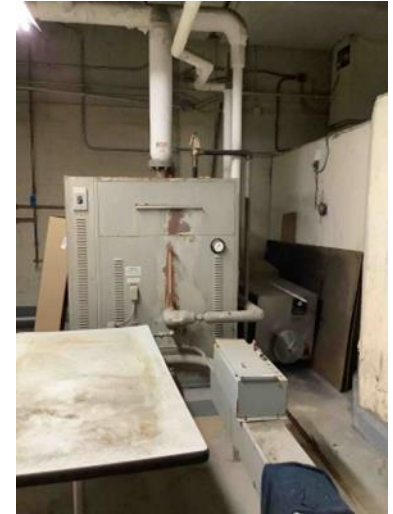
### General HVAC

- The balance of AHU upgrade work is recommended to complement previously completed work on coil and supply fan components. Existing original return air section cabinets are in poor condition.
- No longer used electric boiler and hot water heating equipment takes up space area that can be used for other purposes, like storage.

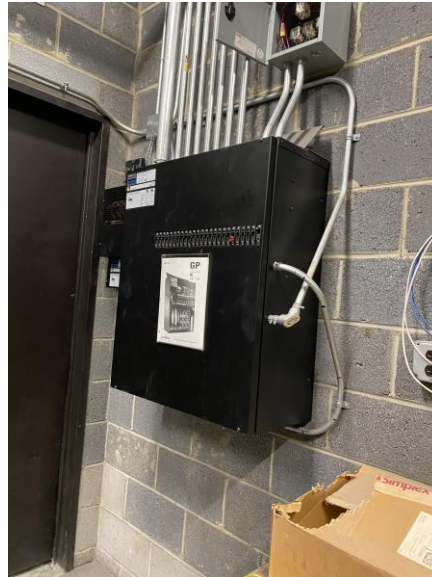
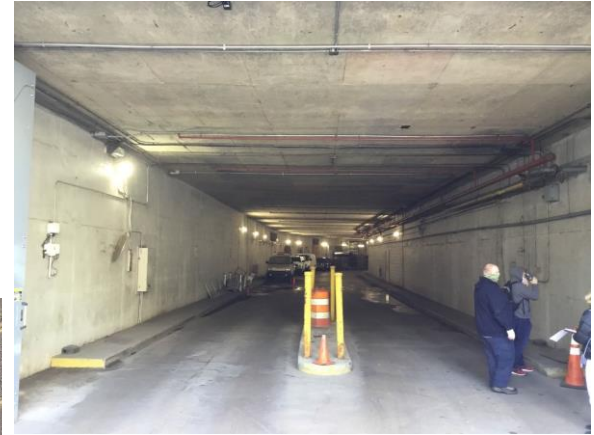
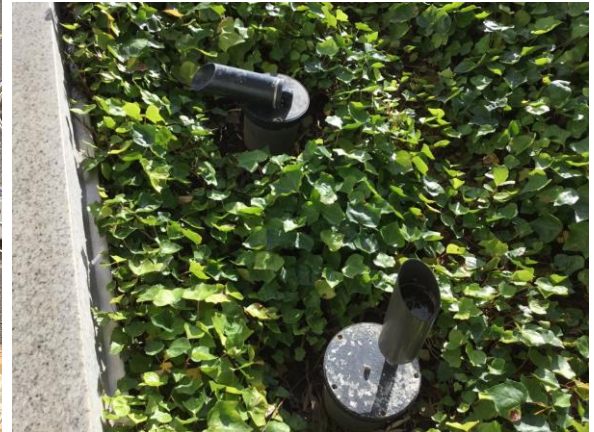
### Lighting

- Lighting system is not centrally controlled at one single location. Central control would reduce maintenance for interior and exterior fixtures.
- Site street lighting control by JFK but powered by PEPCO.
- Many decorative fixtures have incandescent lamps that can be replaced with LED.
- Garage lighting does not follow most recent code ASHRAE 90.1.

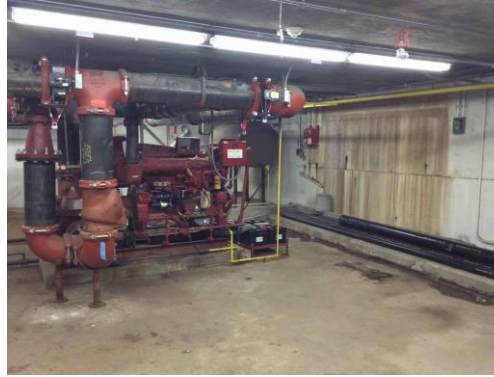
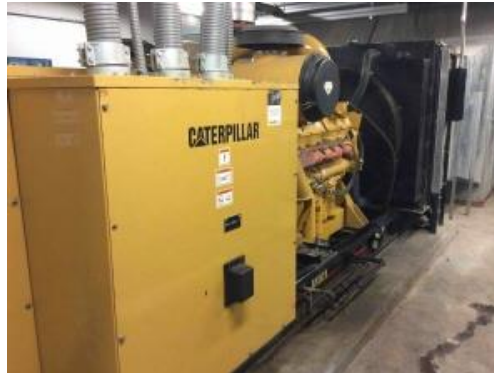
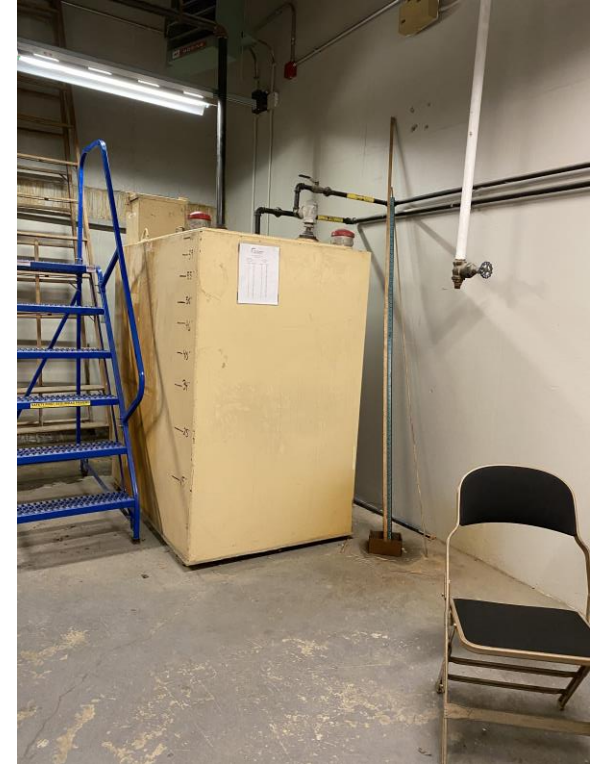
- Study may be needed to confirm correct genset size. Genset does not seem large enough to power all emergency and standby loads in the building. Generator and fuel storage may need to be upsized.
- Fire pump not served from an emergency source.

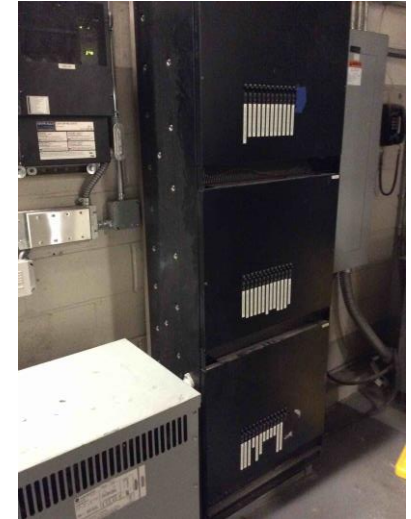
- Electrical equipment near boilers has water damage/rust. Equipment is located in an area that has danger of water sprays when boilers are undergoing maintenance.
- Exterior camlock enclosures are NEMA 1 rated.
- Some circuits on lighting control panels that are not lighting related.
- Various ground mounted transformers are not installed on top of concrete pads.

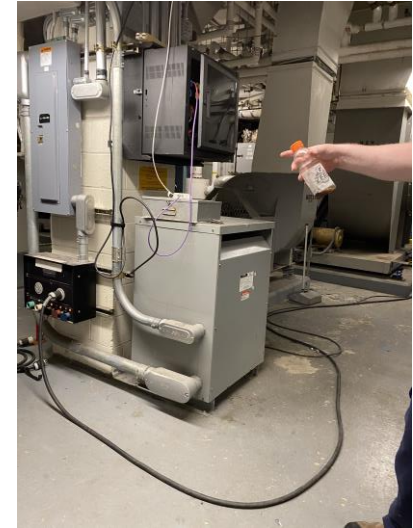
- Electrical equipment near boilers has water damage/rust. Equipment is located in an area that has danger of water sprays when boilers are undergoing maintenance.
- Exterior camlock enclosures are NEMA 1 rated.
- Some circuits on lighting control panels that are not lighting related.
- Various ground mounted transformers are not installed on top of concrete pads.

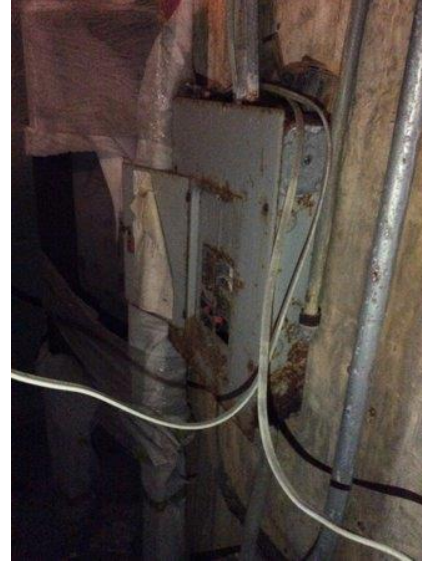
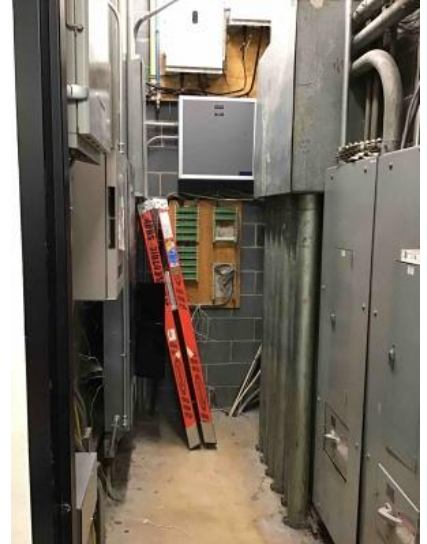
- Equipment/material not associated with electrical system is being stored in front of electrical equipment.
- Areas with abandoned electrical equipment, controls, conduit, raceway, and wiring.

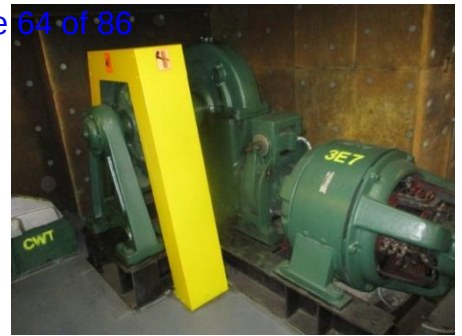
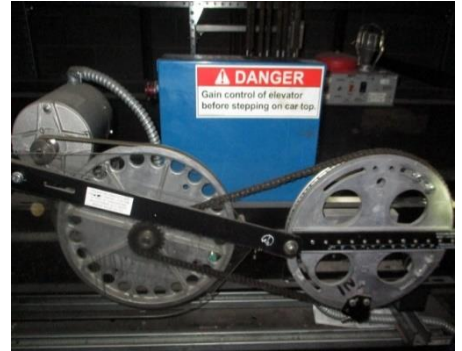
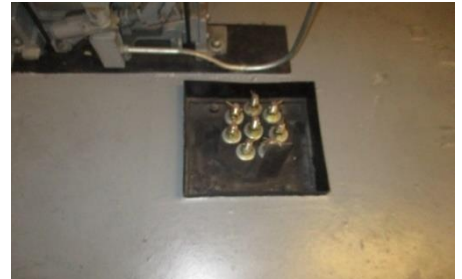
Elevators are in varying conditions based on past repairs and maintenance. Obsolete equipment that should be replaced with next round of renovations include:

- Original Geared Traction Elevator Machines
- Obsolete Otis I-Motion II Door Operators
- Missing Hitch Plate Covers
- Original Counterweight “Pull Out” Safeties
- Original Car Safeties
- Original Otis Flyball Speed Governor
- Original Machine Deflector Sheaves
- Original Governor Car/Counterweight Tension Sheaves
- Original Car and Counterweight Sheaves

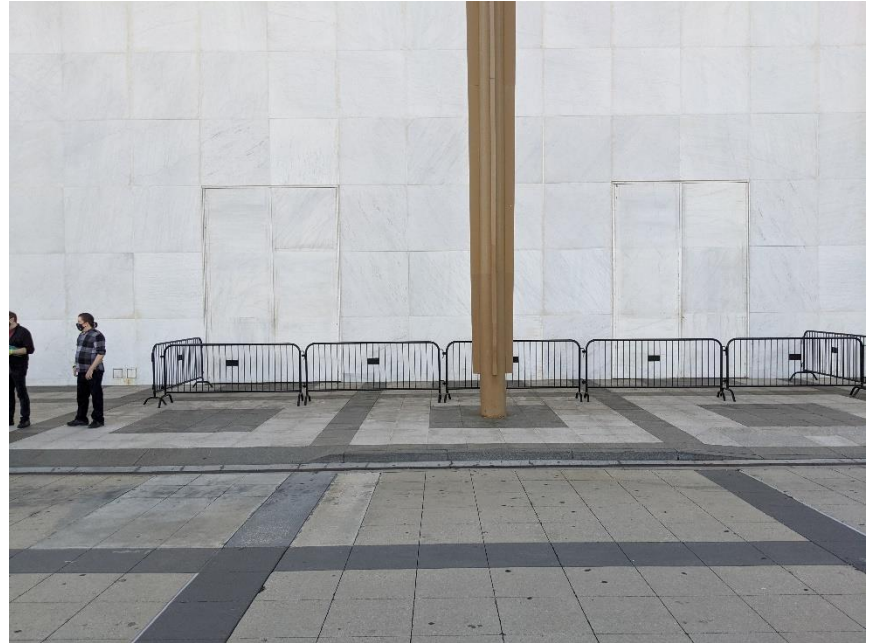
- Opera House and Eisenhower Theater loading is through exterior doors from front plaza using forklifts. This is a safety issue.
- Dock lift recessed in pavement should be considered.

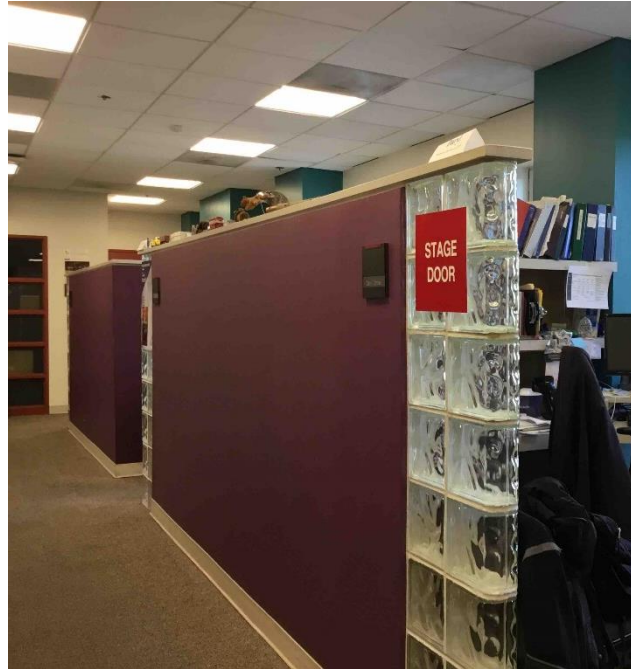
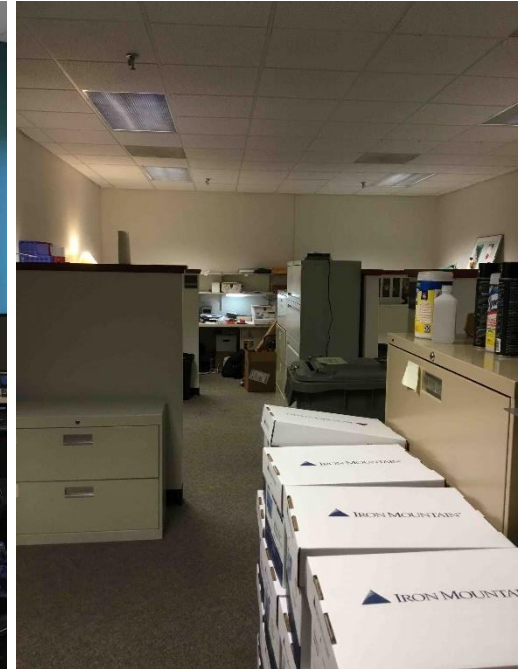
- Partial renovations and improvements have been completed since original building was completed – no comprehensive current building model including building systems or set of documents exist
- Comprehensive life safety assessment of current conditions is needed

- Project specifications vary from project to project resulting in variations of models and manufacturers of products (e.g. light fixtures, door hardware, ceiling tile etc.)
